Applies To: **See VEHICLES AFFECTED****July 19, 2012****Popping or Clicking When Turning the Steering Wheel**

(Supersedes 09-078, dated October 23, 2009, to revise the information marked by the black bars)

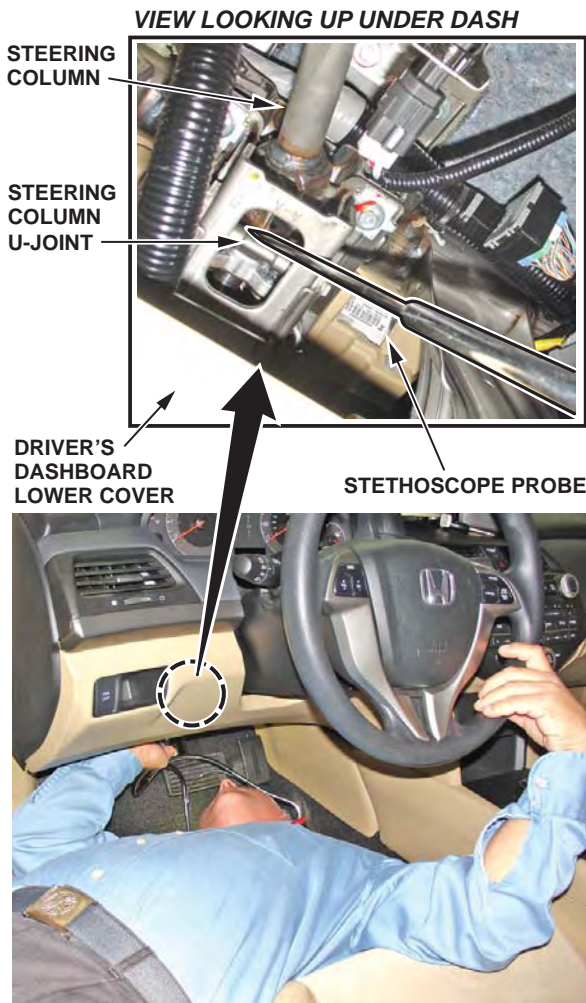
1. With the transmission in P and the parking brake set, start the engine, and let it idle.
2. Tilt the steering column all the way down, and pull it all the way out.
3. Using a stethoscope or a ChassisEar, listen to the lower area of the steering column while turning the steering wheel.

*Do you hear a pop or click from the steering column in the area shown below?*

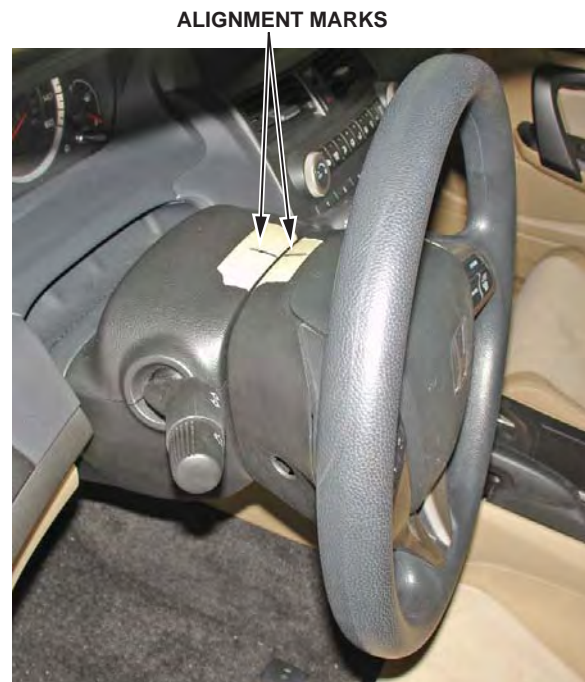
- Battery Terminal Disconnection and Reconnection
  - Driver's Airbag Removal/Installation
  - Steering Wheel Removal/Installation
  - Driver's Dashboard Lower Cover Removal/Installation
  - Steering Column Cover Removal/Installation
  - Front Toe Inspection/Adjustment
1. With the engine idling, set the steering wheel/front wheels in the straight ahead position, then turn off the ignition switch, and remove the key.
  2. Stick a piece of masking tape on top of the steering wheel hub and another on the steering column cover, then draw a line in the middle of both pieces of tape. This helps to align the steering wheel when you reinstall it later.

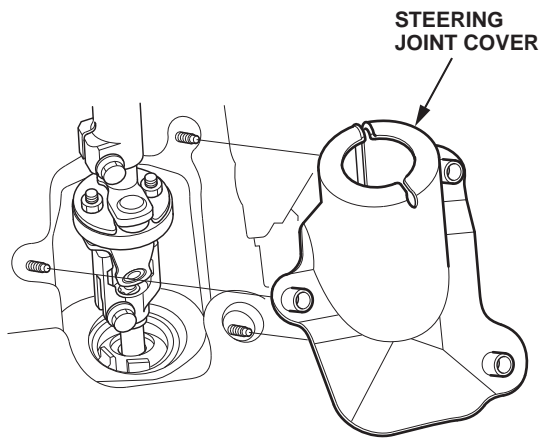
8. Remove the steering joint cover.

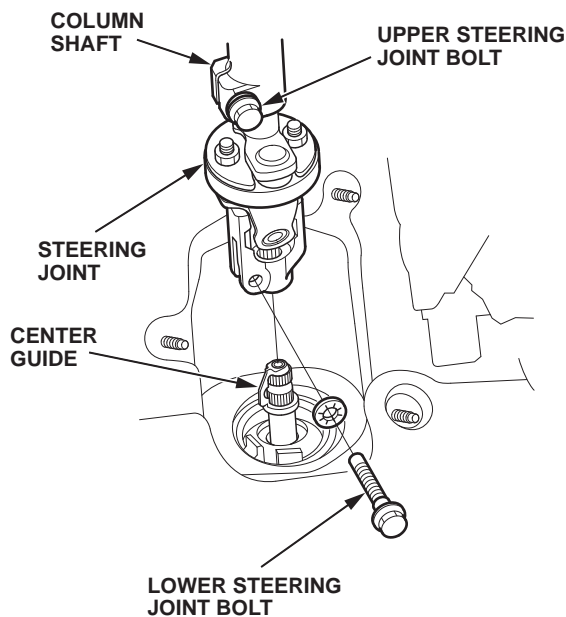
9. Loosen the upper steering joint bolt, and remove the lower steering joint bolt. Disconnect the steering joint by sliding it toward the column shaft.

- Do not disconnect the steering joint from the column shaft.
- If the center guide is in place on the pinion shaft and hasn't moved, leave it in place. If the center guide is out of place, discard it.

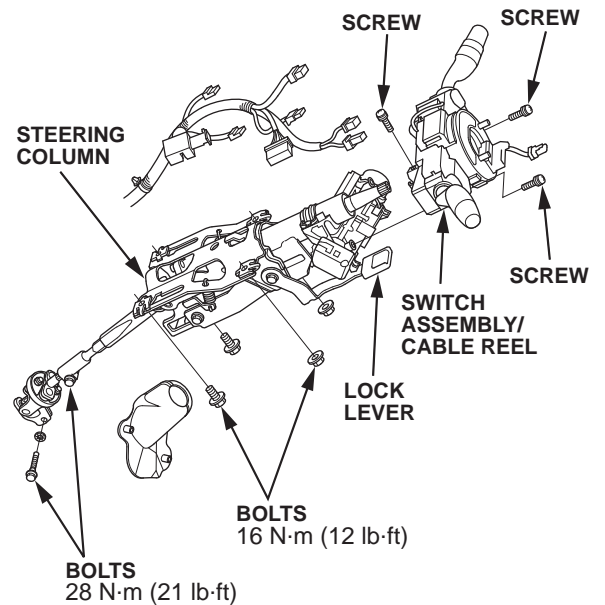
10. Remove the steering column:

- Disconnect the wire harness connectors from the combination switch assembly/cable reel.
- Remove the combination switch assembly/cable reel from the steering column shaft by removing the three screws. Make sure not to turn the cable reel.
- Disconnect the ignition switch connectors, then release the wire harness clips from the steering column.
- With the lock lever in its locked position, remove the steering column by removing the attaching nuts and bolts, and then carefully guiding it out of the dashboard.

NOTE: Do not release the lock lever until the new steering column is installed.

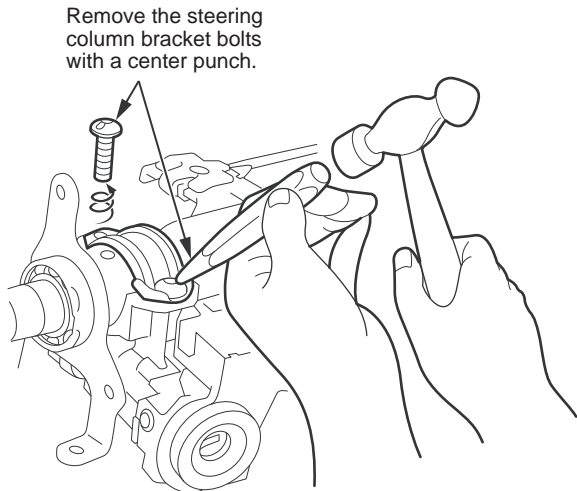
11. Remove the steering lock from the original steering column:

- Using a center-punch and a hammer, carefully “walk out” the two bolts from the steering column bracket. Discard the bolts.
- Remove the steering lock and its bracket from the steering column. The steering lock and the bracket will be reused on the new steering column.

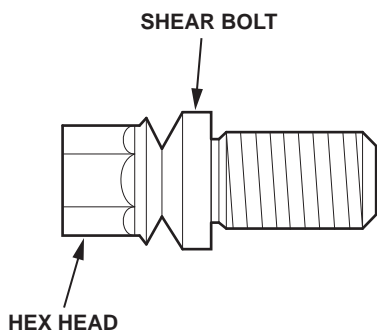
12. Install the steering lock and its bracket on the new steering column, and loosely tighten the new steering lock shear bolts.

14. Tighten the steering lock shear bolts until their hex heads twist off.

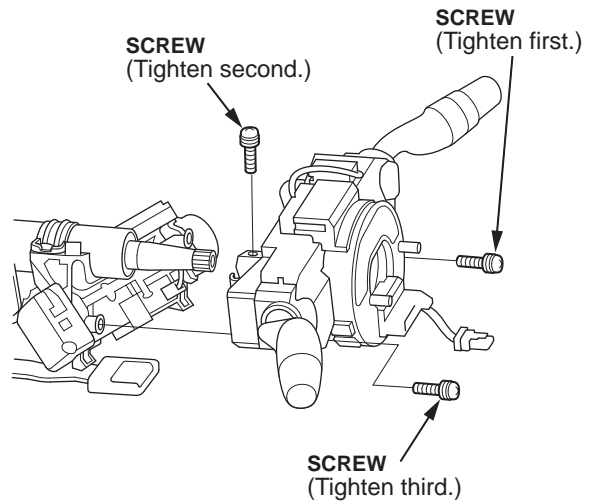
15. Carefully guide the new steering column into place, then install the attaching nuts and bolts, and tighten them to the torque in the illustration.

17. Reinstall the combination switch assembly/cable reel on the steering column shaft, reconnect the wire connectors, then tighten the three screws in the order shown below.

NOTE: If the cable reel was turned while the combination switch assembly/cable reel was off, center the cable reel: Turn it clockwise until it stops, then turn it counterclockwise about three turns (until the arrow on the cable reel label points straight up).

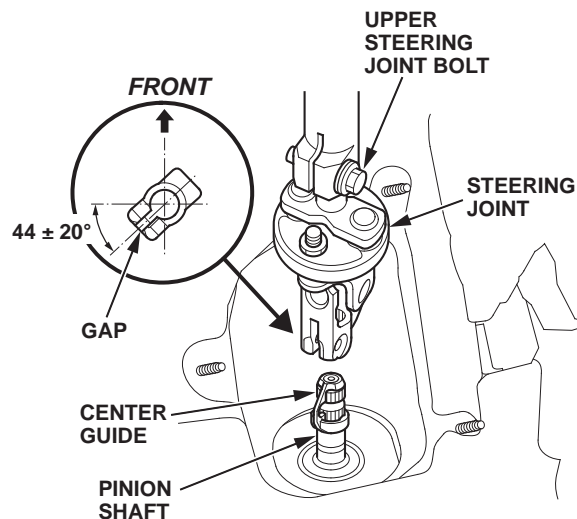
18. Check that the steering rack is still centered within its stroke, with the front wheels straight ahead. Then slip the lower end of the steering joint onto the pinion shaft.

- If the center guide is in place on the pinion shaft, install the steering joint by aligning it with the center guide.
- If there is no center guide on the pinion shaft, position the steering joint by aligning its gap within the angle shown below.

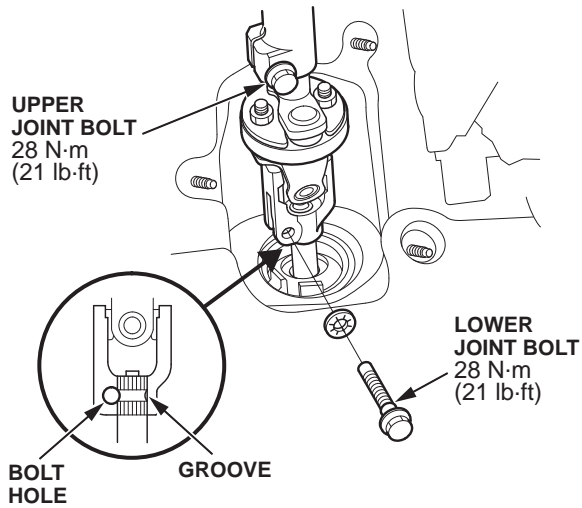
- Align the bolt hole on the steering joint with the groove around the pinion shaft, then loosely install the lower joint bolt. Make sure the bolt is securely in the pinion shaft groove.

- Pull on the steering joint to make sure it's fully seated, then tighten the lower joint bolt and the upper joint bolt to the torque in the illustration.
