Technical Service Bulletin

01 MIL on, R8 Intake Air Hose leaking

24 12 27 2029233/1 April 23, 2012.

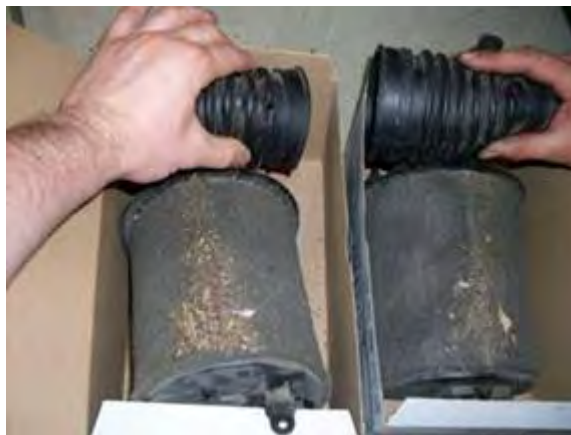
The air filter change intervals are provided for vehicles operated in normal conditions. In unusual driving situations, for example, driving on dusty roads or on race circuits, the air filter can get dirty quicker than normal. Because of the position of the air intake close to the ground behind the front wheel, a larger amount of dirt can get into the intake air in extreme situations (dust/race circuit).

On the R8, a clogged air filter can lead to MIL light, misfiring, and fuel trim related DTCs.

Figure 1. Example of excessive dirt on air filters.

1. Check for cracks/damage on both intake air hoses.
2. If either hose is damaged, replace both hoses and both air cleaner elements.

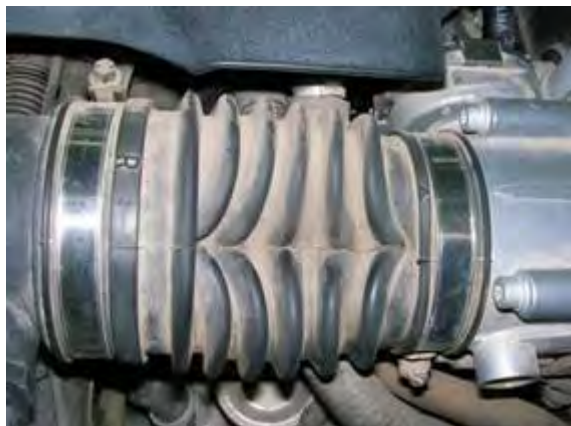
Because of the dirty air filter, not enough intake air is available for the engine. The resulting excessive vacuum in the air duct hose between air filter and throttle valve can collapse and damage the air duct hose.

Figure 2. Vacuum in the air duct hose between air filter and throttle valve.

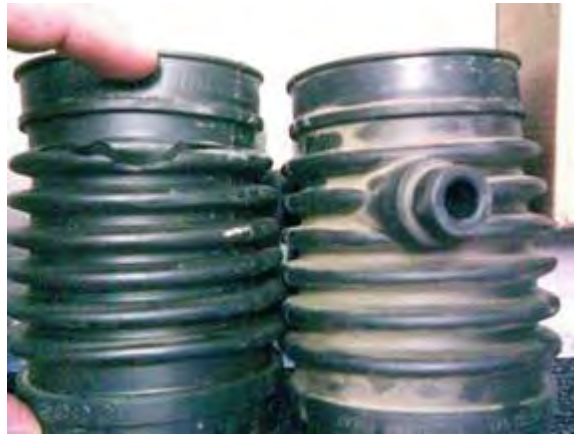
Repeated deformation of the hose can damage it.

Bypass air then gets in via a crack in the intake hose and can cause the MIL light to come on and fuel trim related DTC's.

Figure 3. Crack in the intake hose.
