UPDATE Technical Bulletin

72 12 01 July 10 2012 2029919

UPDATE – 72D8 Seat Linkage Bolts

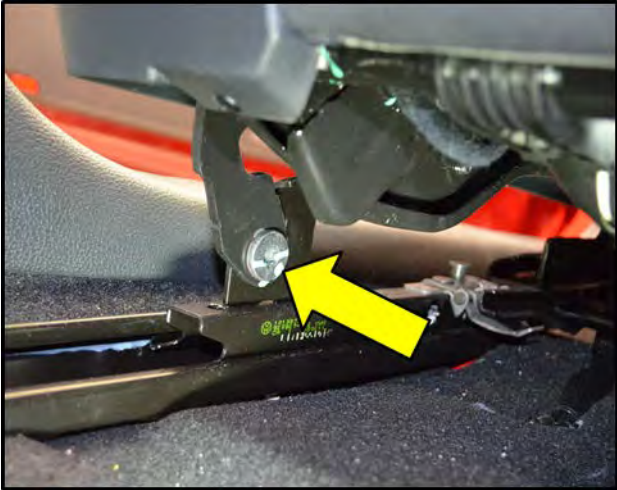
<p>Section A – Replace Link Bolts</p> <p>Note: Driver seat shown. Perform procedure on both front seats (if applicable) based on chart below:</p>

<p>Tip: To make repair easier, perform procedure on one bolt at a time.</p> <ul style="list-style-type: none"> • Move front seat forward. ⇐ Adjust seat height so that the seat bolt (link screw) <arrow> is accessible. ⇐ On left rear of seat frame, remove screw <arrow> using T-50 torx. • In same location, install new screw and washer from parts kit (5C6 898 515) first by hand, then tighten with ratchet equipped with T50 torx bit. ⇐ Torque screw <arrow> to 26 Nm. 	Criteria	Repair	01 & 02	Both front seats	03	Driver seat only
Criteria	Repair						
01 & 02	Both front seats						
03	Driver seat only

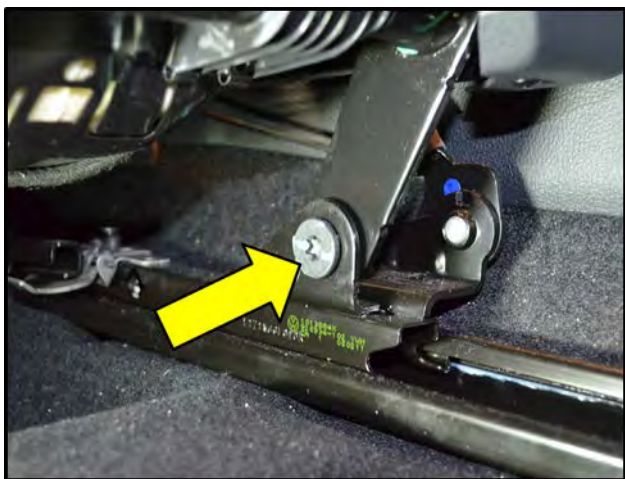
<ul style="list-style-type: none">⇐ On right rear of seat frame, remove screw <arrow> using T-50 torx.• In same location, install new screw and washer from parts kit (5C6 898 515) first by hand, then tighten with ratchet equipped with T50 torx bit.⇐ Torque screw <arrow> to 26 Nm.

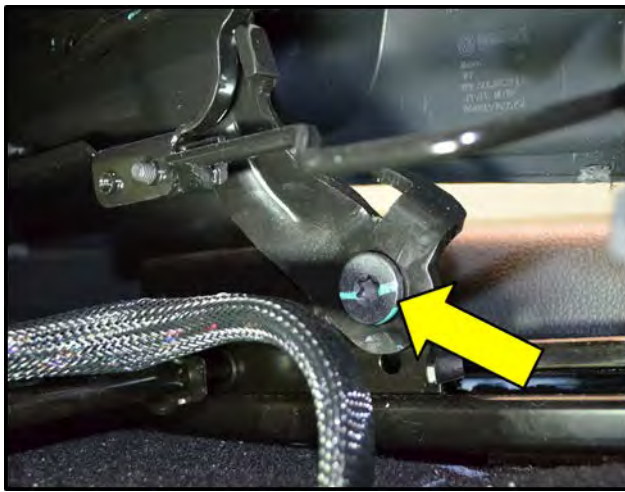
<ul style="list-style-type: none">• Move seat rearward so that the link screw <arrow> is accessible.⇐ On left front of seat frame, remove screw <arrow> using T-50 torx.• In same location, install new screw and washer from parts kit (5C6 898 515) first by hand, then tighten with ratchet equipped with T50 torx bit.⇐ Torque screw <arrow> to 26 Nm.• Vehicles with criteria 01 and 02, Move to opposite front seat and perform all steps above.• Vehicles with criteria 03 WORK COMPLETE <p>WORK COMPLETE</p>
