VOLVO D13 ENGINE – EGR VALVE STUCK ISSUE

Prevost vehicles

Special Bulletin

SP12-23

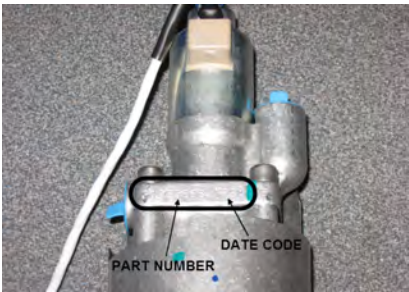
BEFORE UNDERTAKING ANY CORRECTIVE MEASURES, YOU MUST CHECK FIRST THAT THE PRESENT EGR VALVE IS REALLY INVOLVED. CHECK THE PART NUMBER AND DATE CODE ON THE EGR VALVE BODY (refer to the table of involved EGR valve below).

VOLVO PART NUMBER	DATE CODE OF AFFECTED EGR VALVE

1	21735861	from 086M to162M incl.	
2	21735862		
3	21735863		
4	21735864

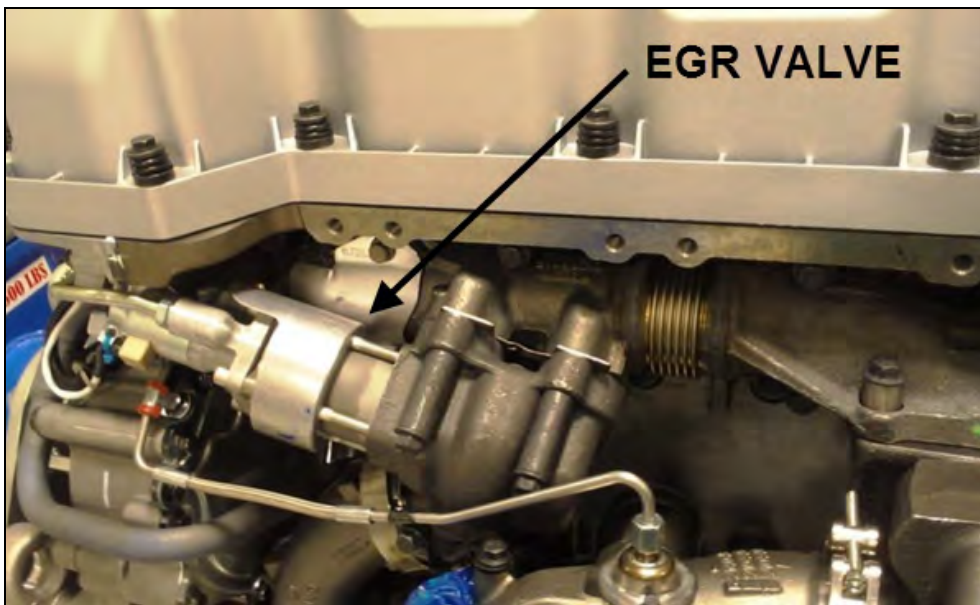
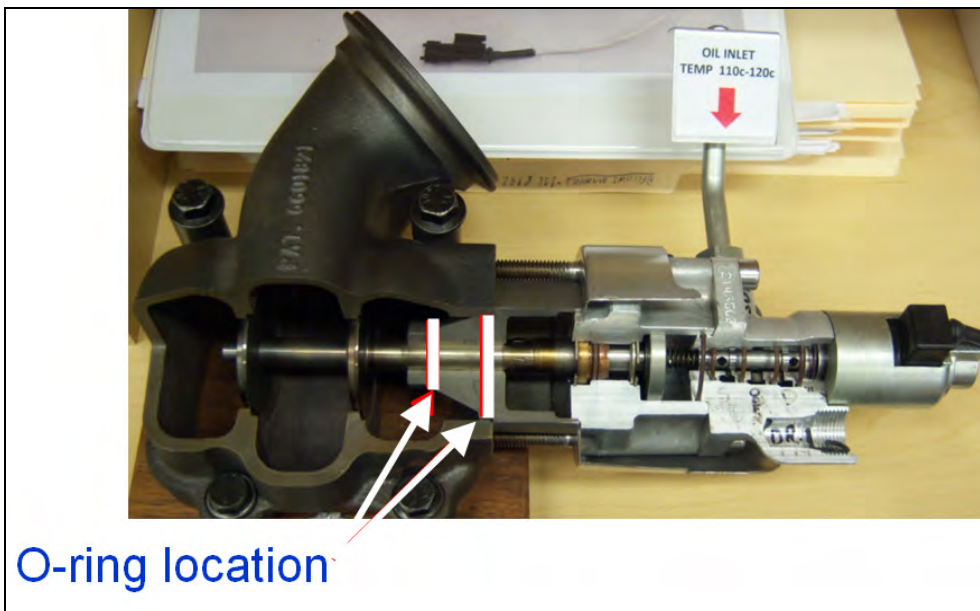
- To easy removal and replacement of the EGR valve, you must proceed to the standard removal procedure of the cooling pack (charge air cooler, radiator, radiator fan clutch and angle drive assembly). Remove the cooling pack and proceed to the EGR valve replacement as described in **EGR VALVE, REPLACEMENT** procedure found on IMPACT (see images below).

1) SERVICE TAB
 2) SELECT PREVH
 3) LOOK INTO FUNCTION GROUP 293
 4) CLICK ON SEARCH

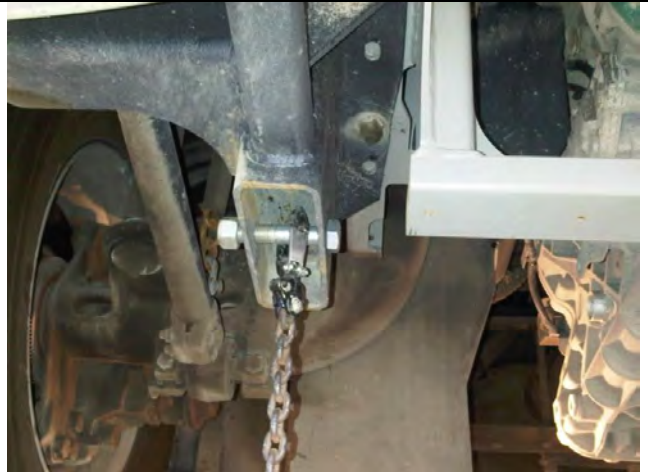
X3 MODEL

Use the holes at the bottom of 3x9 inches rear sub frame tube to bolt or hook the chain. Use at least grade 8 bolts, 3/4 inch diameter or M20.

Do not use the engine cradle to hold the vehicle

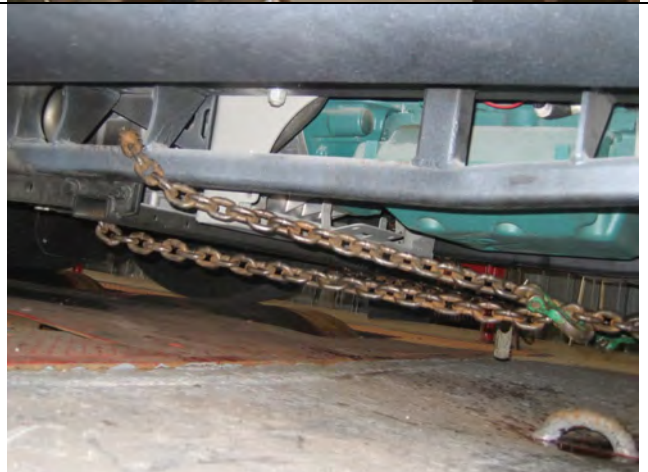
H3 MODEL

Route the chain around the bottom structure in front of the gussets and the transverse frame tube.

Do not use the engine cradle to hold the vehicle

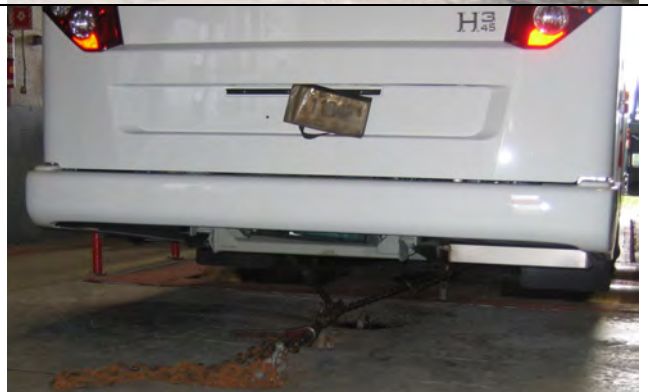
Attached the chain both side of the vehicle to form a "V" as long as possible.

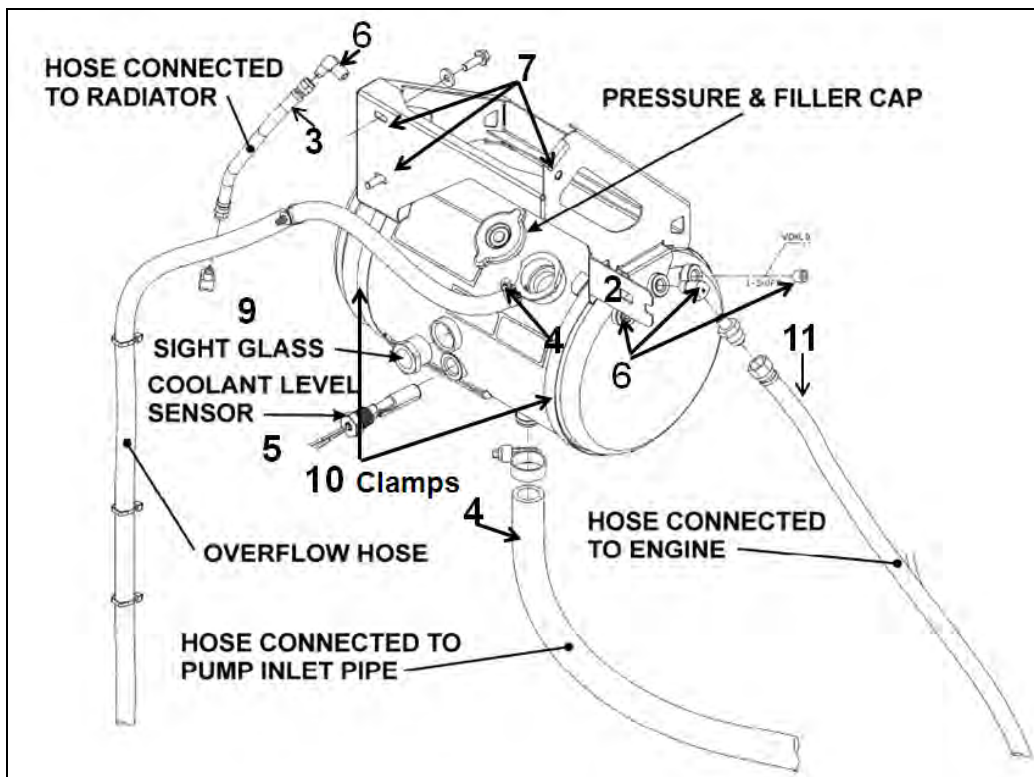
REMOVAL OF THE ORIGINAL COOLANT SURGE COOLANT SURGE TANK

1. Cut the tie wrap holding the DEF lines to the coolant surge tank bracket.
2. Disconnect each hose connected to the coolant surge tank.
3. Place a clean rubber tube into the coolant surge tank. Using siphon effect, drain coolant surge tank.
4. Remove tie wraps and unplug low level sensor connector (5).
5. Loosen all fittings and sight glass.
6. Remove 3 bracket bolts (7) and remove coolant surge tank and bracket. Pull the coolant surge tank through the SCR converter.
7. Turn the tank in order to have the level sensor at the top, in a vertical position and then unscrew it from the coolant surge tank.
8. Remove sight glass and all fittings from coolant surge tank.
9. Loosen band clamps (10) and separate coolant surge tank from bracket. Return to Prevost for full reimbursement.

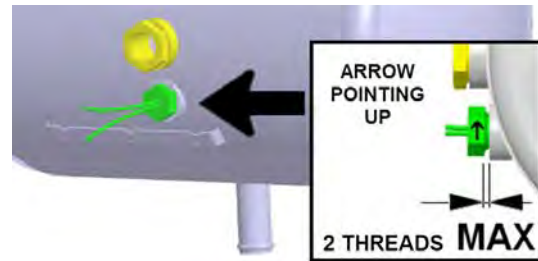
1. Using Loctite Thread Sealant 567 on threads, install level sensor in new coolant surge tank with sensor in a vertical position at the top of the tank. Tighten so that arrow on the side of the sensor is pointing up. Leave no more than two visible threads.

ARROW POINTING UP
NO MORE THAN 2 VISIBLE THREADS

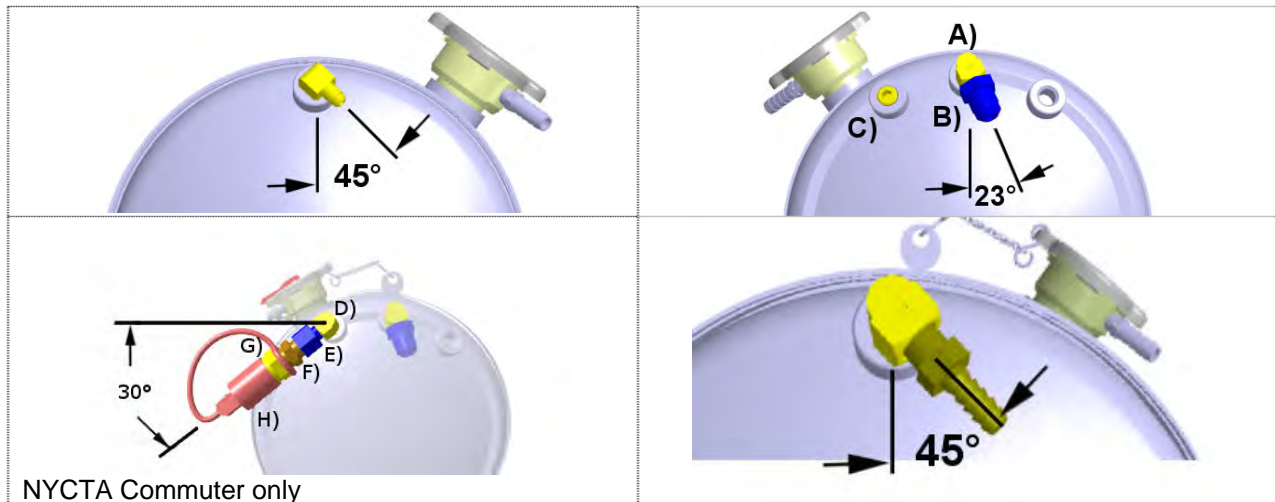
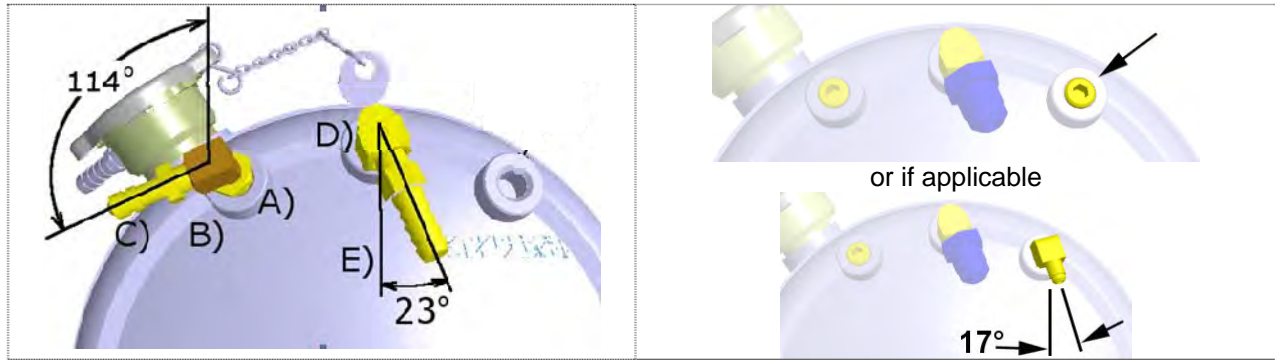
2. Install all hose fittings and sight glass using Loctite 567 Thread Sealant.

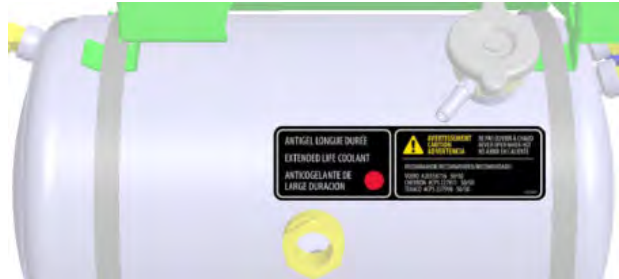
3. Affix decal #053597 on surge tank. For NYCTA Commuter coaches, affix decal #053625 in addition.

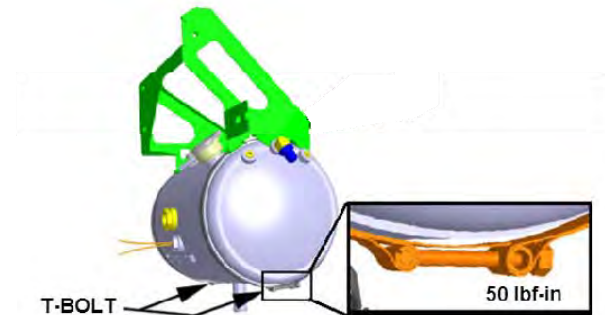
4. Fix surge tank onto support. Tighten T-bolt clamps to 50 lbf-in.

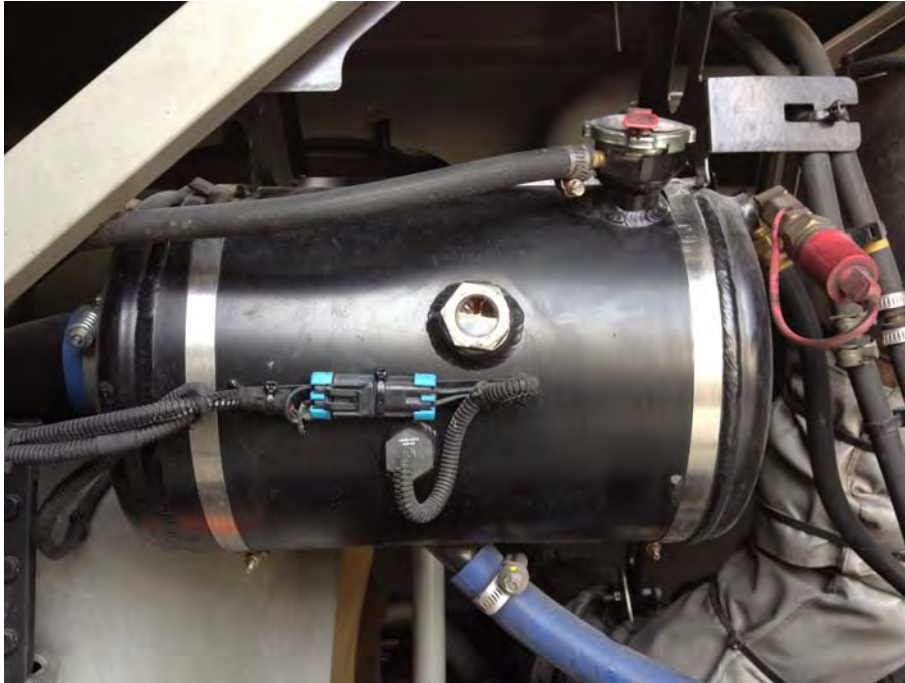
NEW COOLANT SURGE COOLANT SURGE TANK INSTALLED

5. Install coolant surge tank and support assembly in engine compartment. Tighten bolts to 16 lbf-ft.
6. Install all hoses and tighten properly.
7. Secure two DEF lines to tank support with tie wrap.
8. Use the cap from the original surge coolant surge tank on new surge tank.
9. Fill coolant surge tank to midpoint of sight glass and pressure test system. Close the heating system shut off valves to isolate this part of the system. Proceed to pressure test with 14 psi. Pressure should remain the same. Test for 5 to 10 minutes.
10. Run the coach and check coolant level once again.
