Seat Harness Routing
VN, VT

FSB 375-008, Seat Harness Routing

(August 2012)

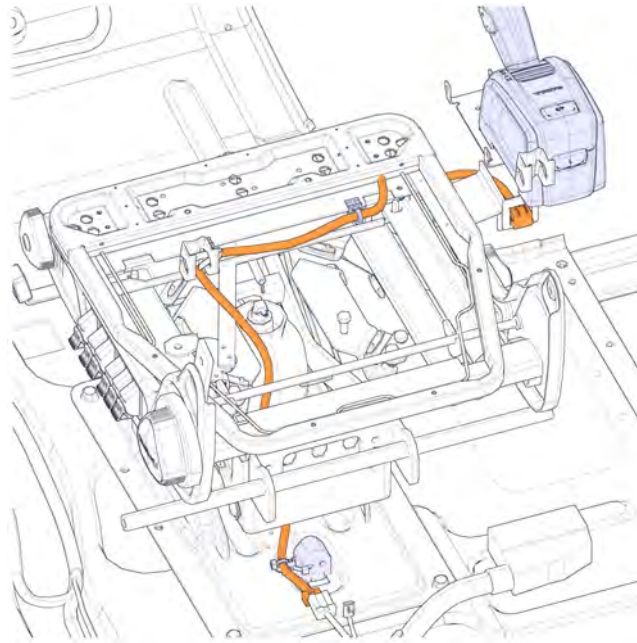
W3076418

On vehicles equipped with a driver side swivel seat and I shift transmission built prior to August 13, 2012, may experience the seat harness dropping or pulling away from the clipping points. This could lead to the harness rubbing or wires being pulled out of connectors during operation.

To correct the situation a new routing has been implemented to prevent the above failures.

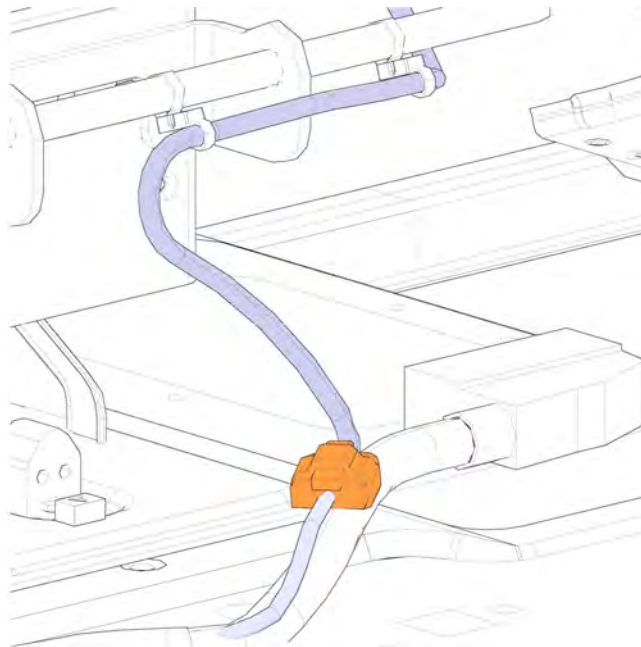
W3076413

- 1 Secure the vehicle for service by parking it on a flat level surface, applying the parking brake, chocking the rear wheel, and placing the transmission in neutral.
- 2 Disconnect all cables from the negative (ground) battery terminals to prevent personal injury from electrical shock and prevent damage to electrical components.
- 3 Disconnect the wiring harness connector at the floor.

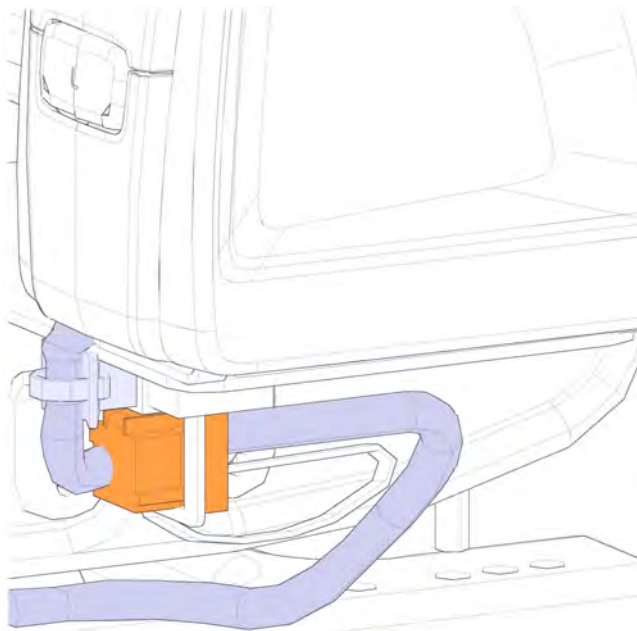
W3076414

- 4 Disconnect the wiring harness connector at the shifter.

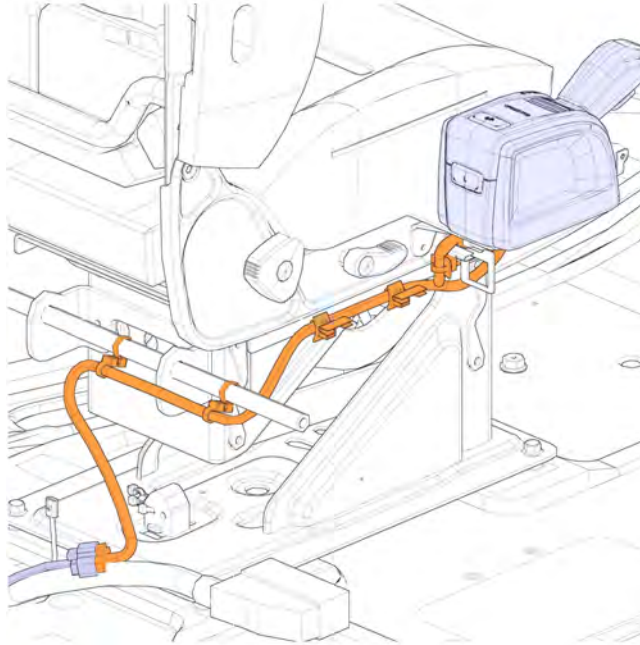
W3076516

- 5 Remove the cable ties from each clip point until the shifter harness is free from the seat. Remove shifter harness.

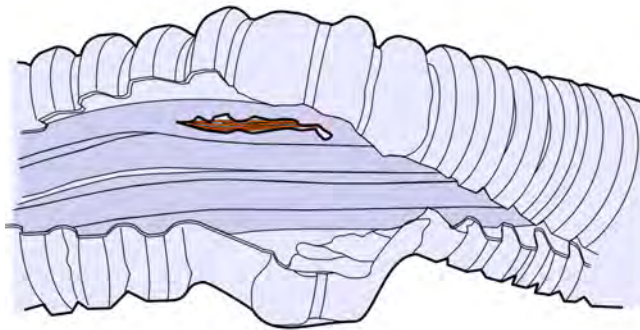
W3076421

Note: Look for chafed wires. Reuse harness if undamaged.

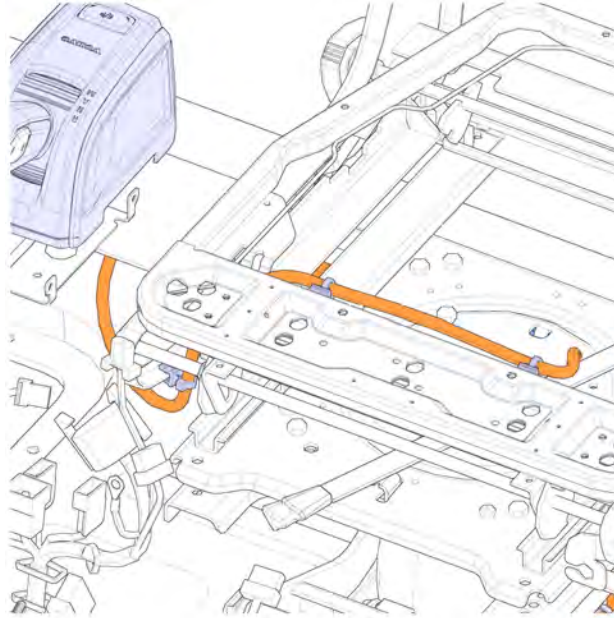
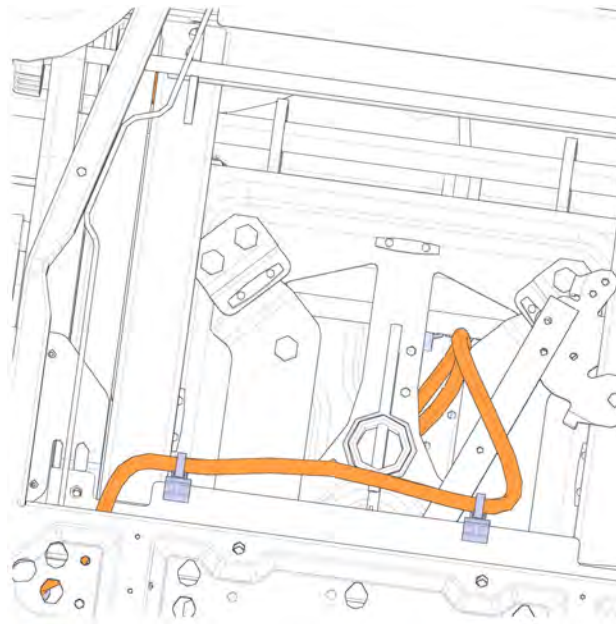
W3076417

- 6 Flip seat cushion up and loosely install and cable tie the shifter harness along the new path for routing and clipping.

Cable Tie with Horizontal Edge Clip # 21096682, Qty 2

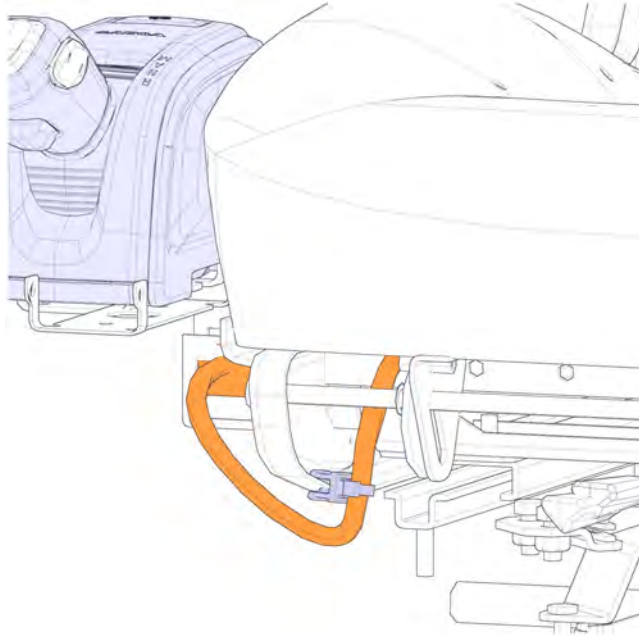
W3076419

- 7 Secure the shifter harness by cinching all the cable ties until the corrugated loom is lightly snug.

Cable Tie with Vertical Edge Clip # 25375492, Qty 1

Note: Do not over tighten the cable ties, otherwise the wires and loom will become damaged.

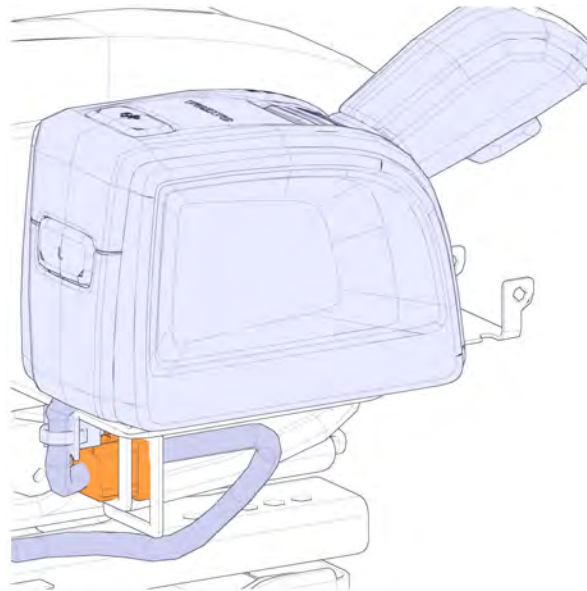
W3076416

8 Connect the wiring harness connector at the shifter.

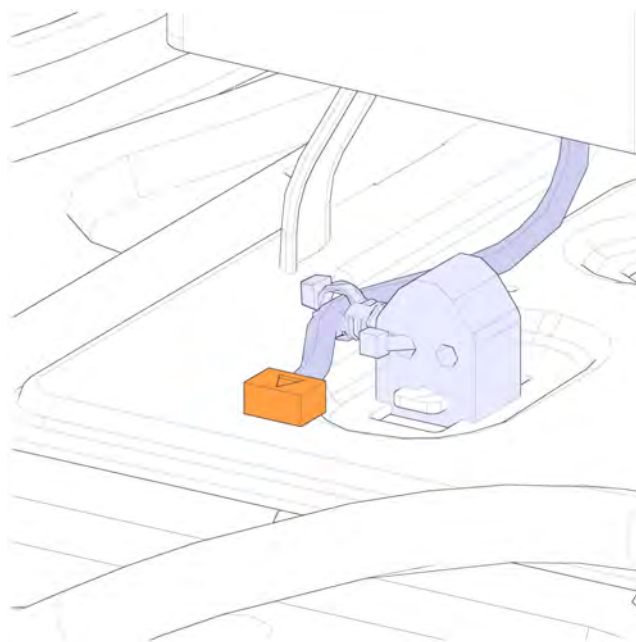
W3076415

9 Connect the wiring harness connector at the floor.

Double Cable Tie # 20885496, Qty 1
