**SB-10045802-9092**

**Title:** Alternator Wiring Re-route - 12643

**Applies To:** PayStar®, TranStar®, and ProStar® models built 6/1/09 thru 5/31/11 with a MaxxForce® 11 or 13 engine feature code 12UXJ or 12UXH and with alternator featurecode 08GGN, 08GGR, 08 GHG, or 08GHH.

Alternator wiring re-route to prevent rub points.

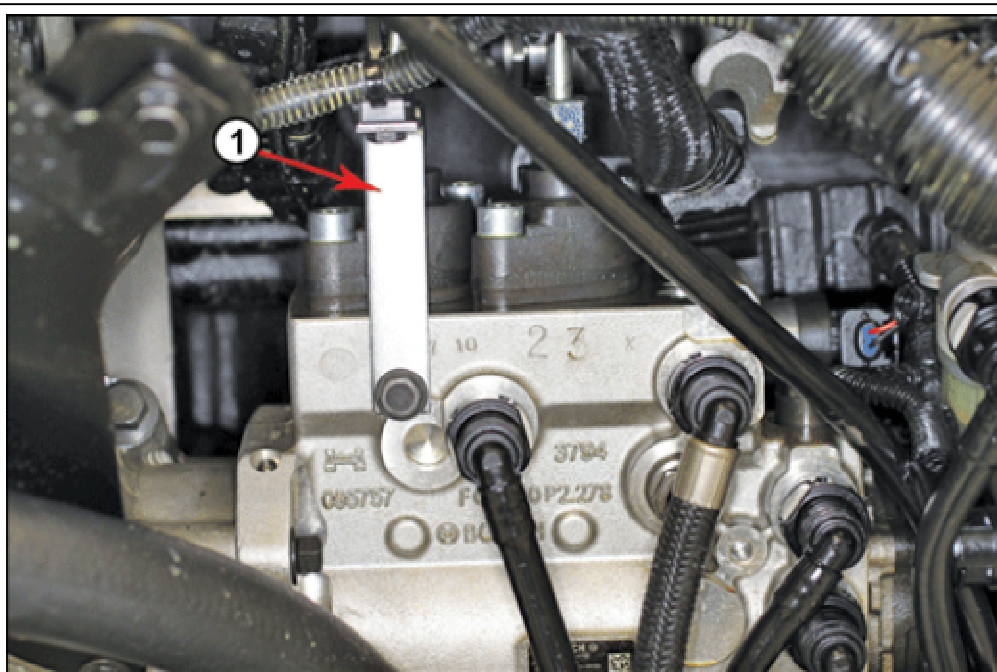
**Figure 1**

1. Extension bracket may already be mounted to the fuel case.

1. Open battery compartment, disconnect both the frame and starter negative battery cables, and the Clean Power harness connector.
2. Inspect the fuel case area (close to the power steering pump) to see if an extension bracket, saddle, and cable strap has already been installed as shown in Figure 1. If the extension bracket is present, remove the fuel case bolt that secures it and cut the cable strap that is securing the alternator harness. Go to step 4 and re-use the extension bracket.

If the extension bracket is currently installed on the fuel case, proceed to step 3.

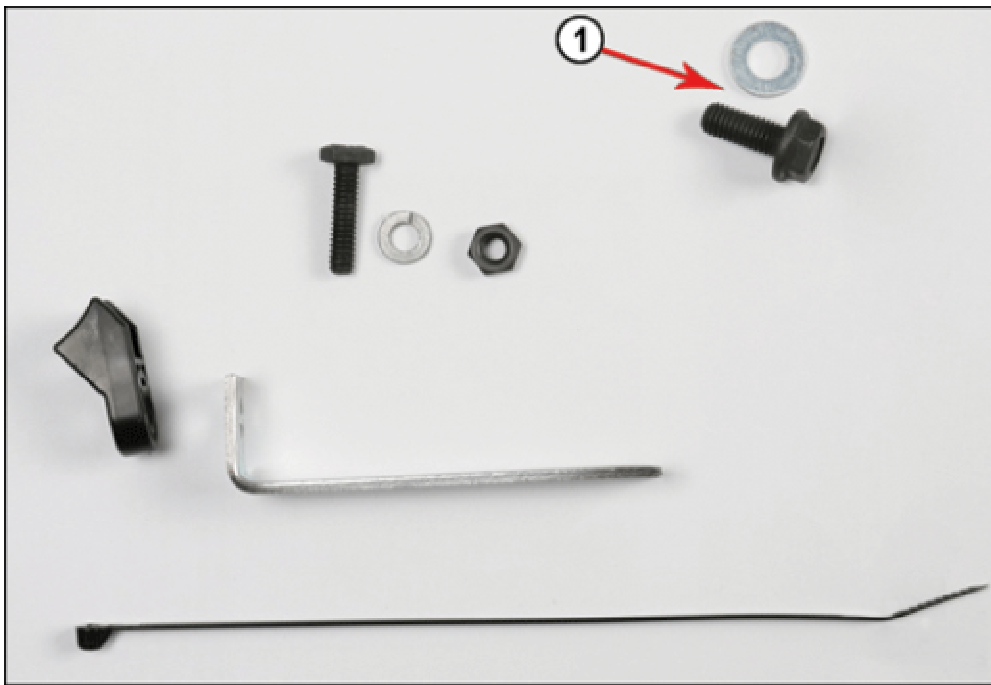
**Figure 2**

1. Fuel case bolt and washer NOT needed.

3. Assemble hardware (Figure 2) to match Figure 3. Attach saddle (3545771C1) to extension bracket (922860R1) and secure with saddle bolt (25483R1) using saddle lock washer (120380) and saddle nut (25519R1).

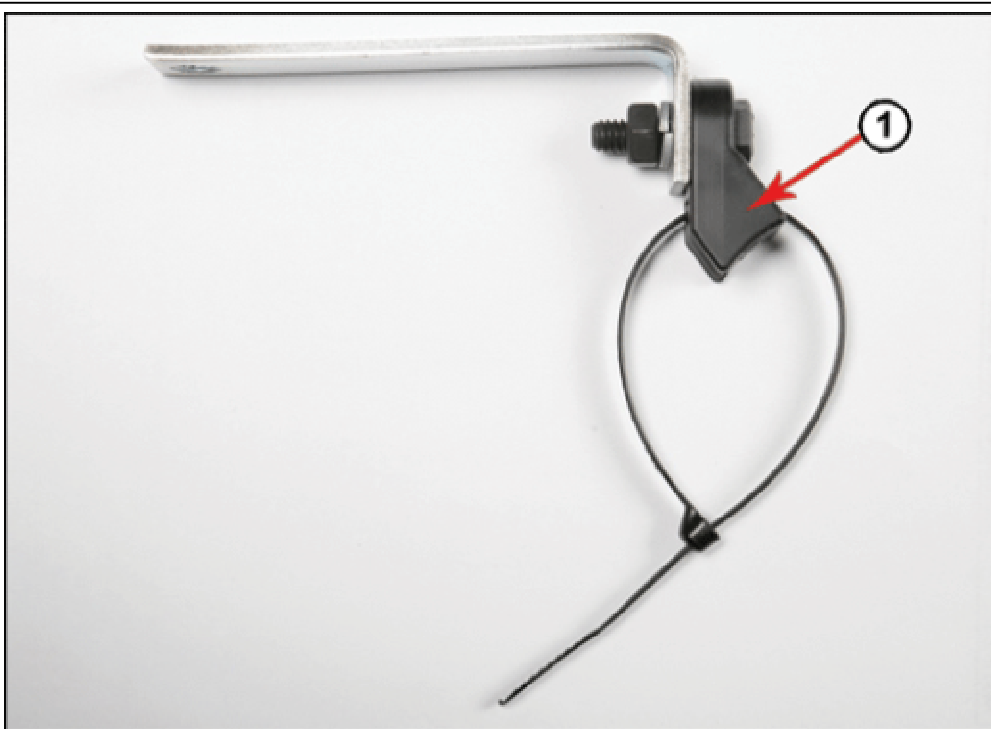
**Figure 3**

1. Alternator cables need to be strapped to the curved surface of the saddle strap.

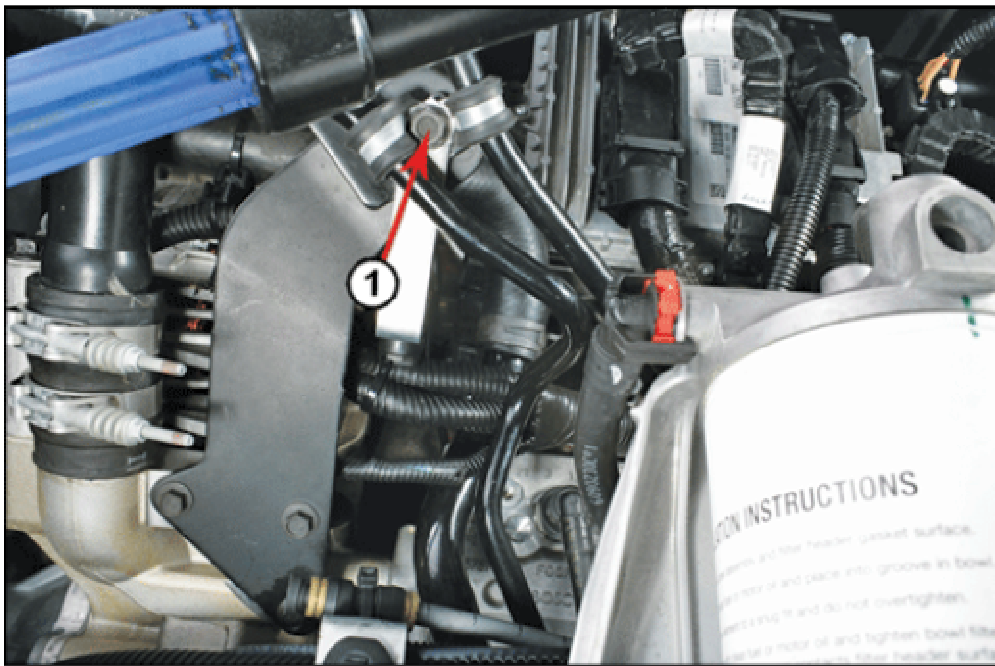
**Figure 4**

1. Dipstick bracket attachment bolt.

4. Remove dipstick bracket attachment bolt (Figure 4).

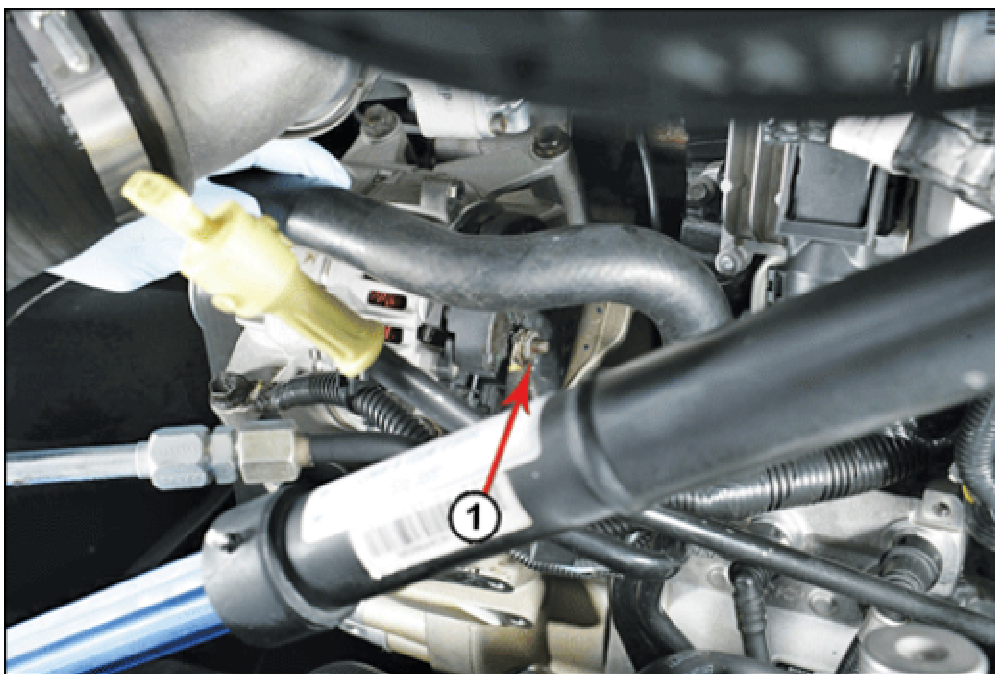
**Figure 5**

1. Alternator harness attachment nut.

5. Remove the alternator harness attachment nut (Figure 5).

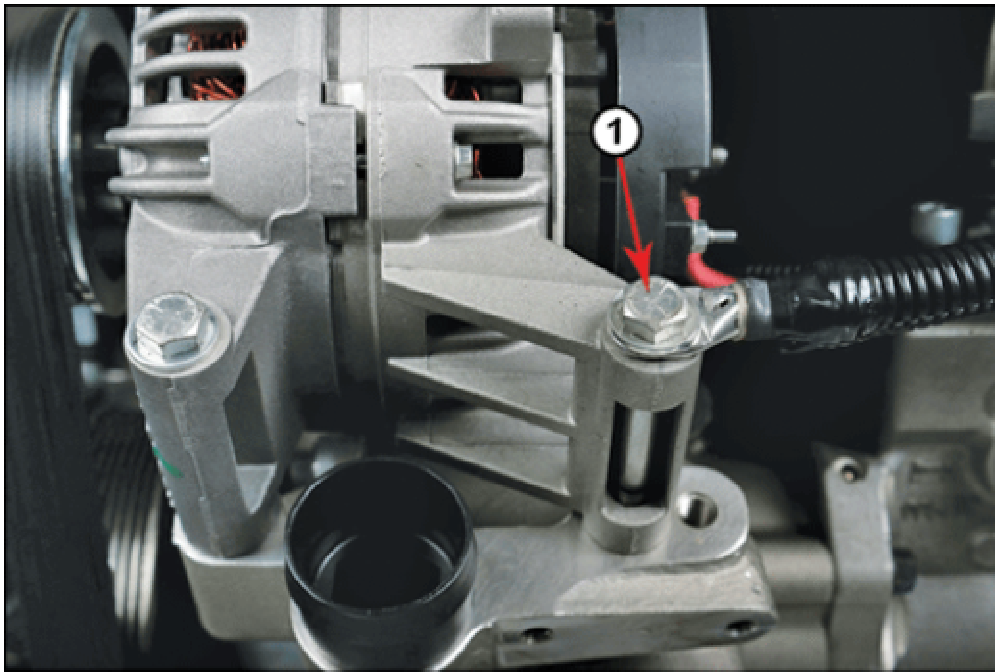
**Figure 6**

1. Alternator mounting bolt.

6. Remove the alternator mounting bolt that secures the ground cable of the alternator harness (Figure 6).

Reinstall the bolt and tighten to 19-23 ft-lb (26-31 N·m) as the ground harness will be relocated in a later Step.

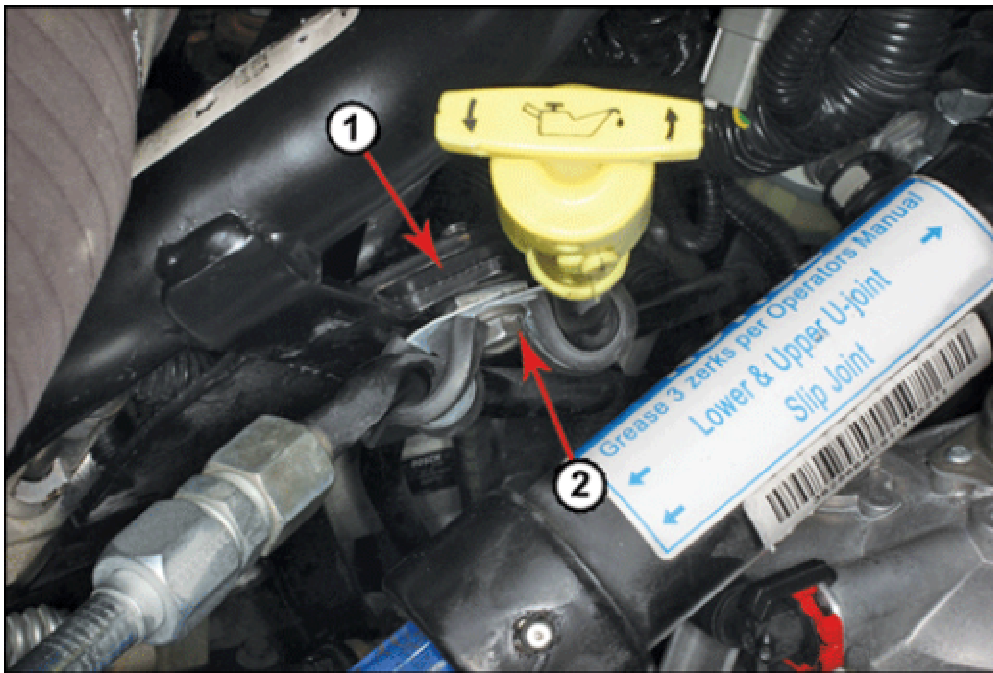
**Figure 8**

1. Extension bracket is underneath the P-clamps.
2. Same bolt used.

8. Use the same attachment bolt removed in Step 4 to attach the extension bracket (922860R1) to dipstick bracket (Figure 8). Verify the extension is placed at a similar angle (Figure 9).

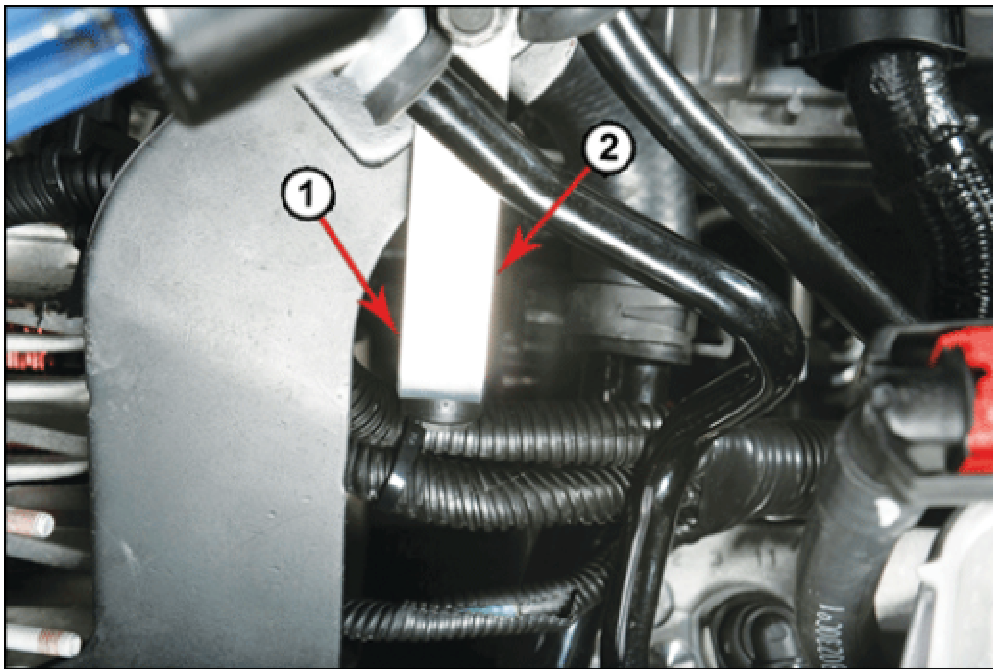
**Figure 9**

1. Extension bracket faces in toward engine compartment.

2. Notice the angle and location of the extension bracket.

18. Pull the cable strap tight and cut off excess length. Inspect the re-routed alternator harness and make sure the alternator harness does not rub on the ECM, Power Steering hose, or other objects. Adjust the extension bracket bolt angle (Figure 9), if needed.

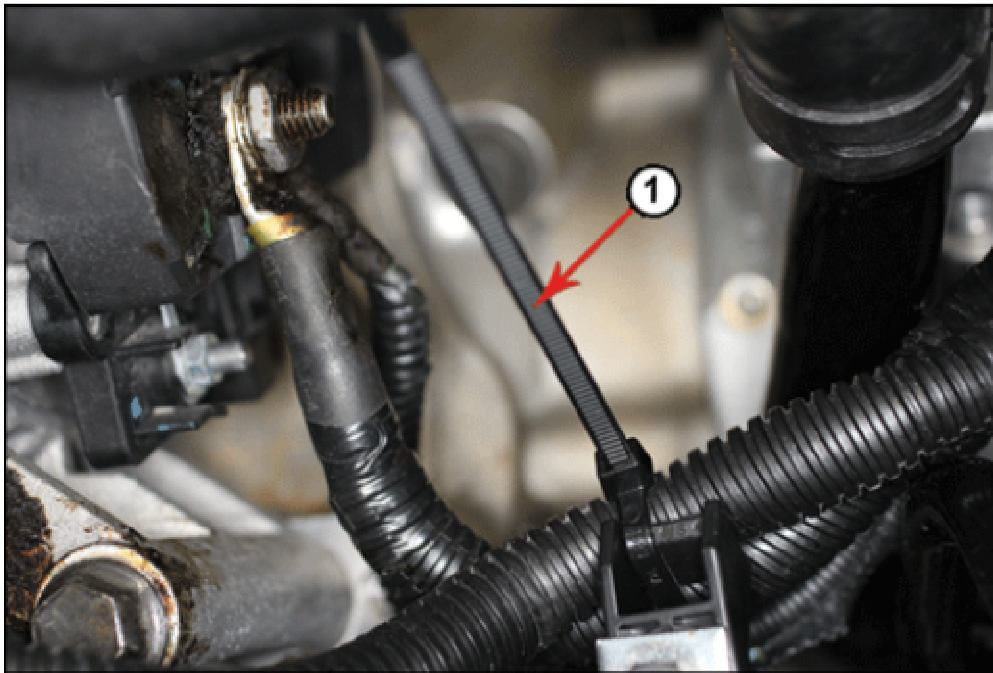
**Figure 10**

1. Adjust cable strap to saddle and cut off excess cable strap.

9. Reroute the alternator harness to the outside of the power steering hose and above the power steering high-pressure line. Attach the alternator harness to the saddle (3545771C1) using the cable strap (289862C1). Tighten the cable strap and cut off the excess strap (Figure 10).

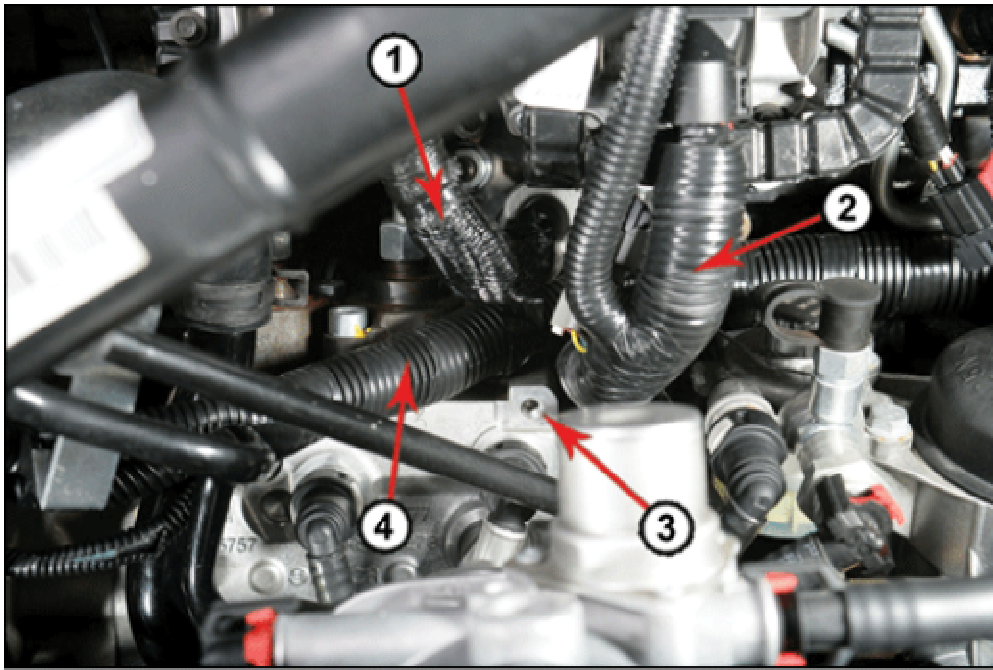
**Figure 11**

| 1. ECM-to-Sensor harness |
| 2. Chassis-to-ECM harness |
| 3. Pump screw boss |
| 4. Alternator harness |

10. Locate and remove the existing cable strap or straps that secure the alternator harness, ECM-to-sensor harness, and chassis-to-ECM harness to the cast-in strain-relief bracket (Figure 11).

11. Insert a new cable strap around the strain-relief bracket and around the alternator harness and the ECM-to-sensor harness and tighten the cable strap enough to lift the harnesses off of the pump screw boss (Figure 11 and Figure 12).

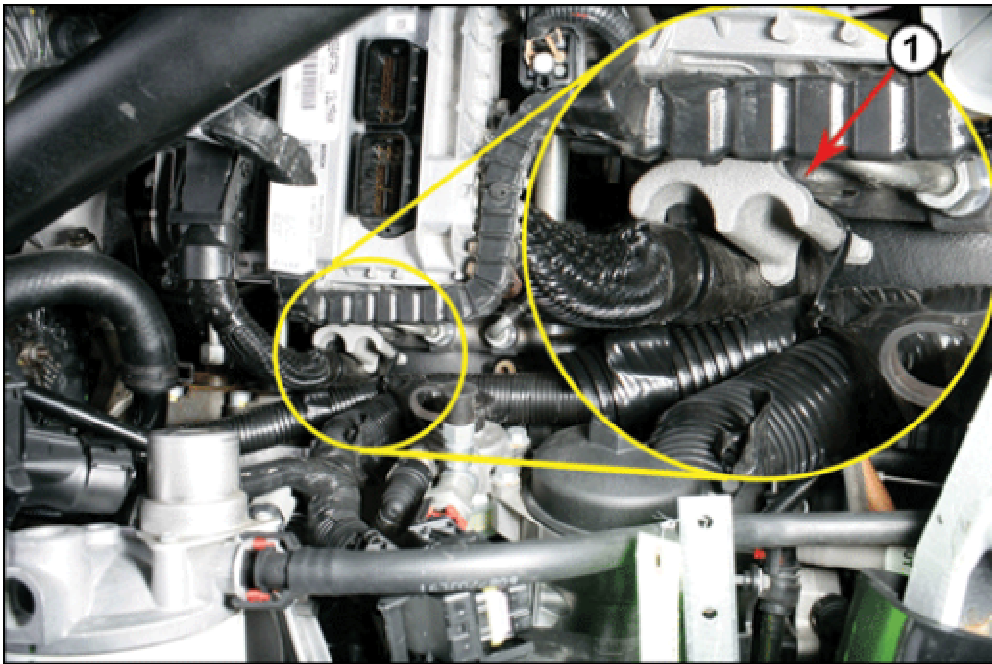
**Figure 12**

1. Strain relief location.

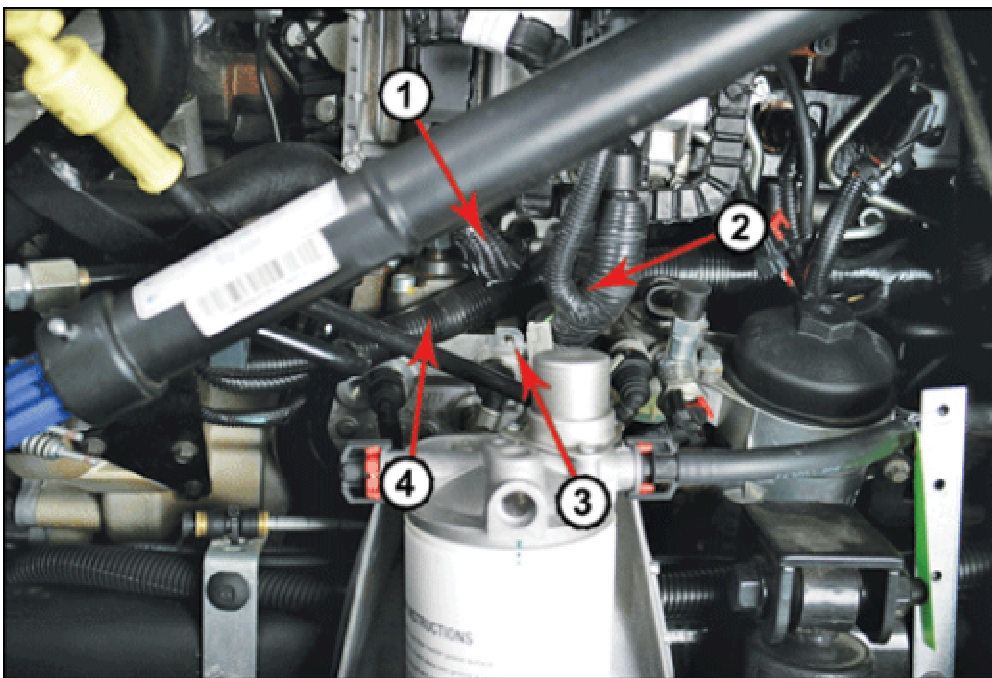
**Figure 13**

1. ECM-to-Sensor Harness

2. Chassis-to-ECM Harness

| 3. Pump screw boss |
| 4. Alternator Harness |

12. Insert a second cable strap around the strain-relief bracket and around the chassis-to-ECM harness and tighten the cable strap enough to lift the harness off the pump screw boss (Figure 13).

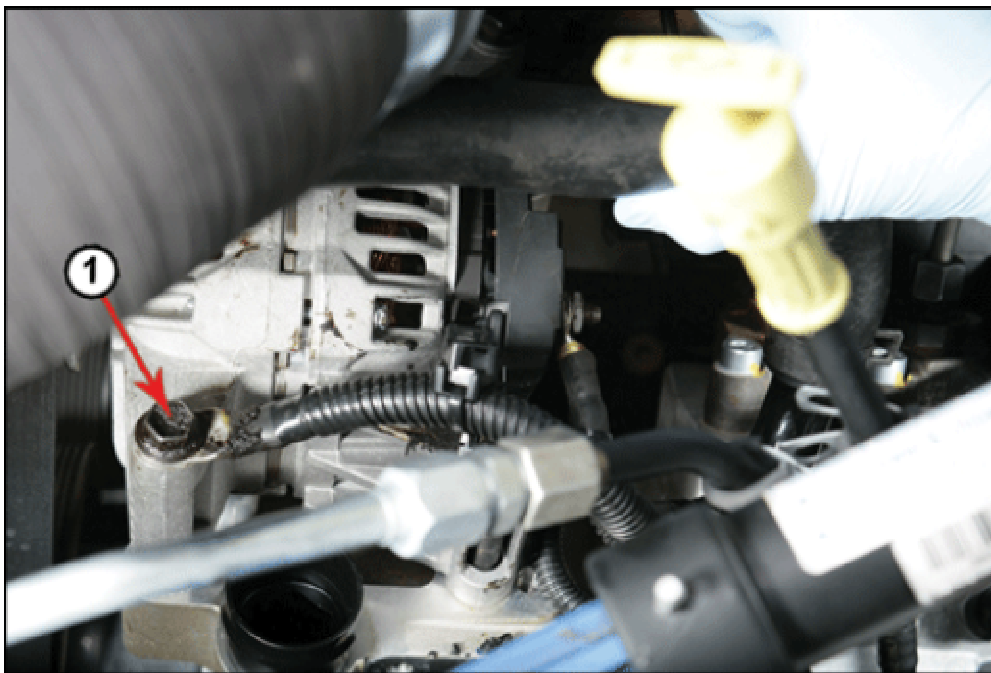
**Figure 14**

| 1. Lower front alternator-mounting bolt. |

14. Remove the lower front alternator-mounting bolt, install the bolt through the ground terminal of the alternator harness, and reinstall the bolt (Figure 14). Tighten to 19-23 ft-lb (26-31 N·m). If there is insufficient length to reach the front bolt location of the alternator, then use the rear bolt location. Apply sealant to the bolt head after installation.

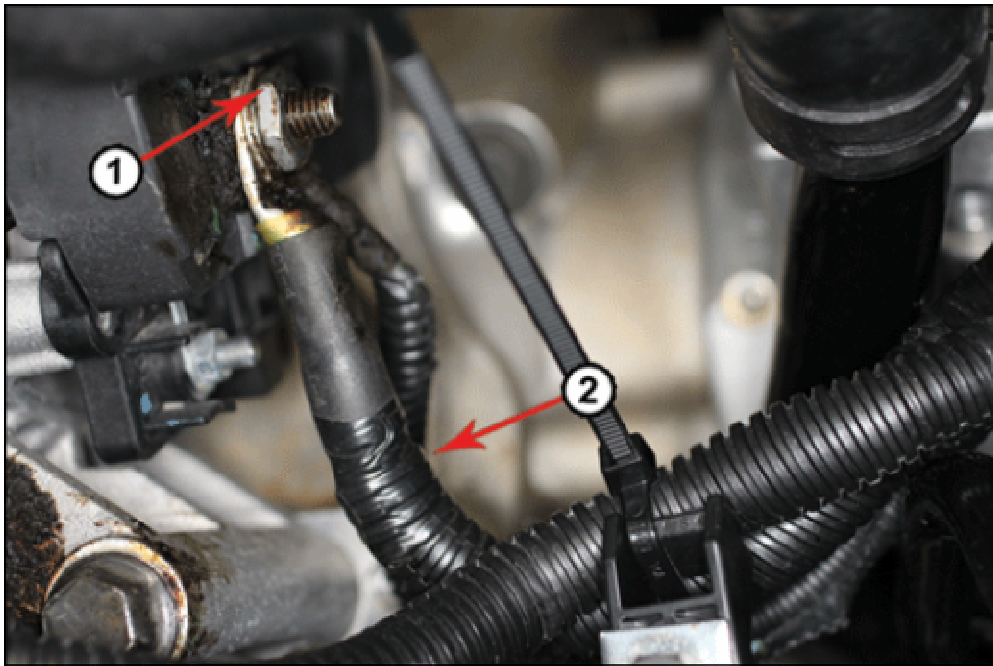
**Figure 15**

1. Positive Terminal

2. **NOTE:** There should not be any extreme bends when the cables are mounted on the alternator.

15. Reinstall the power cable of the alternator harness to the positive terminal of the alternator. Tighten nut to 120 in-lb (13.5 N·m). Apply sealant to the nut after installation (Figure 15).

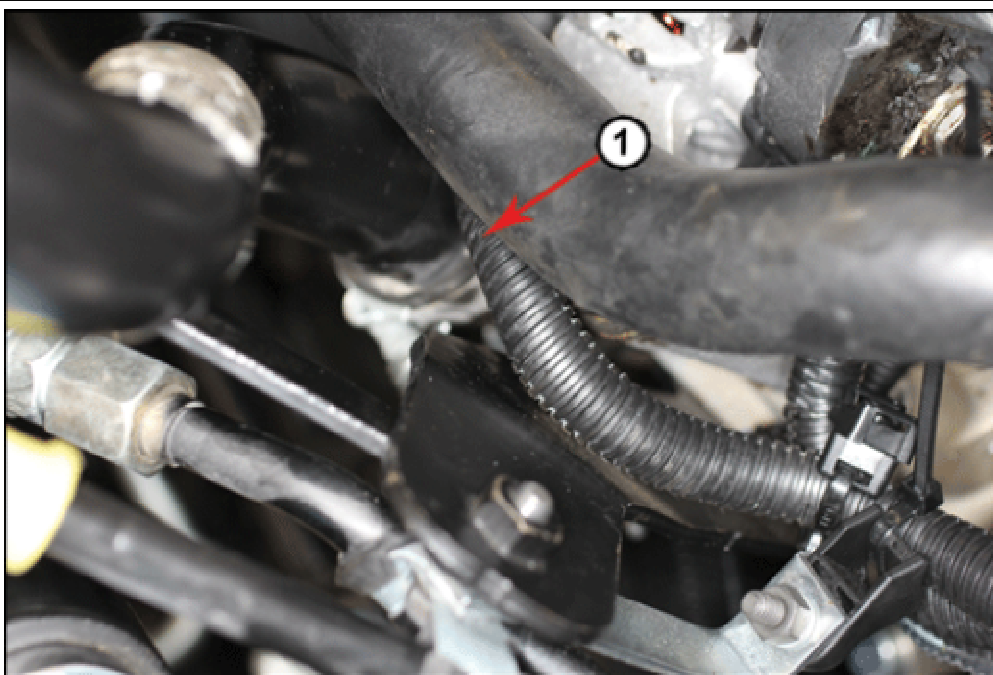
**Figure 16**

1. Add dual swivel to this area

16. Add a dual-saddle swivel guide (3614752C1) between the power steering hose and the alternator ground harness by using two 9 in. cable straps (3551709C1) to the area shown in Figure 16 and Figure 17.
