**SB-10045880-6991**

## **Service Campaign 62-02**

**AFFECTED:** Certain 2013 Model E26HE Winnebago Vista and Itasca Sunstar Motor Homes

**SUBJECT:** House Batteries Not Receiving a Charge When The Engine is Running

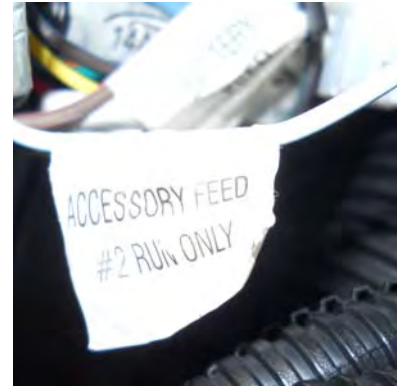
1. Locate Ford accessory feed #2 run only wire (white/light blue) under left side of dash or locate KE wire in harness under dash area.

2. Run 14 gauge wire from accessory # 2 run only feed wire or connect to KE wire from harness under dash to # 4 terminal on battery boost switch.

Add this wire.

Note: This will allow house batteries to charge from engine battery when engine is operating.

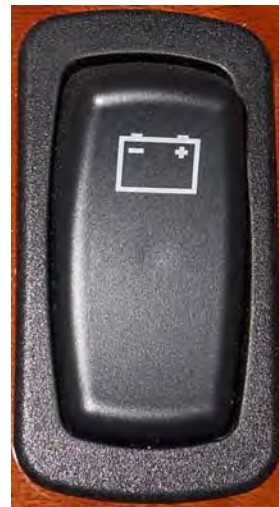
Battery Boost Switch

Terminal p/n 129236-02-000  
Female, M/P, 630, 14-16 gauge

# 4 terminal KE wire/

#2 terminal LR wire

#1 terminal LS wire
