## Folsom 30L4RE-01: Smoke Test

**Property and Top Bus Number:** Folsom, 146000

**Issue:** Check the rear bulkhead seal.

Work instruction number: L3/FSV-103  
L4/QUA-003

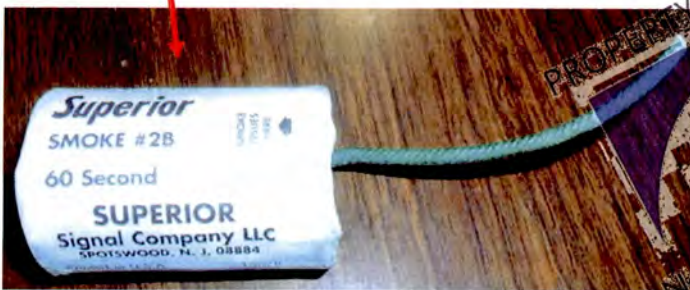
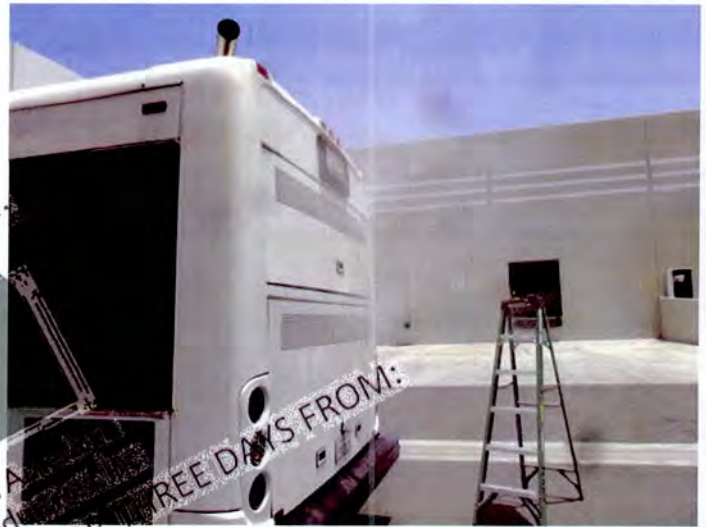
1. Park the bus and apply the parking brake.
2. Ensure that the side windows and roof hatch are closed and engine turned off.
3. Open the rear engine compartment.
4. Ignite the smoke bomb and place it into a steel container. Follow instructions written on the smoke bomb.

5. Place the container onto the top of the engine and close the engine door.
6. Go inside the bus and check if smoke enters into the bus.
7. Repeat test written between steps 3-5 with engine is running. **Ensure that the container is secured so it won't fall off or contact with any moving parts.**
8. Repeat test written between steps 3-5 with engine is running and AC is on.
9. Record location of leaks if any.
10. Record bus number, date of inspection and name of technician who completed the work.
