Volume: XIX
Number: TC12-011
Date: 4/23/2012
 Action
 Retain
 Information

Vice President, Product Quality and Service Support
Subject: Limited Service Campaign C0F
Certain 2011 and 2012 MY Highlander HV and Certain 2012 MY Prius V Vehicles
Exhaust Gas Control Actuator Replacement

TECHNICAL INSTRUCTIONS
FOR
LIMITED SERVICE CAMPAIGN C0F
EXHAUST GAS CONTROL ACTUATOR REPLACEMENT
CERTAIN 2012 MODEL YEAR PRIUS V

TECHNICAL INSTRUCTIONS
FOR
LIMITED SERVICE CAMPAIGN C0F
EXHAUST GAS CONTROL ACTUATOR REPLACEMENT
CERTAIN 2011 – 2012 MODEL YEAR HIGHLANDER HV

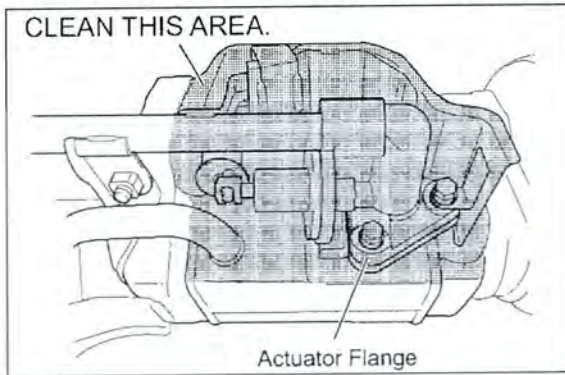
1. CLEAN THE AREA AROUND THE EXHAUST GAS CONTROL ACTUATOR SUB-ASSEMBLY

- a) Clean the area shaded in the illustration to prevent foreign material from entering the cooling system.

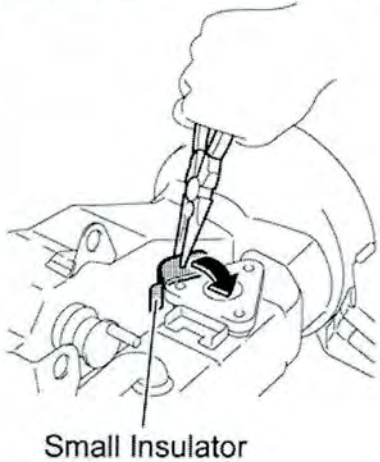
a) SLIGHTLY TILT THE SMALL INSULATOR FORWARD.

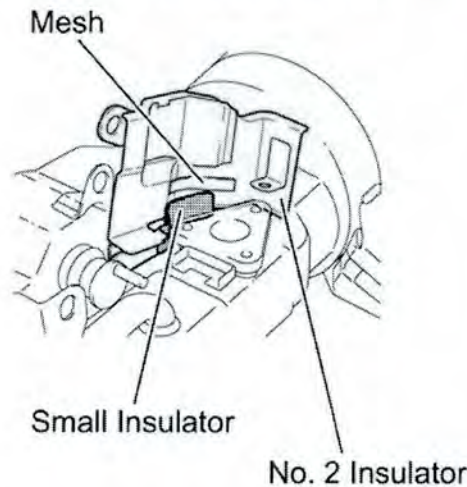
b) INSERT THE LOWER PART OF THE NO. 2 INSULATOR BEHIND THE SMALL INSULATOR.

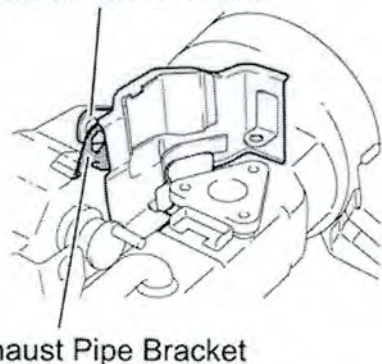
No. 2 Insulator Bracket

c) INSERT THE NO. 2 INSULATOR BRACKET BEHIND THE EXHAUST PIPE BRACKET.

NOTE: The mesh on the new No.2 insulator is used to prevent rattle and vibration noise.

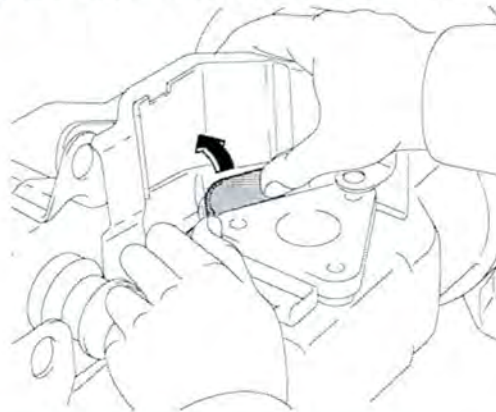
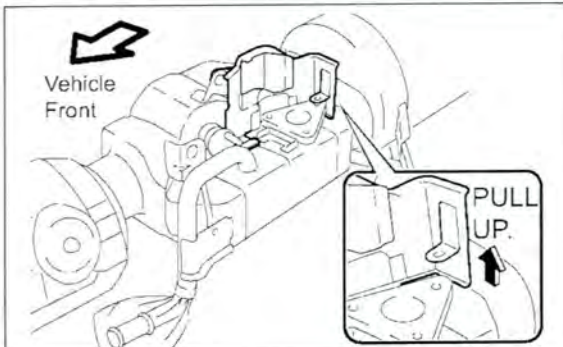
8. LOOSELY INSTALL THE EXHAUST GAS CONTROL ACTUATOR

- a) Lift the rear side of the No.2 insulator to allow the actuator to be installed below the flange on the insulator.

- b) Loosely install the **NEW** actuator, confirm the actuator is installed below the flange on the insulator and that the hook is engaged with the valve pin.

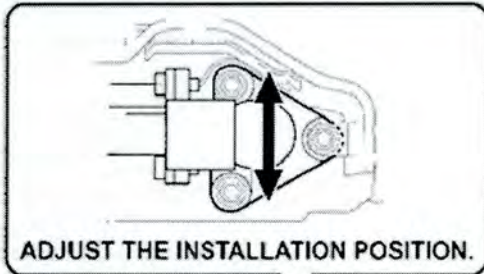
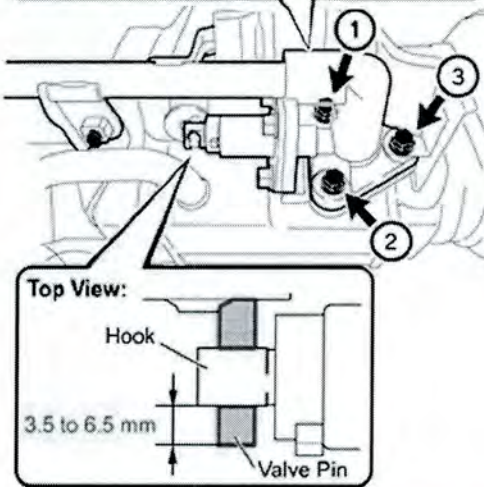
- b) Position the actuator so that approximately 4.5mm of the valve pin is protruding past the actuator hook.
- c) Tighten the 3 bolts evenly following the torque sequence shown in the illustration.

Torque: 44 in.lbf (5.0N·m)

If the protruding pin length is not within specification, the 3 actuator bolts **MUST** be loosened and **ALL** of STEP 11 **MUST** be repeated.

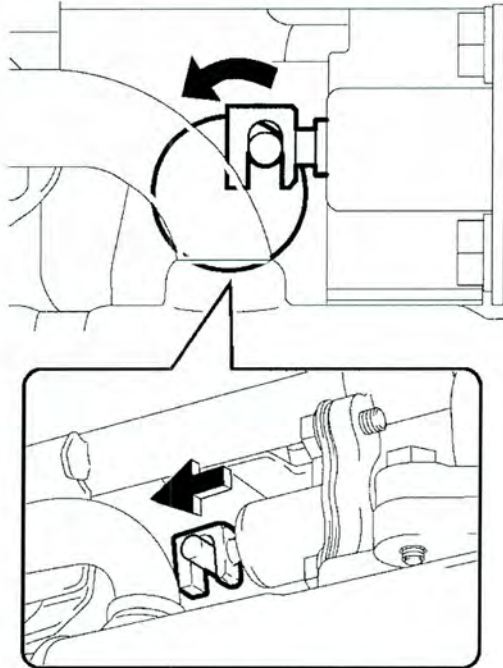
With cold engine:

CONFIRM THAT THE HOOK IS EXTENDED.

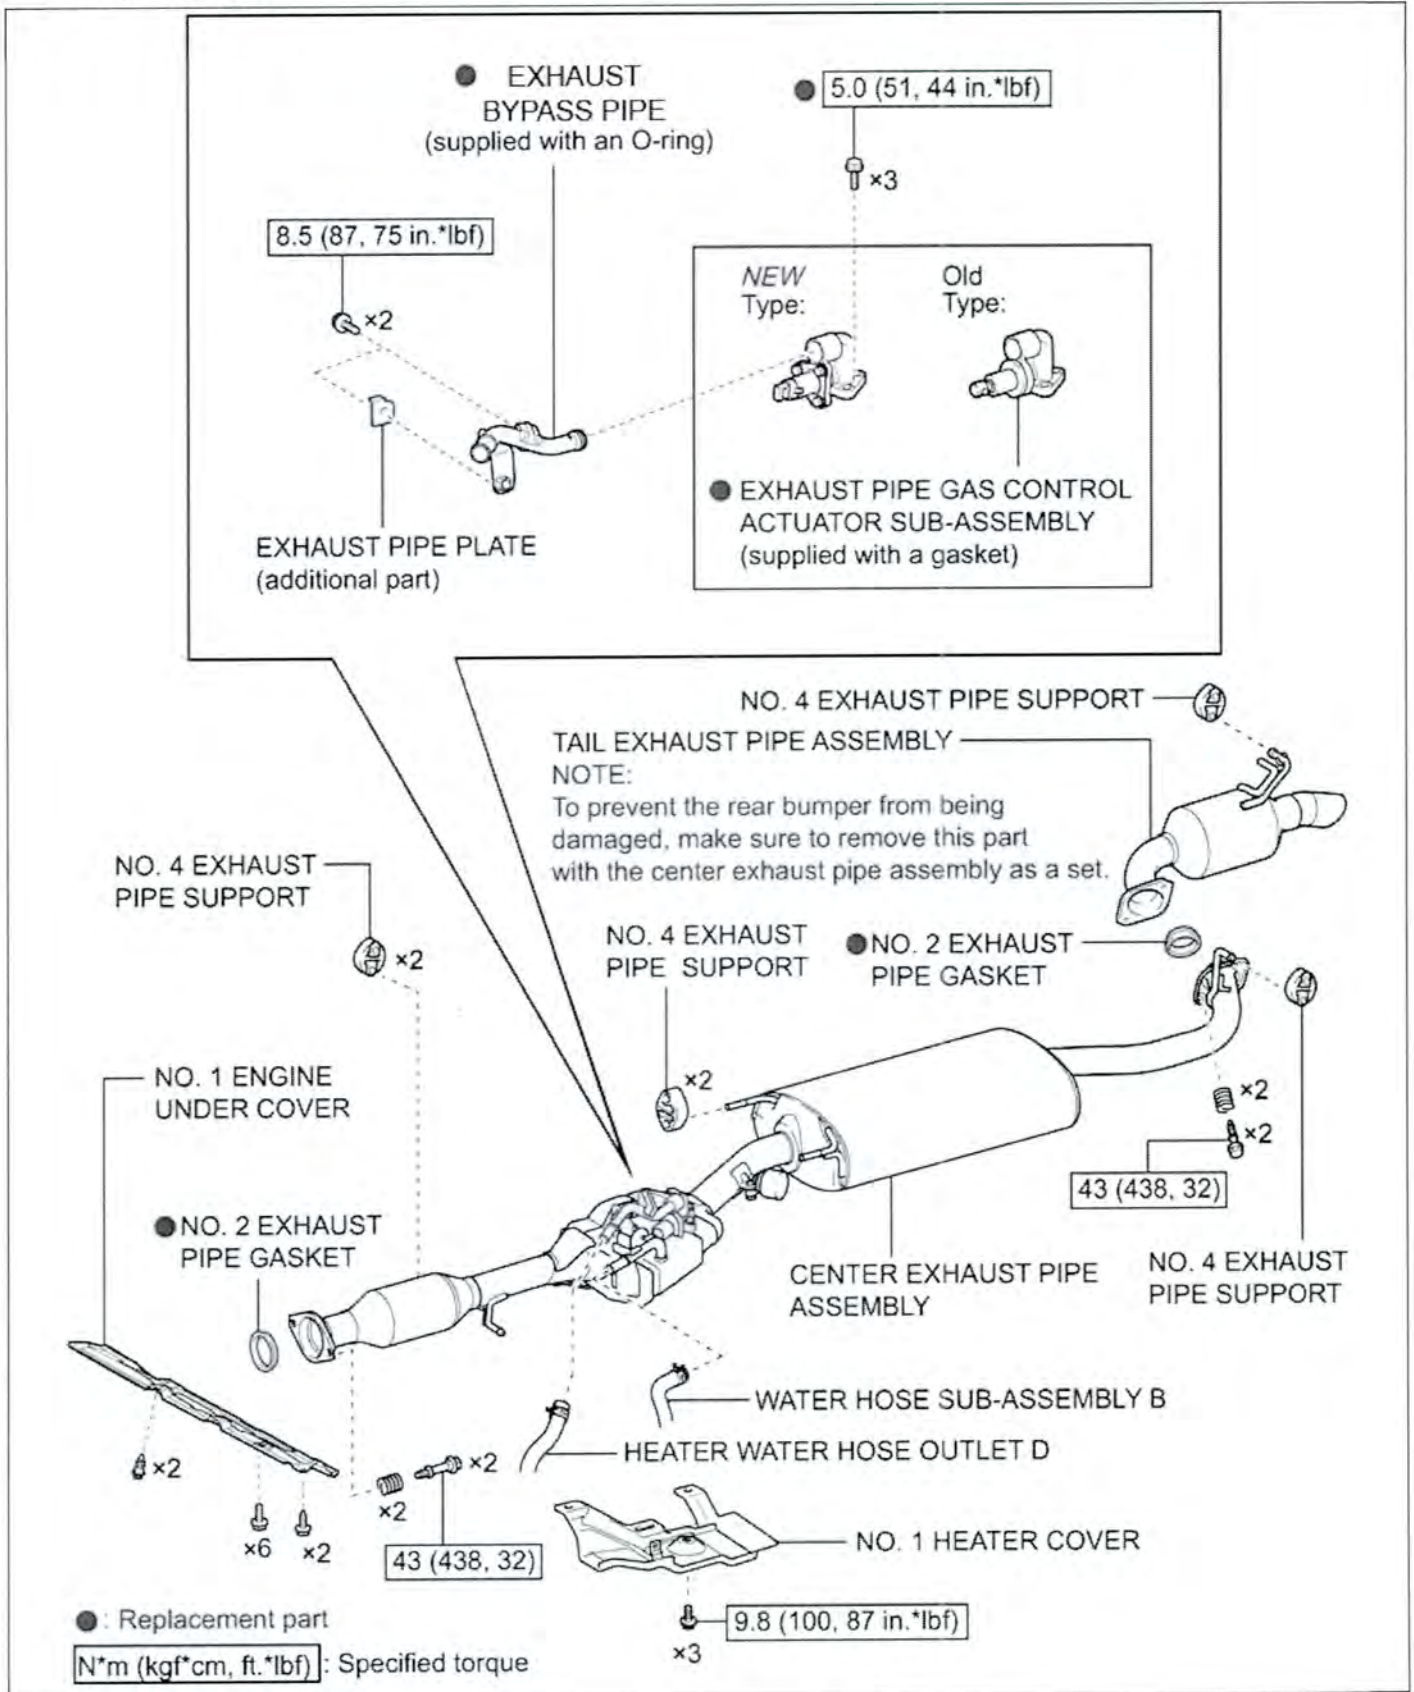
A. COMPONENTS

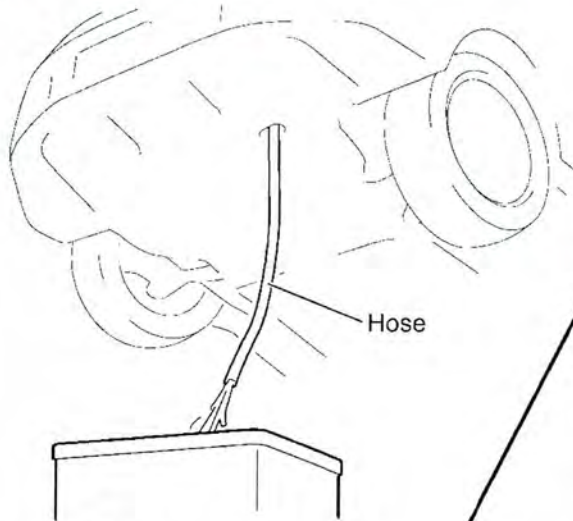
Radiator side

Reusable

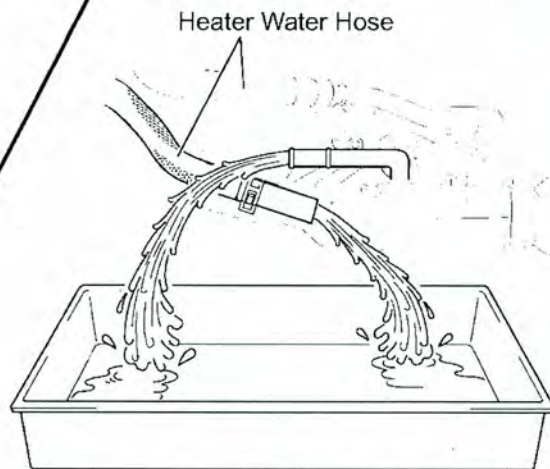
Exhaust heat recirculation system side

Non-reusable

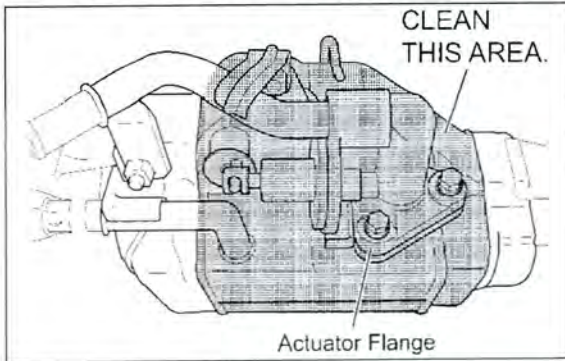
1. CLEAN THE AREA AROUND THE EXHAUST GAS CONTROL ACTUATOR SUB-ASSEMBLY

- a) Clean the area shaded in the illustration to prevent foreign material from entering the cooling system.

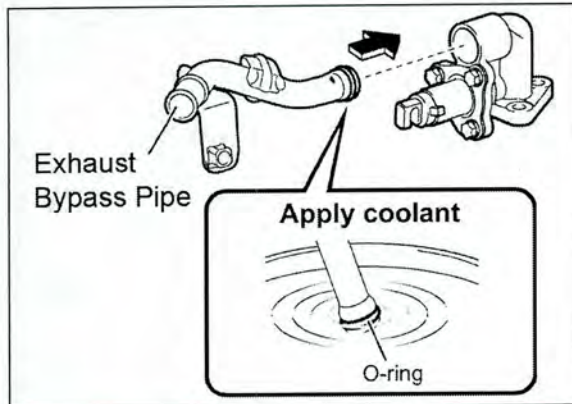
5. **CONNECT THE BYPASS PIPE TO THE EXHAUST PIPE GAS CONTROL ACTUATOR**

- a) Apply clean coolant to the o-ring on the **NEW** bypass pipe to ease installation.
- b) Insert the bypass pipe into the actuator as far as possible.

- **DO NOT** damage the o-ring or allow it to become contaminated before installation.
- Confirm the bypass pipe is installed completely, there may be a yellow mark on the new bypass pipe, **DO NOT** use this mark as an installation guide.

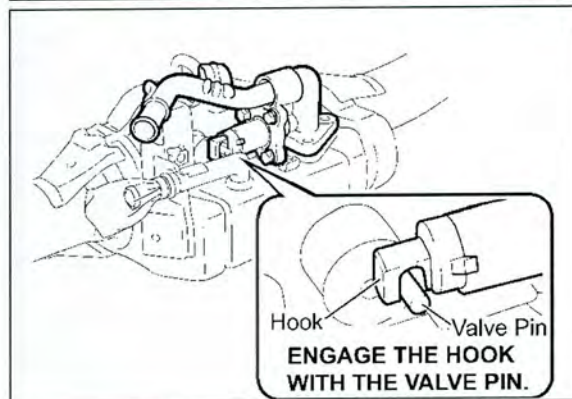
6. **LOOSELY INSTALL THE BYPASS PIPE AND ACTUATOR**

- a) Set the bypass pipe and actuator in place, confirm the actuator hook is engaged with the valve pin.

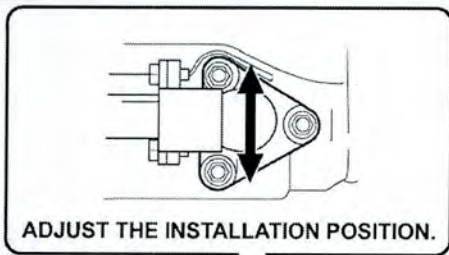
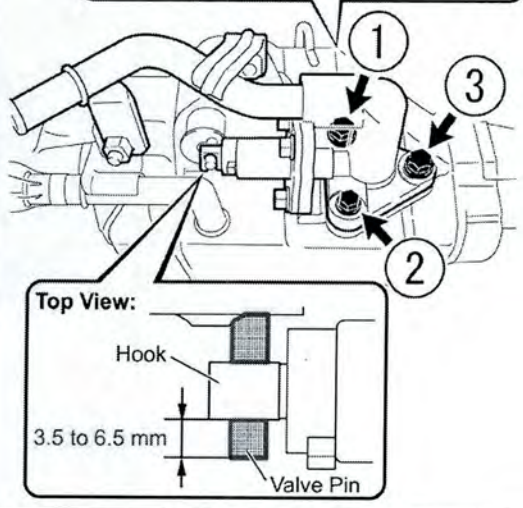
- b) Position the actuator so that approximately 4.5mm of the valve pin is protruding past the actuator hook.
- c) Tighten the 3 bolts evenly following the torque sequence shown in the illustration.

Torque: 44 in.lbf (5.0N·m)

If the protruding pin length is not within specification, the 3 actuator bolts **MUST** be loosened and **ALL** of STEP 11 **MUST** be repeated.

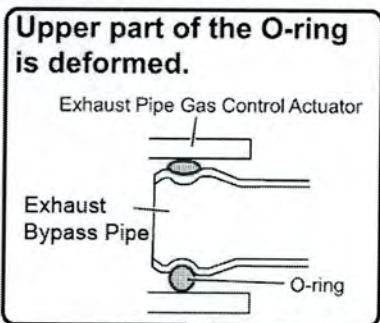
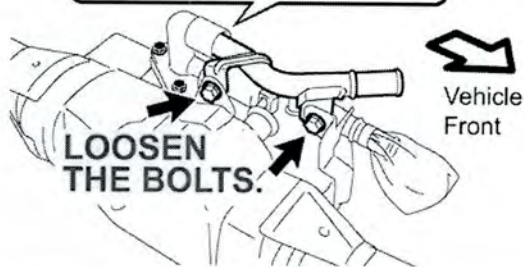
a) BEFORE ADJUSTMENT

- a) Loosen the 2 bolts slightly. **DO NOT** remove the bolts.
- b) Move the bypass pipe up and down to properly settle the o-ring.

If this step is not performed, a coolant leak **WILL** develop.

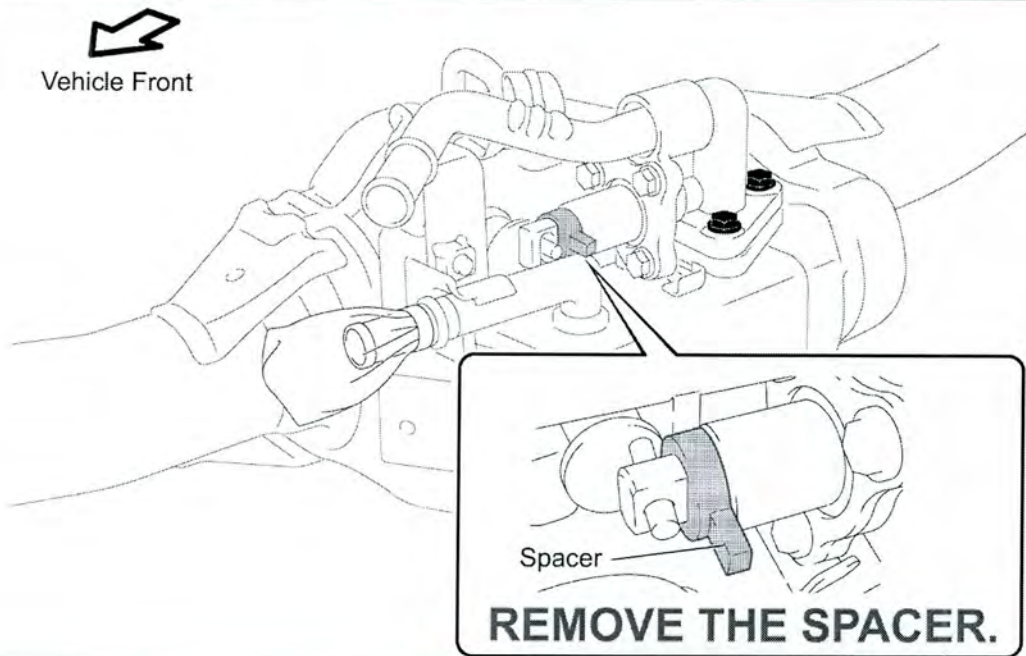
11. REMOVE THE SPACER

- a) Remove the spacer from the actuator.

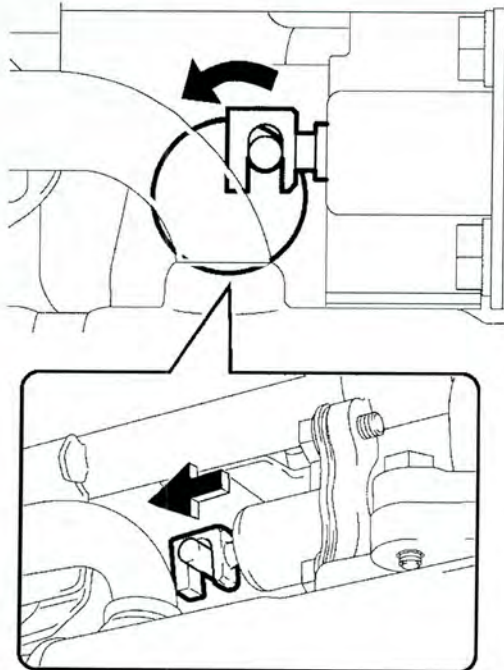
With cold engine:

CONFIRM THAT THE HOOK IS EXTENDED.
