WARRANTY BULLETIN

WB12-18

DATE : AUGUST 2012	SECTION : 23 - Accessories
EXPIRATION: AUGUST 2014	
SUBJECT : AFSS HARNESS MODIFICATION IN FRONT SERVICE COMPARTMENT

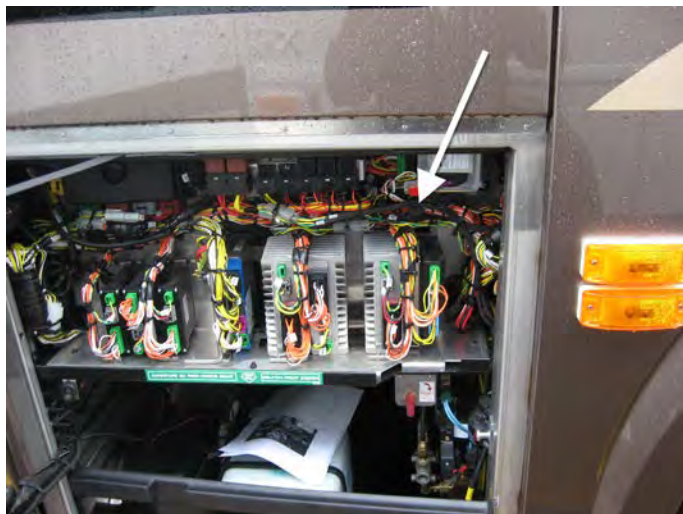
Locate fuse F45 in the front service compartment.

Following the harness path from fuse F45 towards the front of the vehicle, locate the harness identification tab.

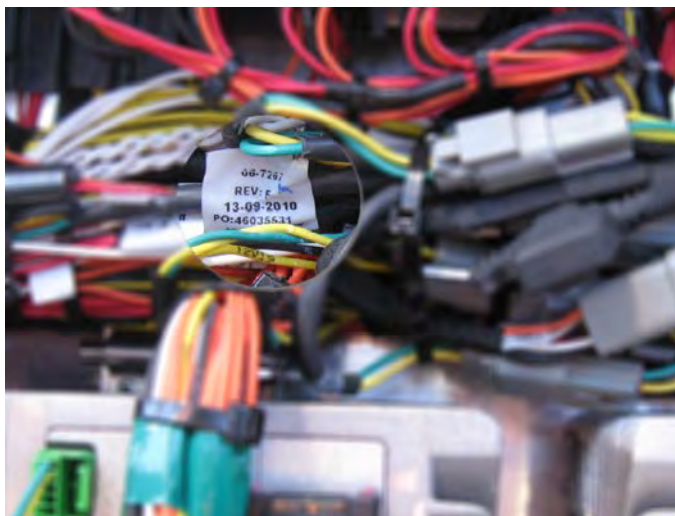
This bulletin applies only to:

Harness 067267 RevG

or

Harness 068270 RevC

Any other version of the harness is not submitted to this modification.

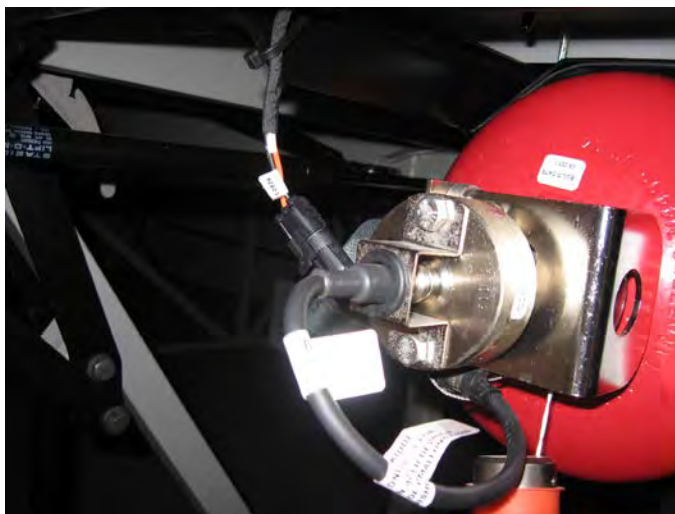
2. Disconnect electrical plug at the extinguisher to prevent any false triggering of the system.

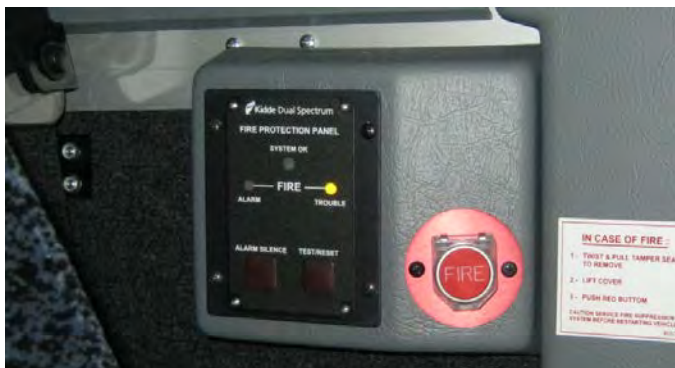
3. Remove fuse F45. Check inside vehicle to confirm the fire protection panel is de-activated.

4. If any light is illuminated on the panel, follow with next steps.

5. If no light is illuminated on the panel, stop procedure as this is the normal behavior.

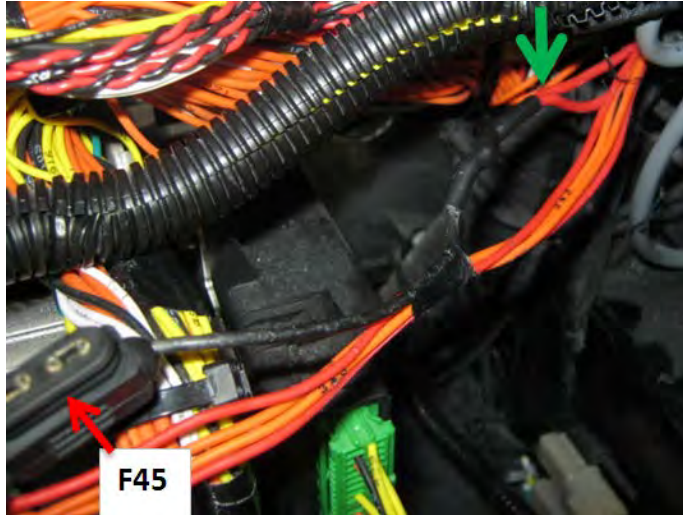
6. Remove electric tape up to splice in harness (Green arrow on photo).

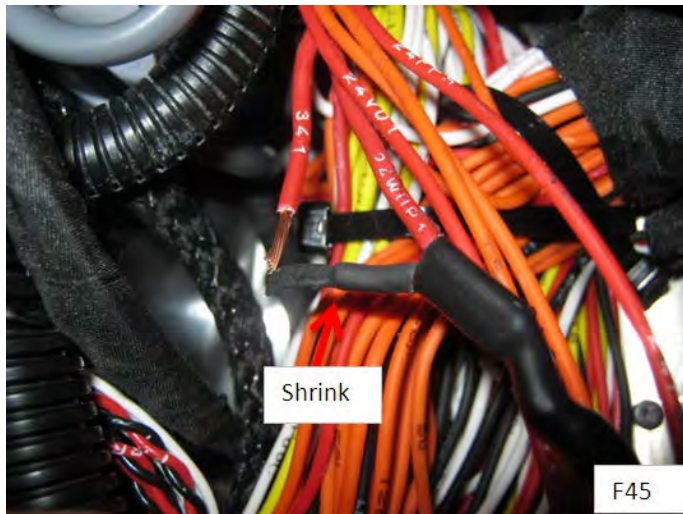
7. Cut wire 341 and slip shrink tube over strand going to F45.

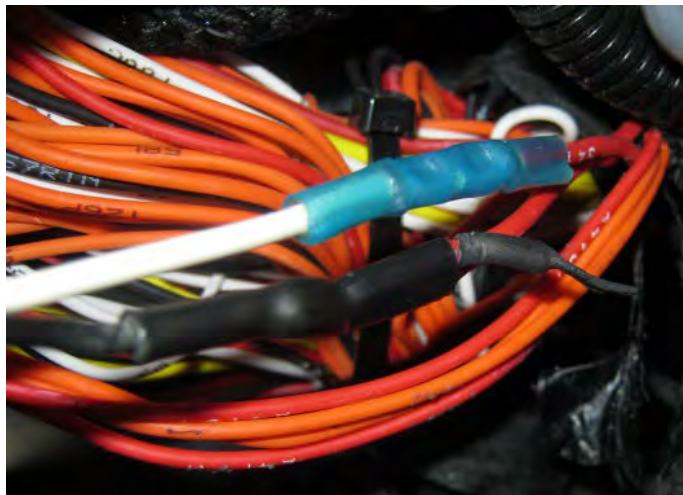
8. Splice a new white wire on the remaining end of wire 341.

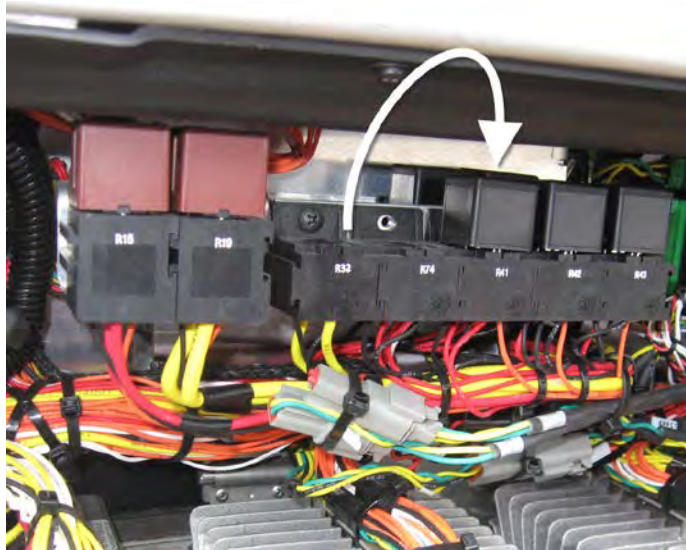
9. Locate R4 relay.

Look behind bracket holding the group of small relays.

In doubt, refer to the panel layout decal inside front service compartment door to locate R4.

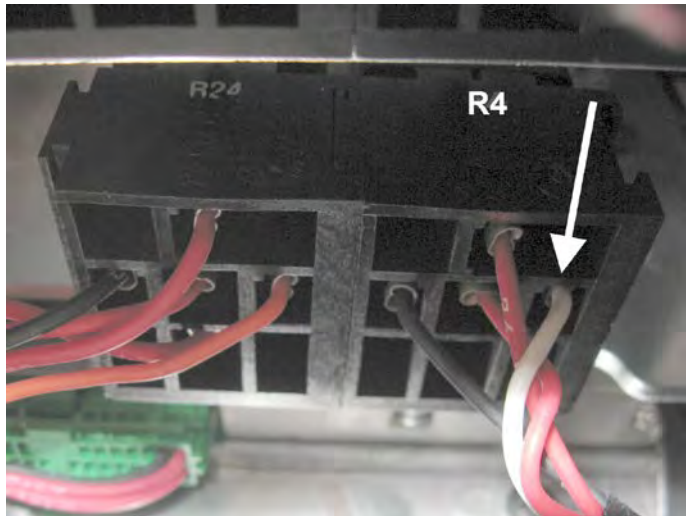
10. Route new white wire up to wire 341 on relay R4, pin 86 (Arrow).

11. Remove wire 341 from relay base.

12. Cut the tab terminal. Strip the wire.

13. Install #561108 new tab terminal and crimp both 341 wires together.

14. Reconnect to pin 86 of R4 relay.

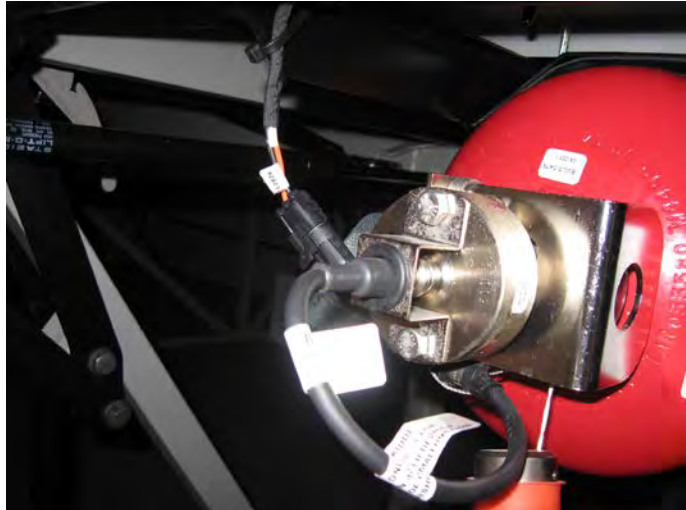
15. Protect whole length of harness modification with tape.

16. To confirm proper operation, perform inspection steps 3 & 4.

17. Reconnect plug at the extinguisher.
