SERVICE BULLETIN

APPLICABILITY: 2011MY Forester Models with FB Engine **NUMBER:** 07-70-12
SUBJECT: Engine Harness Retention Clip Modification **DATE:** 09/20/12
 Procedures

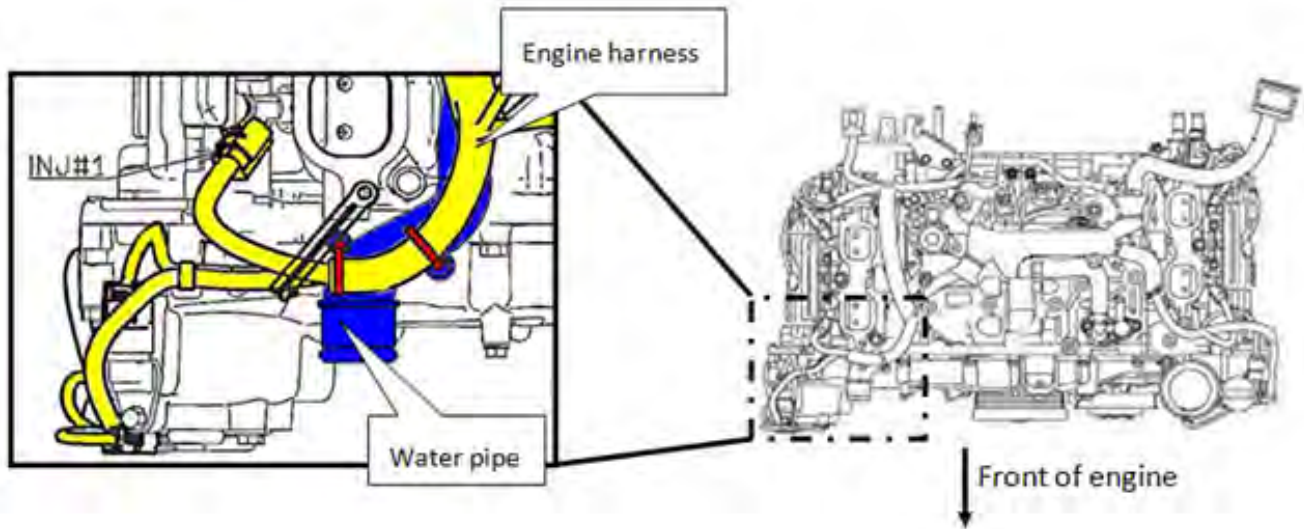
Figure 1- Positions of the applicable parts

Repositioning the clip on the engine harness is required when replacing either the harness, water pipe or both.

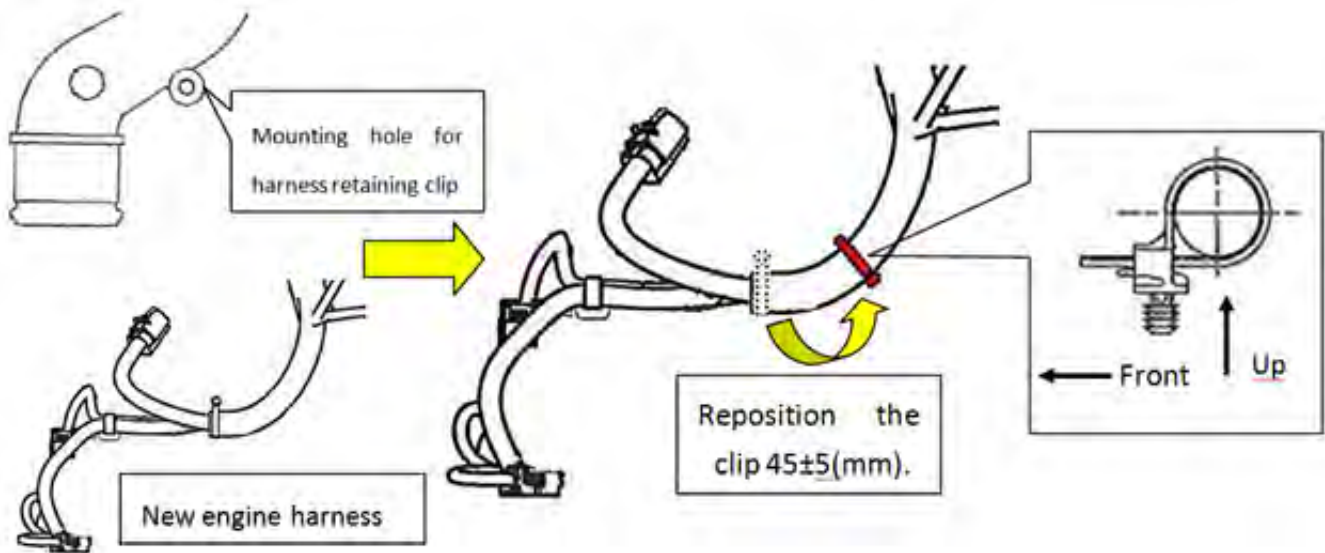
Figure 2- Combination of old-style water pipe and new engine harness:

There are 2 combinations of the water pipe and the retaining clip position on the engine harness.

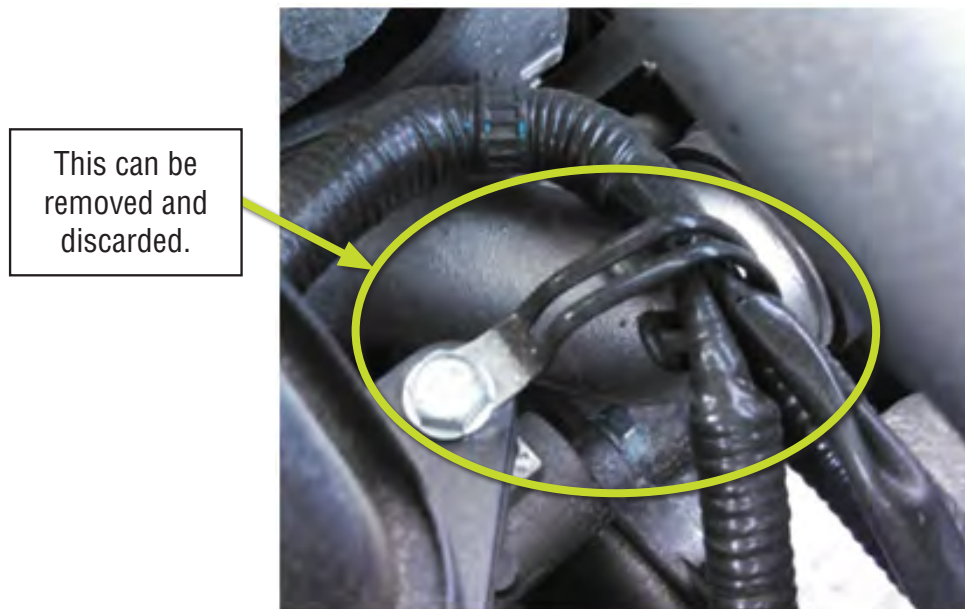
When performing the procedures in **Figure 3**, after repositioning the harness retaining clip, the bendable, rubber-coated clamp indicated in the photo below can be removed and discarded.
