Technical Service Bulletin

94 Side mirror turn signal inoperative

94 12 88 2030956/1 September 25, 2012.

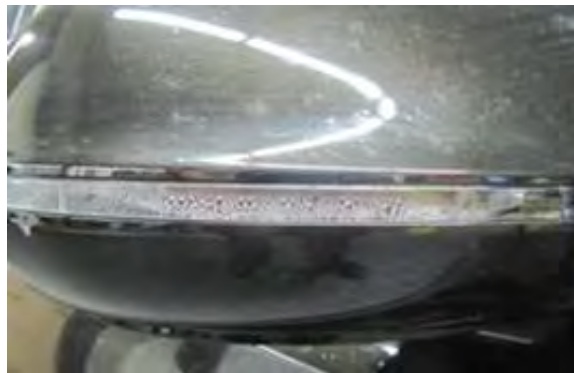
The turn signal indicator lens is inoperative without any damage from outside influence. Cracks have formed in the lens and as a result condensation can be seen behind the lens as seen in Figure 1.

Figure 1 Condensation in turn signal lens

The turn signal lens can crack due to the high amount of tension in the side mirror housing. The tension is due to improper installation of the mirror at the factory and is not a defect in the mirror housing. Replacing the mirror housing will not affect this condition.

1. Remove the side mirror as instructed by the ElsaWeb Repair manual.

2. Replace the damaged turn signal lens in the side mirror.

3. Test turn signals.
4. Clear DTCs in electrical system.
