October 2012

Customer Satisfaction Notification M20 Engine Coolant Hot Bottle

2012 (FF) Fiat 500

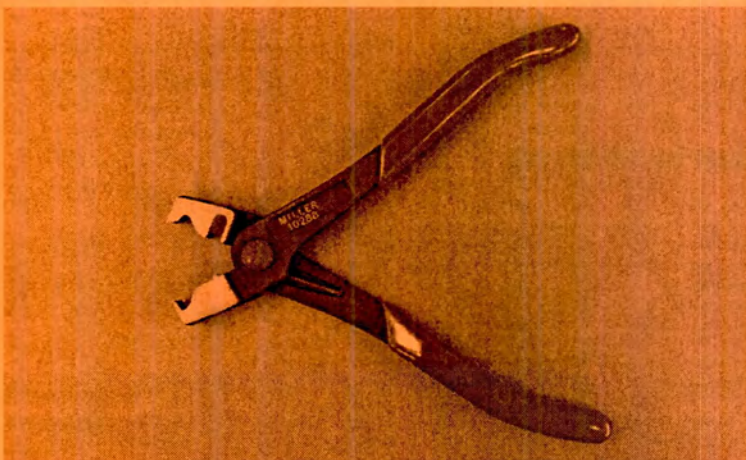
- 10288 Pliers, Hose Clamp

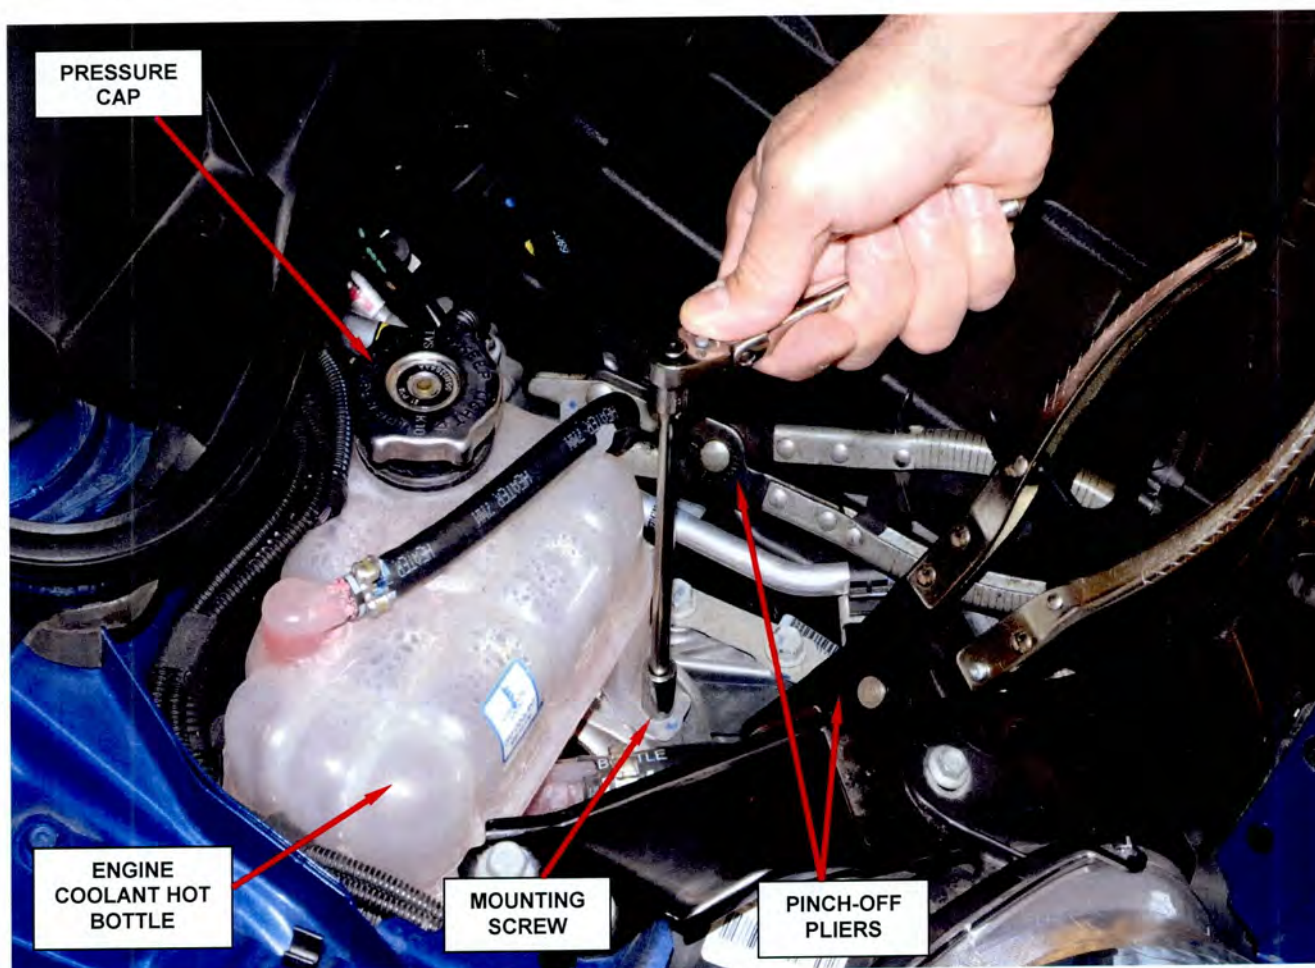
Figure 1 – Clamp-off Engine Coolant Hot Bottle Hoses

1. Open the hood.
2. Clamp off the small coolant hose at the engine coolant hot bottle with hose pinch-off pliers (Figure 1).
3. Clamp off the large coolant hose at the engine coolant hot bottle with hose pinch-off pliers (Figure 1).
4. Remove and save the engine coolant hot bottle mounting screw (Figure 1).

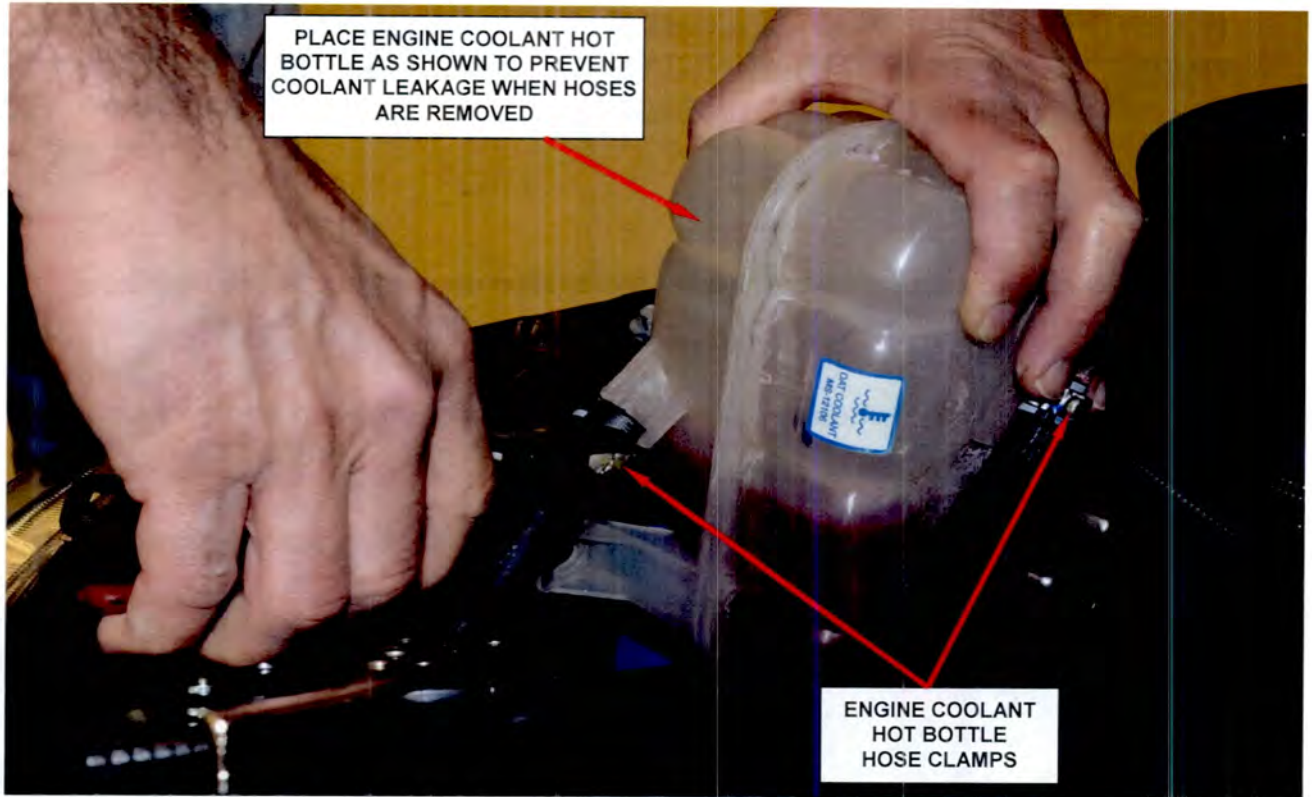
Figure 2 – Remove and Discard Hose Clamps

5. Lift up the engine coolant hot bottle and tilt it on its side (Figure 2).
6. Remove and discard the hose clamps from the large and small coolant hoses at the engine coolant hot bottle (Figure 2).
7. Remove the large and small coolant hoses from the engine coolant hot bottle.
8. Carefully remove the original engine coolant hot bottle from the vehicle.
9. Install the new clamps supplied in the kit onto the large and small coolant hoses.

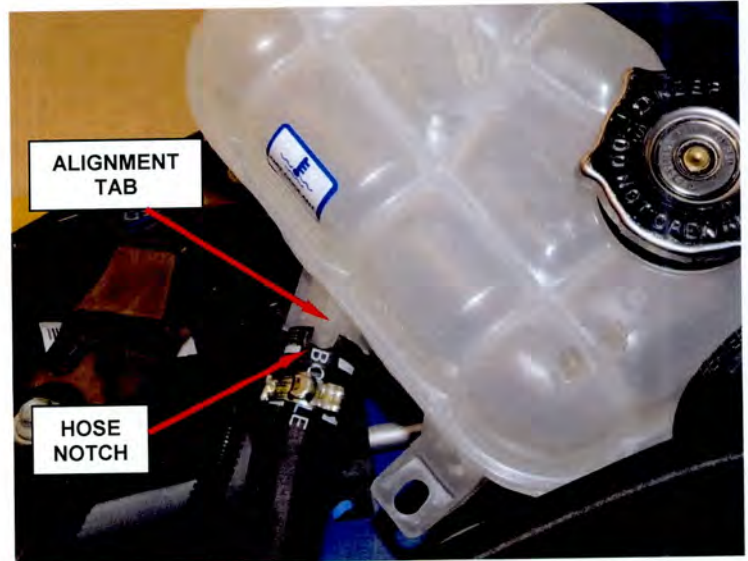
Figure 3 – Align Large Hose to Alignment Tab

NOTE: Be sure that the notch on end of the large hose lines up with the alignment tab on the engine coolant hot bottle hose nipple (Figure 3).

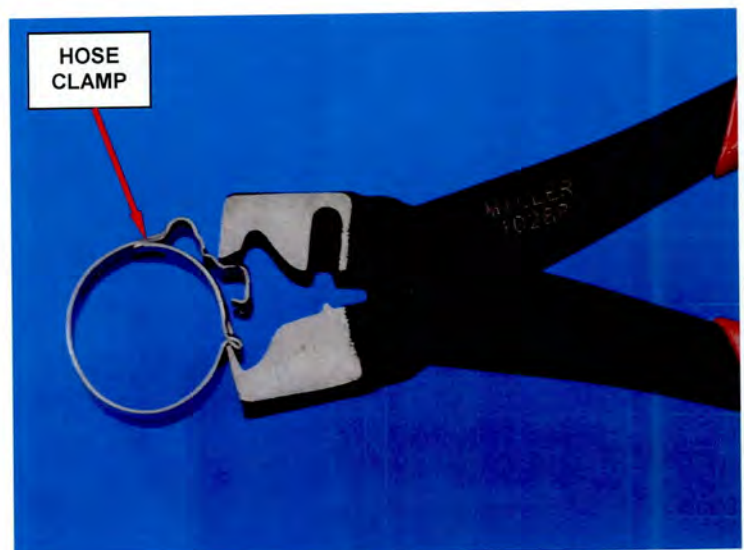
Figure 4 – Special Tool 10288

11. Using special tool 10288, tension the hose clamps for the large and small coolant hoses at the engine coolant hot bottle.

CAUTION: Be sure to grab the clamp with the tool as shown in Figure 4 to obtain proper hose clamp tension.

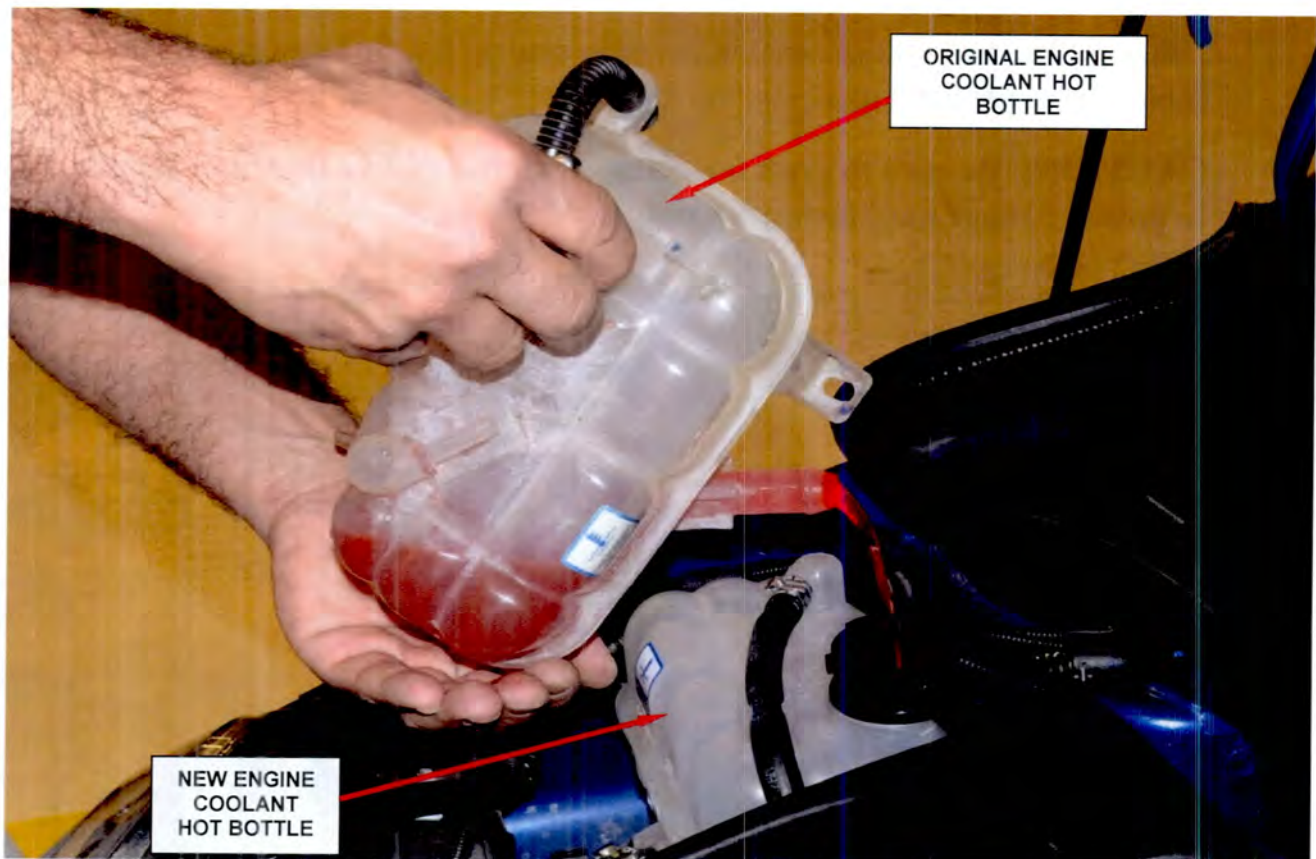
Figure 5 – Transfer Coolant from the Original Engine Coolant Hot Bottle to the New Engine Coolant Hot Bottle

14. Remove the pressure cap from the new engine coolant hot bottle and transfer the engine coolant from the original engine coolant hot bottle to the new engine coolant hot bottle (Figure 5). Add additional coolant if required.
15. Discard the original engine coolant hot bottle.
16. Install the pressure cap onto the engine coolant hot bottle.
17. Start the engine and verify that there are no coolant leaks at the engine coolant hot bottle.
18. Close the hood and return the vehicle to the customer.
