SB-10049422-7391

SI M17 10 12
Cooling Systems

Engine Cranks, No Start and/or Engine Coolant Temperature Faults

All with the N18 engine

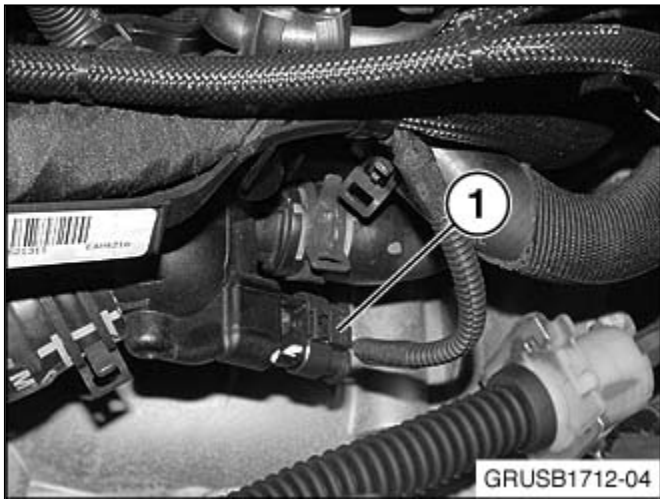
Install the new coolant hose with the engine coolant temperature sensor (1). Note: Reference the Parts Information section for the correct hose, based on model.

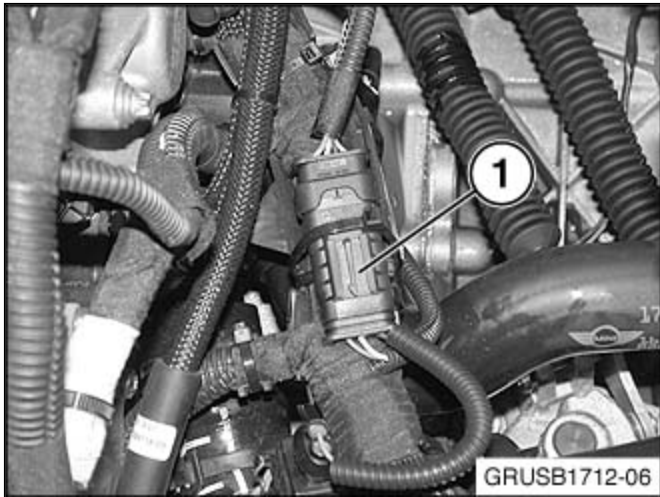
Plug connector X6279 into the 4-pin male connector (1) of adapter harness P/N 12 51 7 647 200. Insert the 4-pin female connector (2) of the adapter harness into the engine thermostat. Plug the 2-pin female connector (3) from the adapter harness into the engine temperature sensor of the new coolant hose.
