Technical Bulletin

17 12 06 December 20, 2012 2032198

Possible Oil Leak from Oil Filter Housing

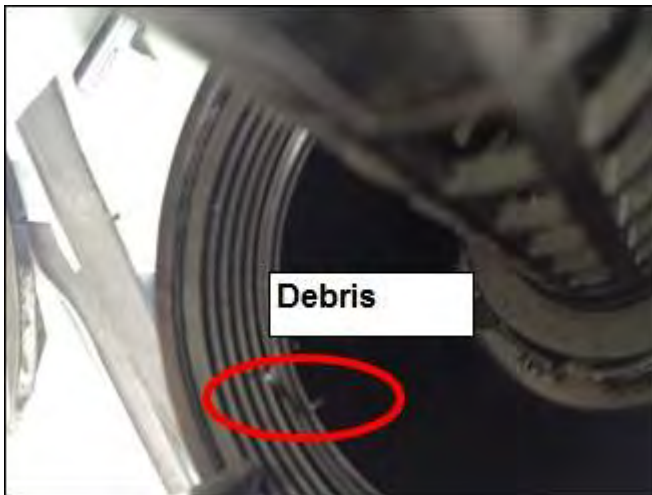
Plastic manufacturing burrs and debris may build up in the seal area of the oil filter housing. This may prevent a proper seal when installed and result in an oil leak.

- Clean debris from oil filter housing and reinstall.
