# SERVICE CAMPAIGN BULLETIN

NTB12-113a

## VOLUNTARY SERVICE CAMPAIGN 2012 NV REAR DOOR CHECK LINKS

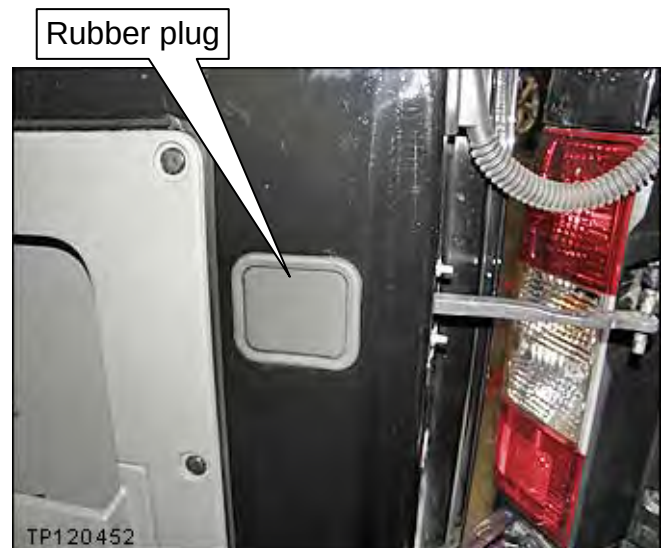
Figure 6

3. Remove the rubber plug from the service hole.

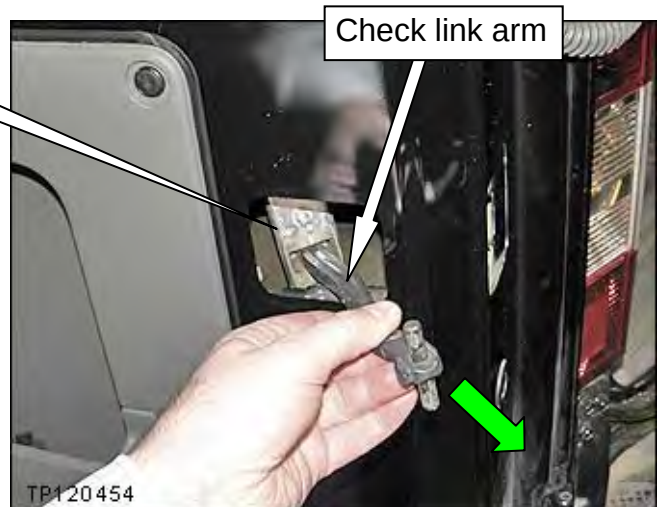
Figure 8

5. Remove the check link arm.

- a. Push the check link arm all the way into the door.
- b. Pull the check link out of the door, arm first, through the service hole.

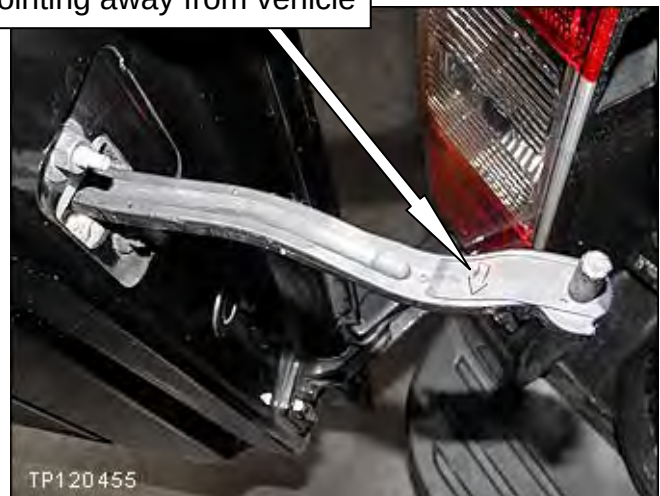
Figure 9

6. Install a new check link arm into the door in reverse order of removal.

- Make sure the arrow on the arm is pointing away from the vehicle as shown.
- Do not reuse the old nuts. Replace with new ones supplied in the link kit (see **PARTS INFORMATION**).

New arm - arrow pointing away from vehicle
