Service Bulletin

Bulletin No.: PI0850

Subject: Whistle Noise Heard from Engine Compartment, Rough Idle and/or DTC P0171 Set

Models: 2011-2012 Chevrolet Cruze
Equipped with 1.4L Engine (RPO LUJ)

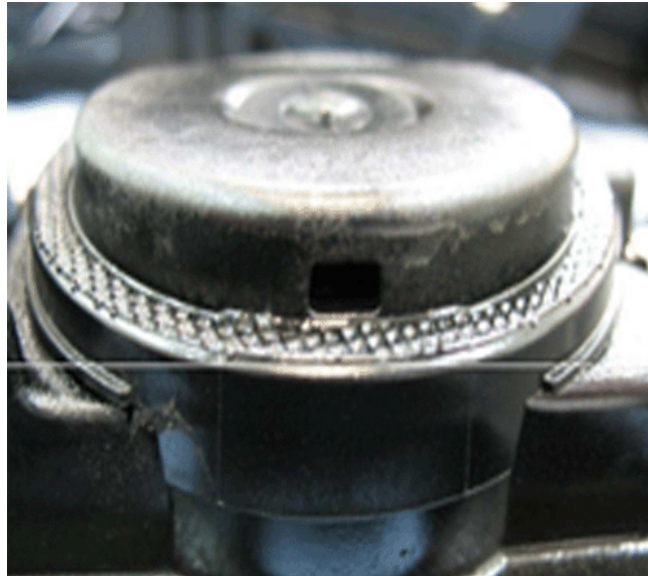
This may be caused by a vacuum leak in the positive crankcase ventilation (PCV) located on the camshaft cover.

Note: The old style camshaft cover has a taller design PCV cap as shown in the illustration above.

With the engine running using your finger, place it over the breather port of the PCV diaphragm to see if the whistle noise goes away and/or the fuel trims are high then return to normal levels.

If the noise goes away, replace the camshaft cover and clear the DTC.
