Subject: BRAKE FLUID SPILLAGE CAUTION	Bulletin No: 04-004/12
	Last Issued: 10/18/2012

2007-2012 CX-7

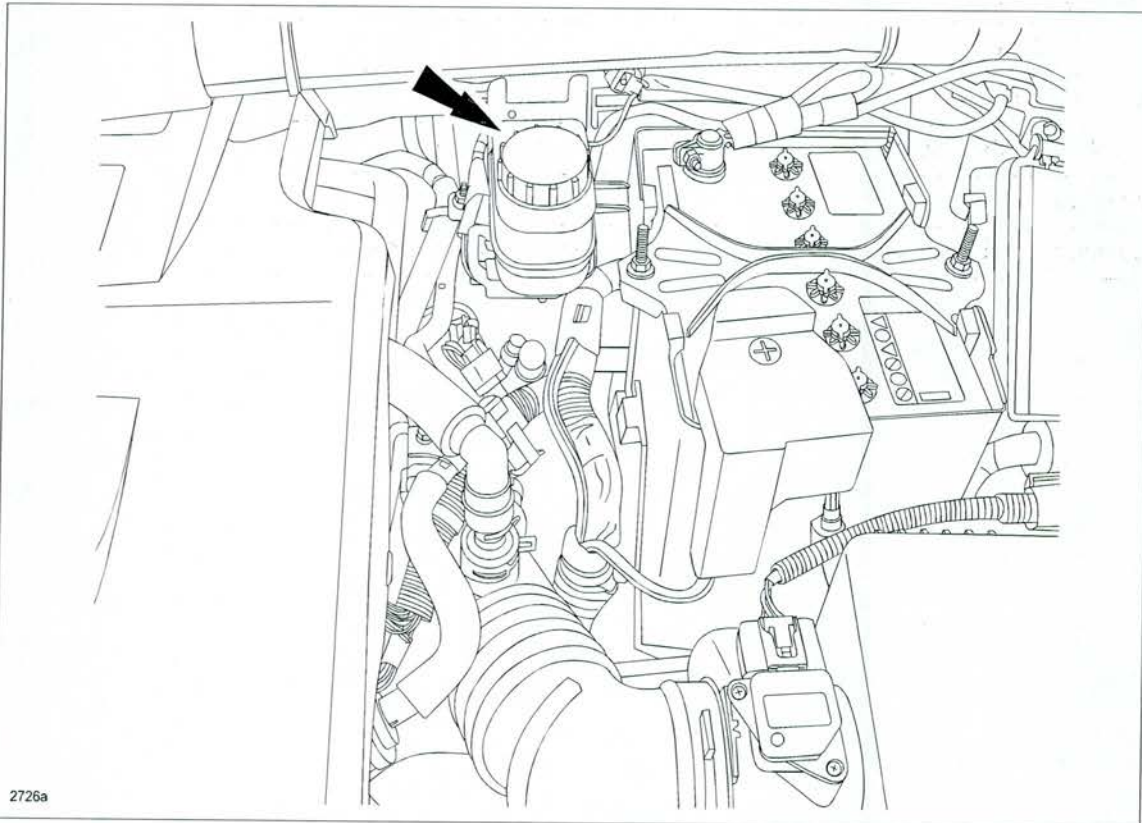
2726a

Use extreme care when replacing or re-filling brake fluid at the master cylinder. There are several wiring harnesses that run under the master cylinder that can be easily spilled upon.

CAUTION: Brake fluid contains properties that can cause a short-circuit in a wiring harness. If brake fluid is spilled on any wiring harness, clean it up immediately using a shop rag and water. Be sure to wipe the fluid completely from the harness.
