**NUMBER: 230120052.01****MODEL: Karma****TITLE: PTC Heater Thermostat****PRIORITY:****If vehicle exhibits the issue****APPLICABILITY:****All variants****MARKET REGION:****U.S., Canada, Europe, Middle East, and China****DATE: December 19, 2012****MODEL YEAR: 2012 - 2013****PURPOSE:**

# SERVICE BULLETIN

FISKER AUTOMOTIVE, INC.

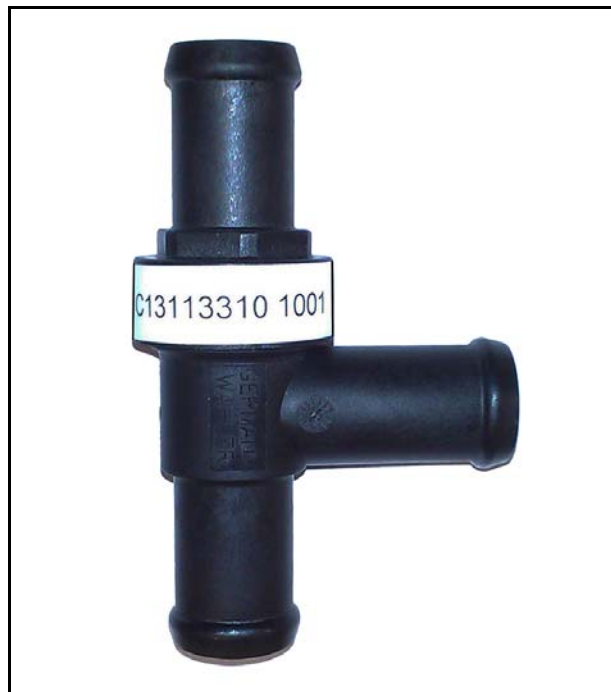
Figure 0A. Updated PTC Heater Thermostat "T"

An updated thermostatic check valve has been released that raises the thermostat's opening temperature to 65° C which will resolve the condition.

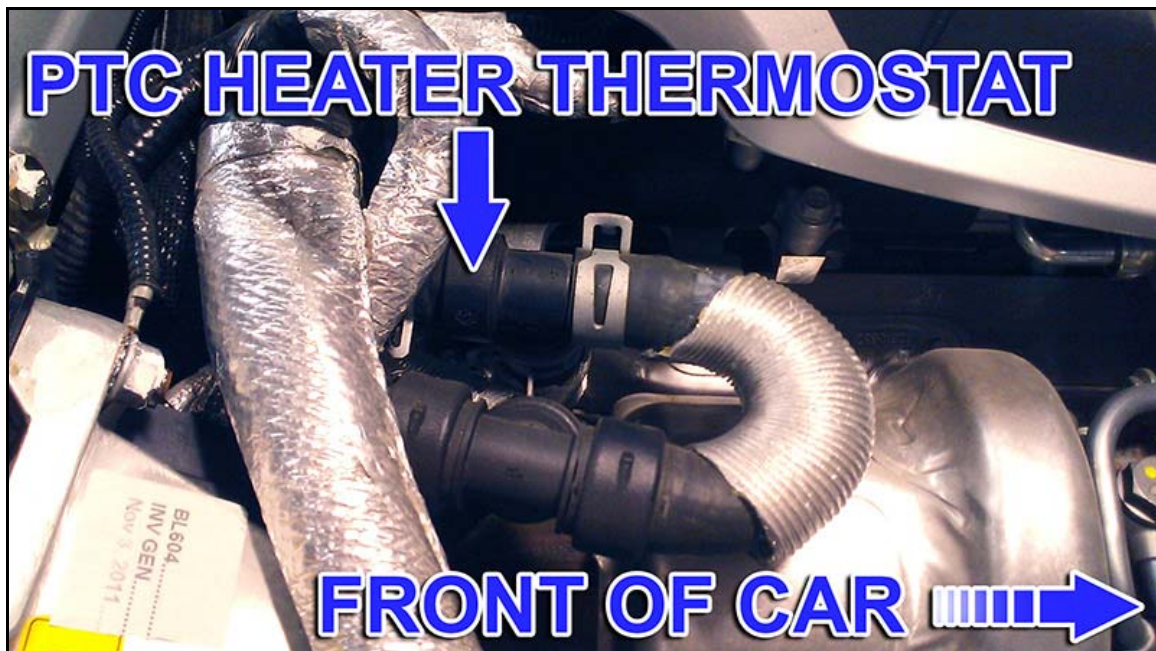
1.2. Locate the thermostatic check valve "T" located in front of the passenger side bulkhead (near turbocharger).

Figure 1A. Shown with RH cross brace removed.

1.3. Clamp off each hose going into the "T" using suitable clamping devices to minimize coolant loss.

1.4. Take note of the tabs on each spring loaded hose clamp's orientation. Remove and discard spring loaded hose clamps followed by removing the 40° C thermostat "T" check valve.
