SERVICE CAMPAIGN BULLETIN

NTB12-112

VOLUNTARY SERVICE CAMPAIGN 2012 NV CARGO LAMP BULBS

CAMPAIGN I.D.: PC177**APPLIED VEHICLE:** 2012 NV 1500, 2500, and 3500 (F80)**Check Service COMM to confirm campaign eligibility.****INTRODUCTION**

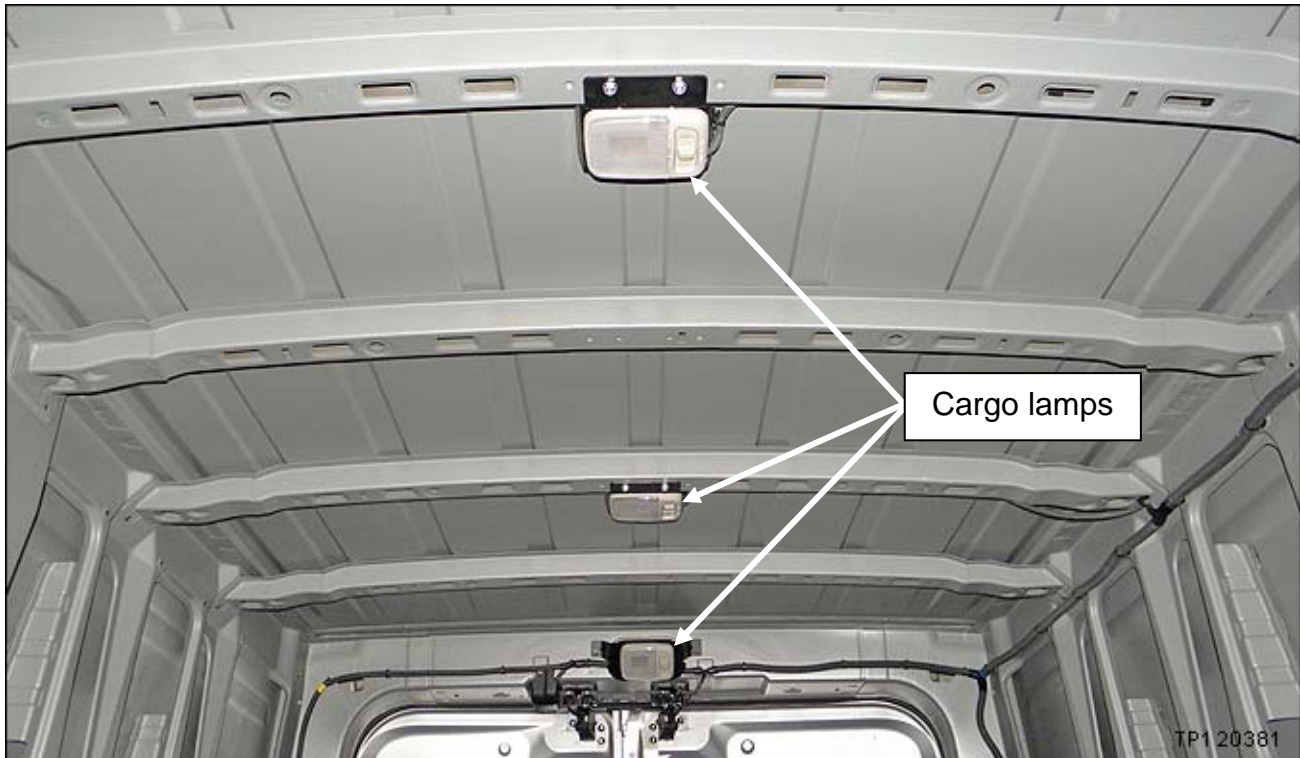
Figure 1

1. Turn OFF all cargo lamps.

NOTE: NV 1500 vehicles have one (1) cargo lamp. NV 2500 and 3500 vehicles have three (3) cargo lamps.

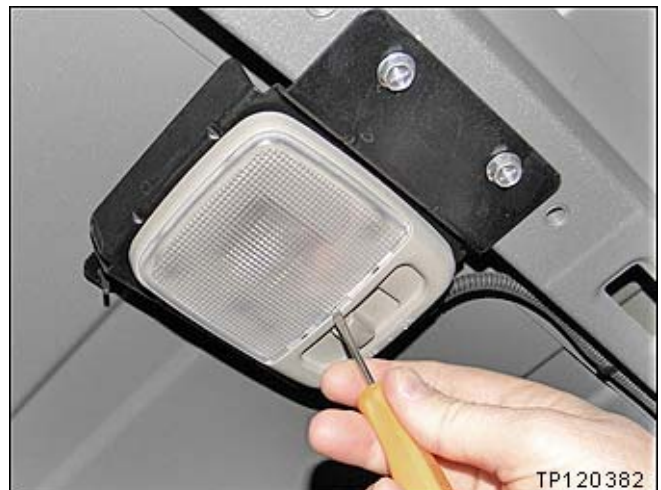
Figure 2

2. Remove each cargo lamp cover.

- Carefully use a small flat blade screwdriver to snap loose and remove lamp covers.

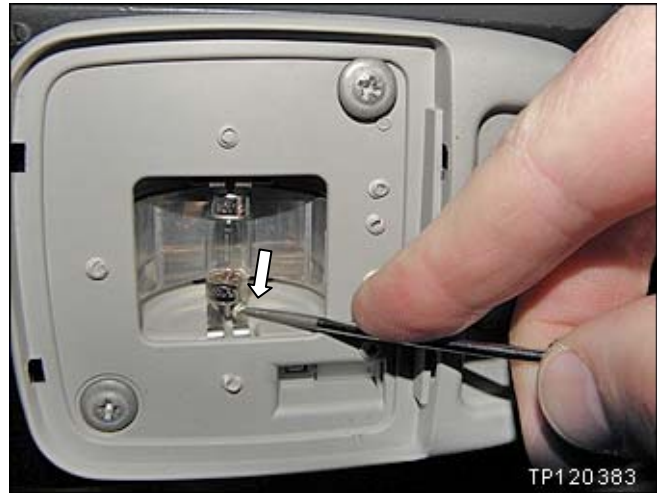
Figure 3

4. Remove the old bulbs.

- Use a small flat blade screwdriver to push back (away from the bulb) on a side contact, and then remove the bulb.

5. Install the **new** bulbs listed in the parts information. Make sure bulbs are securely/correctly mounted.

NOTE: Do not reuse the old bulbs.
