SB-10051604-3285

SB-12-17-013

12V Battery Positive Terminal Update

Classification	Repair Bulletin - Level II	Section/Group	17 - Electrical	Country/Region	North America
Year	2012	Model	Model S	Version	All

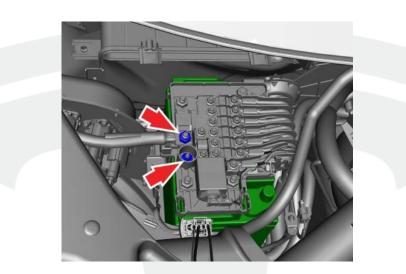
Figure 6

- 11. Remove the battery fuse box cover.
- 12. Remove the body harness nut (torque 6 Nm) and fuse box mounting nut (torque 6 Nm) (Figure 6).

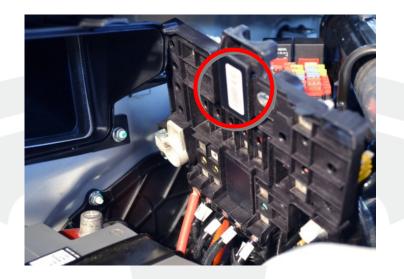
Figure 8

14. Tilt the fuse box up, and check the serial number on the label on the bottom of it (Figure 8). If the serial number starts with IT12G or IT12H, continue this procedure to replace the 12V battery positive terminal.

NOTE: If the serial number does not start with IT12G or IT12H, the terminal does not need to be replaced. Re-assemble the vehicle, following the previous steps in reverse order. When reinstalling the wiper arms, align the tips of the wipers with the L-shaped alignment marks on the windshield.

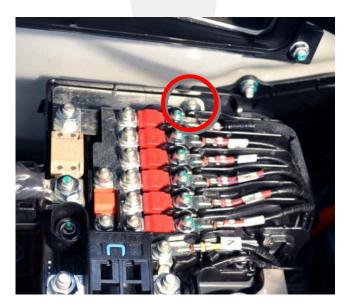
Figure 9

15. Remove the nut and bolt that hold the 12V battery positive terminal to the fuse box (Figure 9), then remove the 12V battery positive terminal. Discard the nut, bolt, and terminal.

- 16. Position the replacement 12V battery positive terminal in the holder on the bottom of the fuse box. Install the included nut and bolt to secure the terminal to the fuse box (torque 11 Nm).
- 17. Reassemble the vehicle, following the previous steps in reverse order.
