GROUP Body	MODEL 2013MY Rio (UB)
NUMBER 087	DATE November 2012

TECHNICAL SERVICE BULLETIN

SERVICE ACTION: LUGGAGE TRAY ASSEMBLY KIT INSTALLATION (SA130)

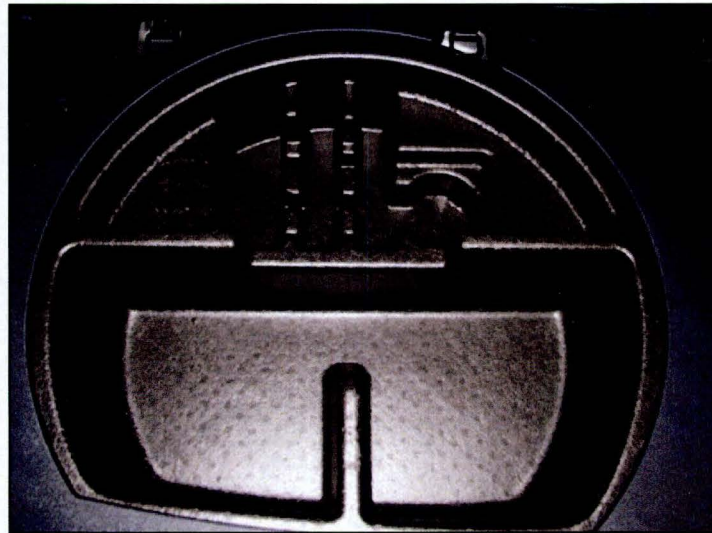
New Luggage Tray Assembly
