L-SB-0106-12

# Loose Trim Panel Material Surrounding the Power Button Switch

YEAR(S)	MODEL(S)	ADDITIONAL INFORMATION
2011 – 2012	CT200H

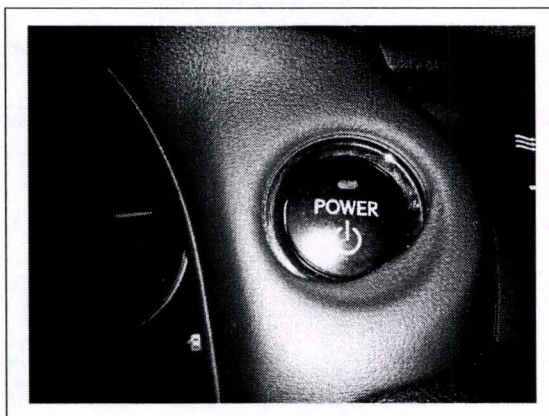
Figure 1.

Some 2011 - 2012 model year CT 200h vehicles may exhibit a loose material condition surrounding the POWER button on the Meter Hood Sub-assembly. Replace the Meter Hood Sub-Assembly to address this condition.

1. Remove the Meter Hood Sub-assembly.

2. Install the new hood meter upper trim panel.
