NUMBER: 07-006-12

Excessive Flash Material on Coolant Overflow Bottle

2013 JK Wrangler

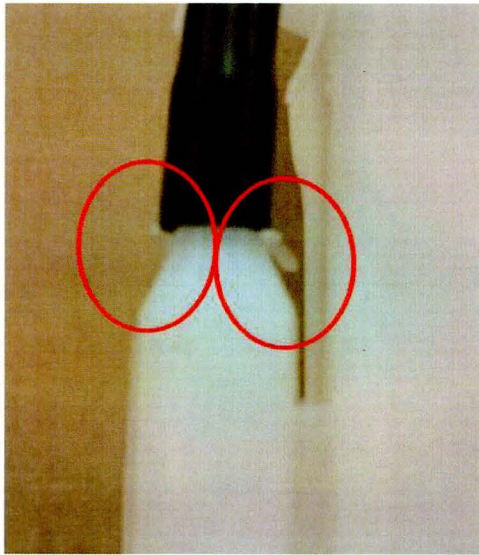
2. Pour the coolant in the recovery bottle into a clean container. The coolant will be re-used. Make sure the container is free of debris and contaminants.
3. Pull and twist coolant overflow hose with necessary force to detach it from the coolant recovery bottle.
4. Inspect the coolant recovery bottle overflow hose nipple for signs of excessive flash material (Fig. 1). The outside diameter of the nipple surface should be free from flash and no parting line should be felt. Inspect the opening of the nipple. Confirm that the hole is free of flash and fully open (Fig. 2).

Fig. 1 Excessive Flash On Coolant Bottle Nipple - Hose Attached

5. Was excessive flash material found on the exterior or the opening of the coolant recovery bottle overflow hose nipple?
 - a. YES>>>Replace the Coolant Recover Bottle (p/n 68091500AC) and proceed to the next step.
 - b. NO>>>Proceed to the next step.
6. Install the coolant overflow hose onto the coolant recovery bottle until it reaches the stop bead on the bottle (Fig. 3).

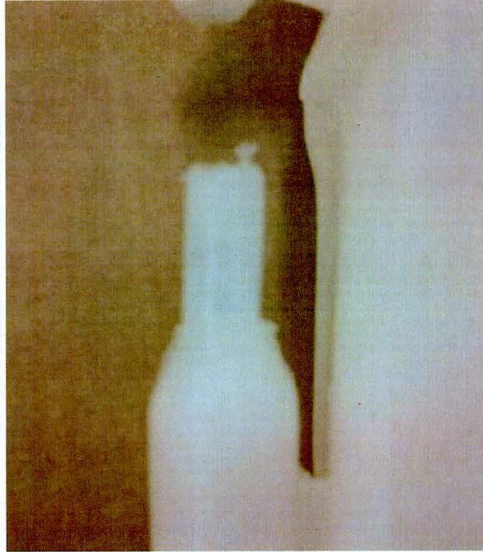
Fig. 2 Excessive Flash On Coolant Bottle Nipple - Hose Removed

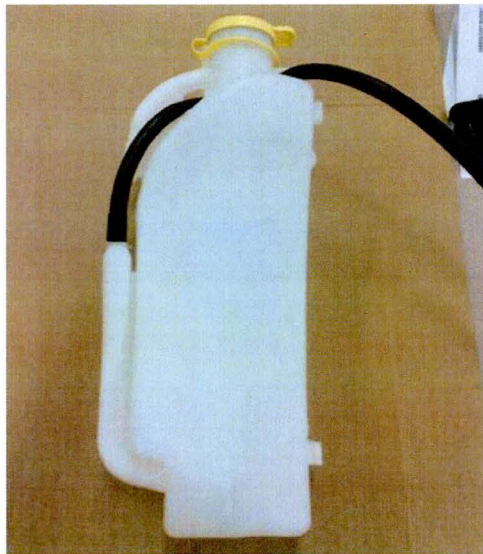
Fig. 3 Coolant Bottle
