**PRODUCT CAMPAIGN BULLETIN**

**APPLICABILITY:** 2009-2012MY Subaru Forester  
**SUBJECT:** Rear Seat Center Seatbelt

**NUMBER:** WQA-37  
**DATE:** March 2012

**REVISED:** 10/10/12

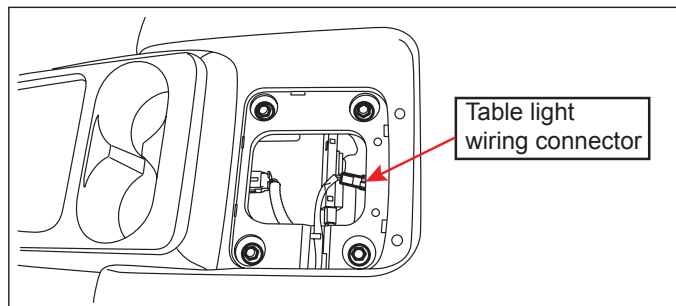
1. Record preset radio stations.
2. Turn ignition switch to OFF. Disconnect the ground cable from battery, and wait for 60 seconds or more before starting work.
3. (Models with seat table). Flip open the seat table of the rear seat cushion and remove trim cover. Disconnect the table light (white) wiring connector. **Caution:** Do not disconnect the satellite safing sensor wiring connector. Remove the 4 (10mm) bolts.

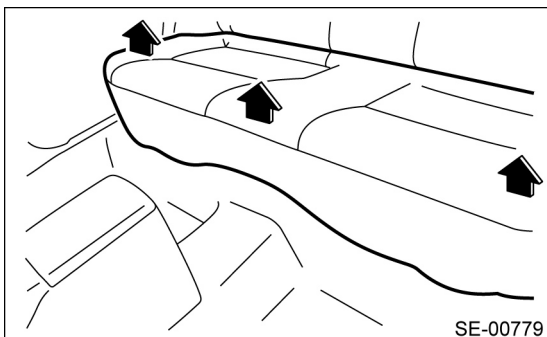
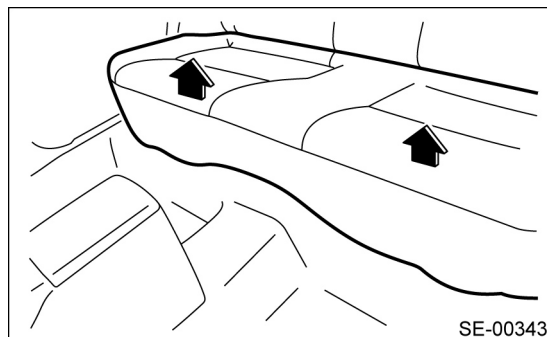
Seat Anchor locations depending upon applicability (with or without seat table).

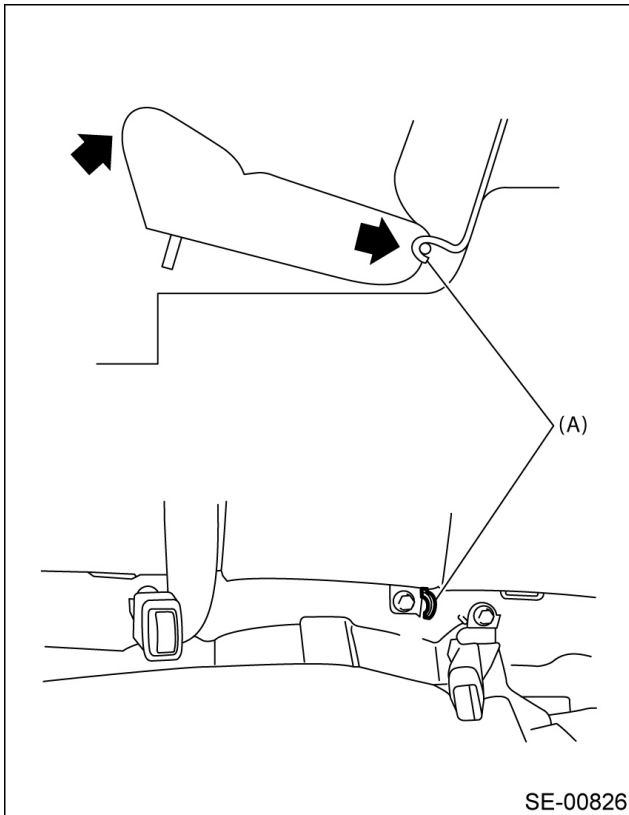
4. Disengage the backrest hook (A) by pushing it back while lifting the front side of the seat cushion. Perform the same procedure on the opposite side. Remove seat cushion from vehicle.

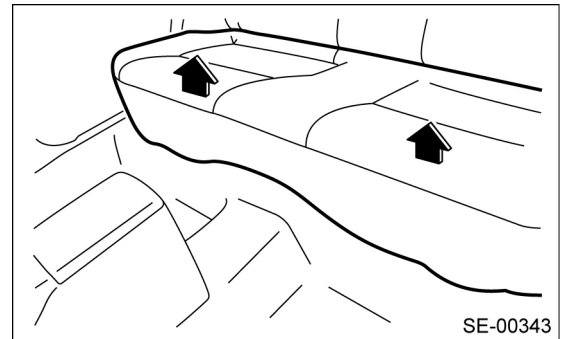
**With seat table**

**Caution:** If the cushion anchor hooks (either two or three, see drawings above) on the vehicle body side are disengaged (remain on the seat cushion) when removing the rear seat cushion, always replace with new cushion anchor hooks to prevent any reduction in the retention force.

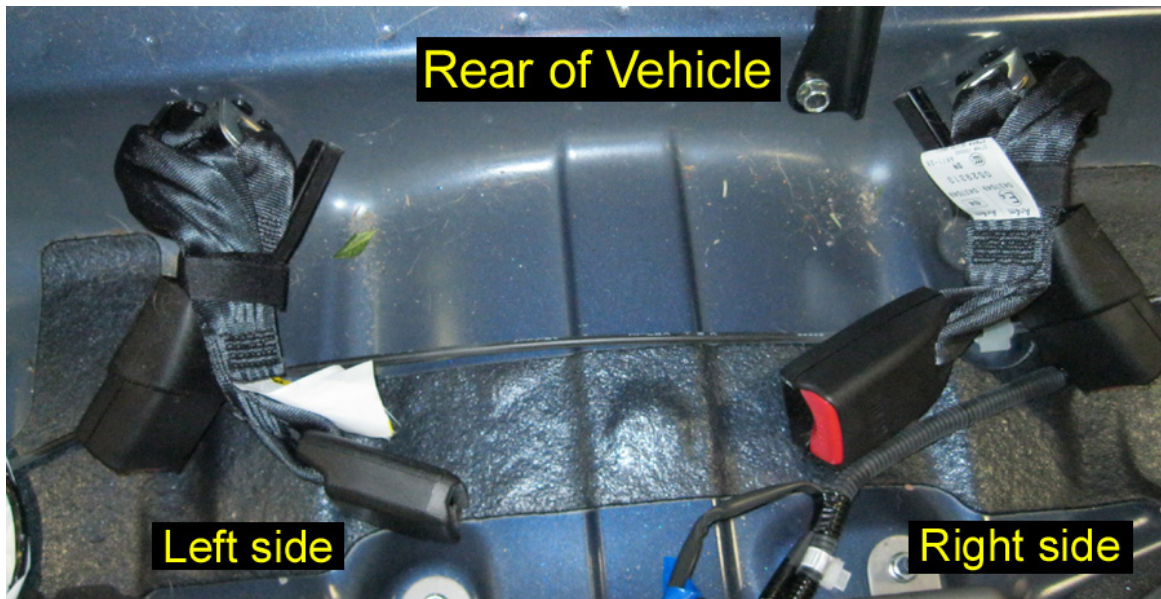
The center seatbelt with “Key Slot Release” requires replacement.  
The center seatbelt buckle marked “Center” requires replacement.

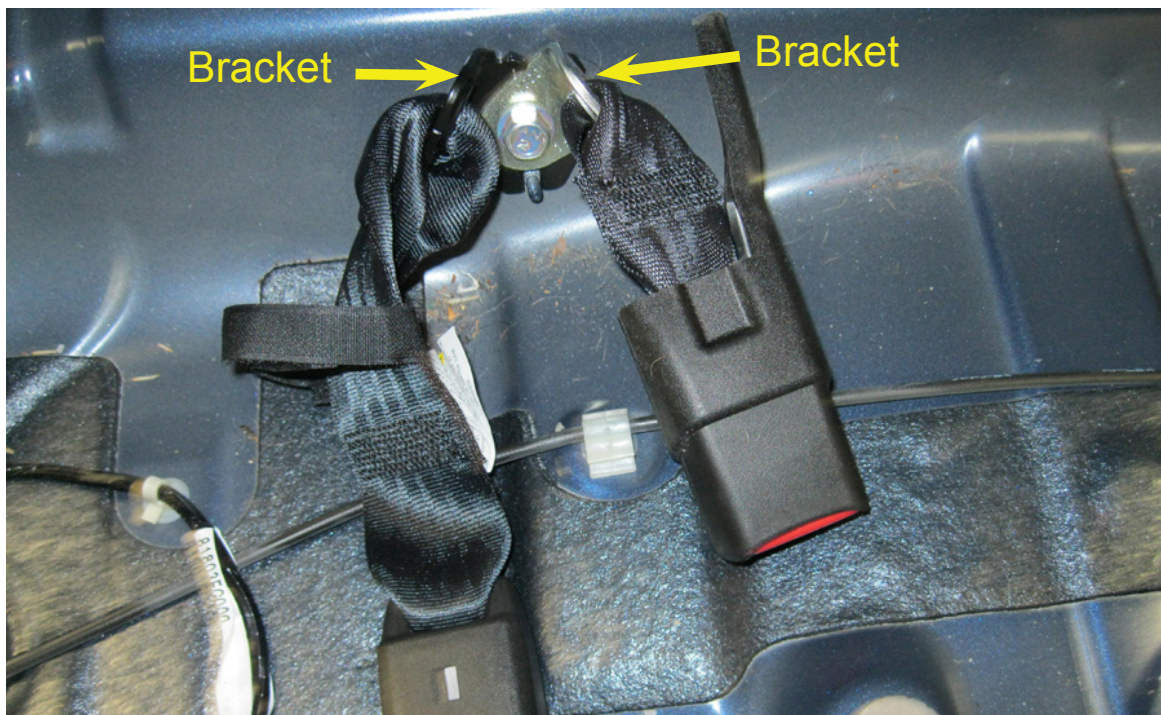
**Note: Make sure to note the location of the seatbelt brackets.**

5. Unwrap the Velcro® strap and remove the bolt to remove the seatbelts. Perform the same procedure on the opposite side.

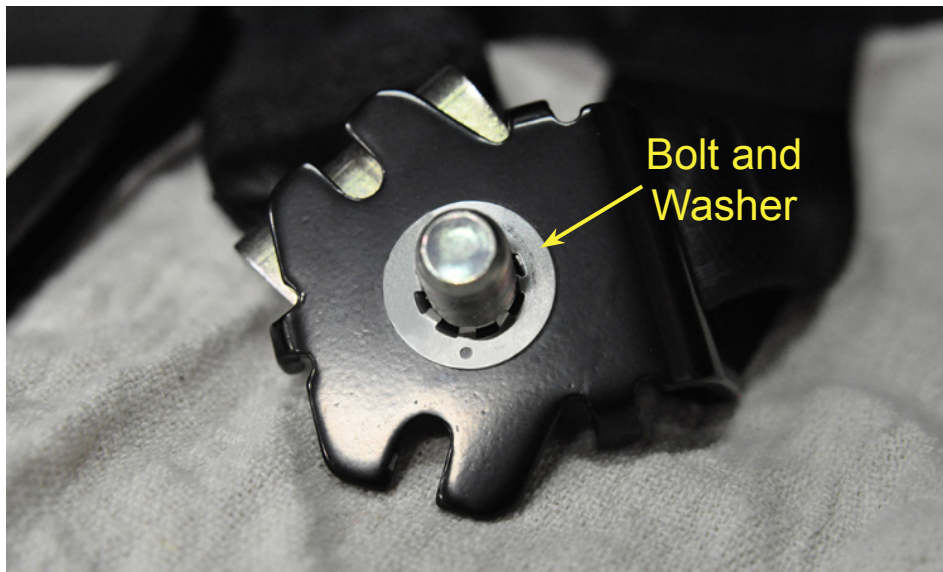
6. Separate seatbelt brackets by removing bolt and washer. Discard bolt and washer.

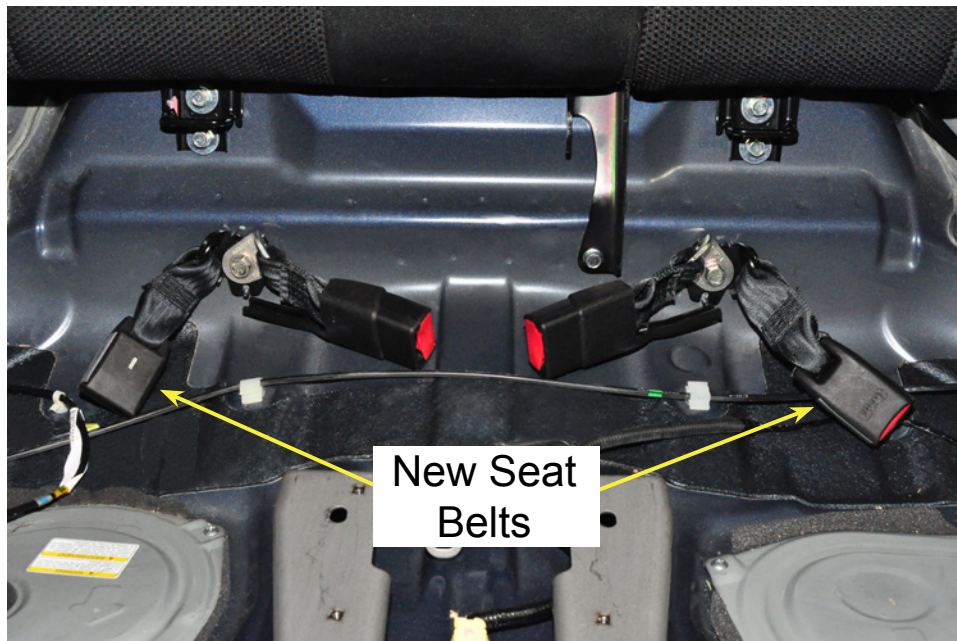
7. Reassemble both belt assemblies using new inner belt and bolt in the same orientation as original. **Note: Washer is not required.**

**Caution: Make sure new belt bracket is on the bottom.**

8. Reinstall assemblies into vehicle and torque to spec. 30 N-m (3.06 kgf-m, 22.1 ft-lb)

**Note:** The replacement belts will be shorter than the original belts. This is intentional. Always use matched belt sets. Do not intermix original and campaign belts

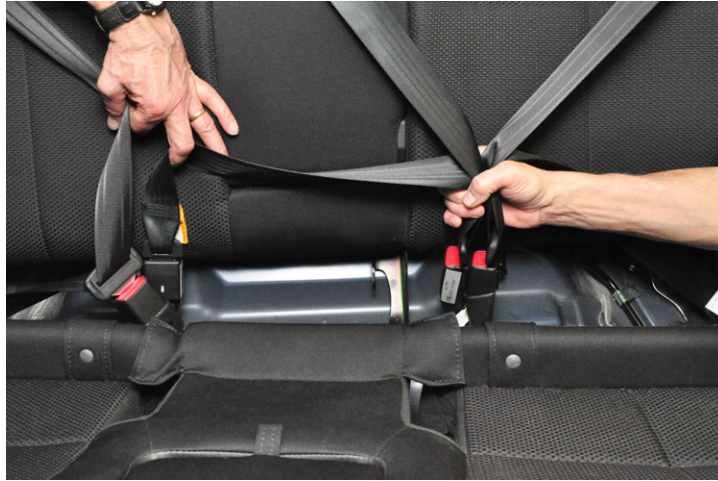
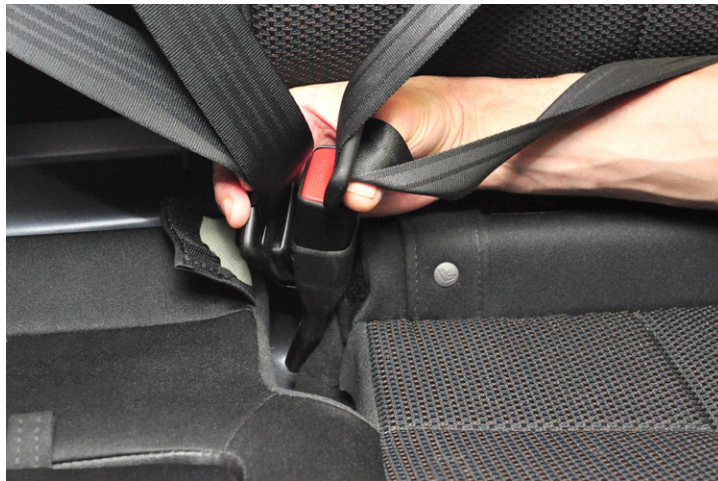
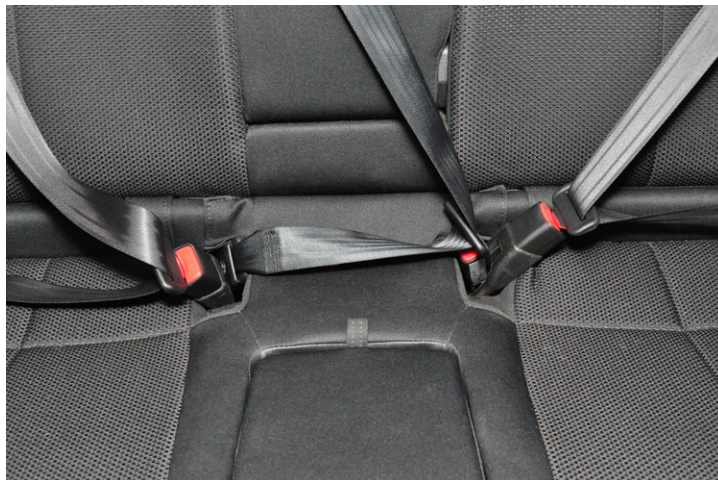
9. Reinstall the seat cushion. To facilitate positioning of the seatbelts in the cushion, connect all of the seatbelts. The next step will require an assistant. With each person holding the left and right seatbelts respectively, slide the cushion into place while pulling the belt buckles into position in the seat cushion opening.

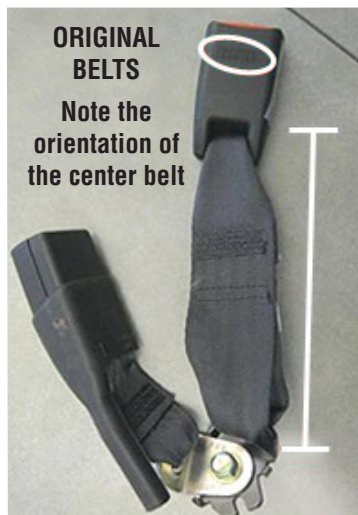
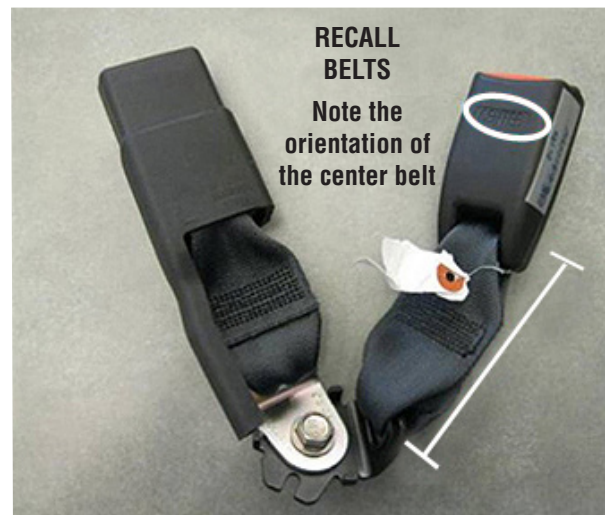
This page should clarify two areas of the Campaign and does not represent any change in procedure. The first clarification is the length of the recall belt. By design, the recall replacement belt is shorter than the original belt.

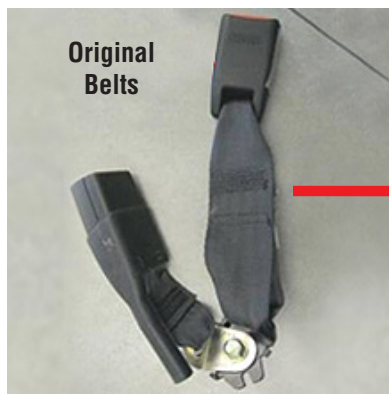
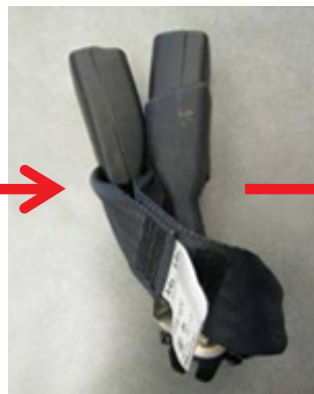
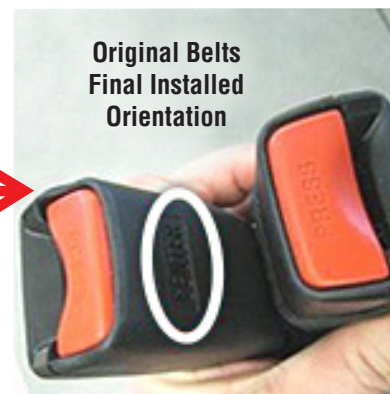
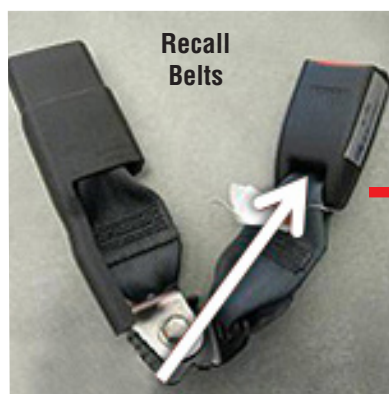
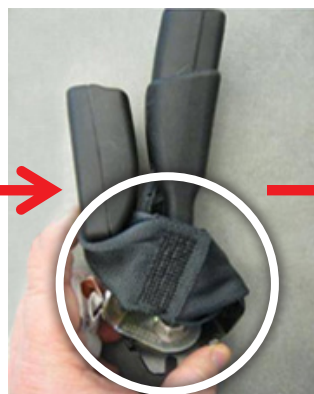
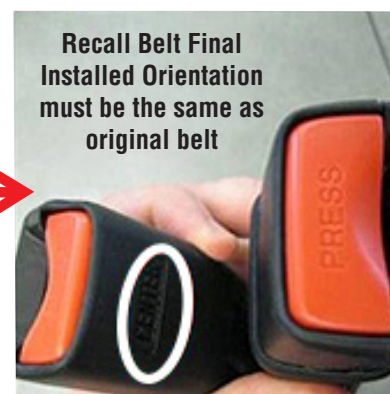
The second clarification is the final buckle/ latch orientation for the center belt. The red latch release button must face away from the seating position it services. Access to the red latch release button must not be blocked by the belt when it is latched in place for use.

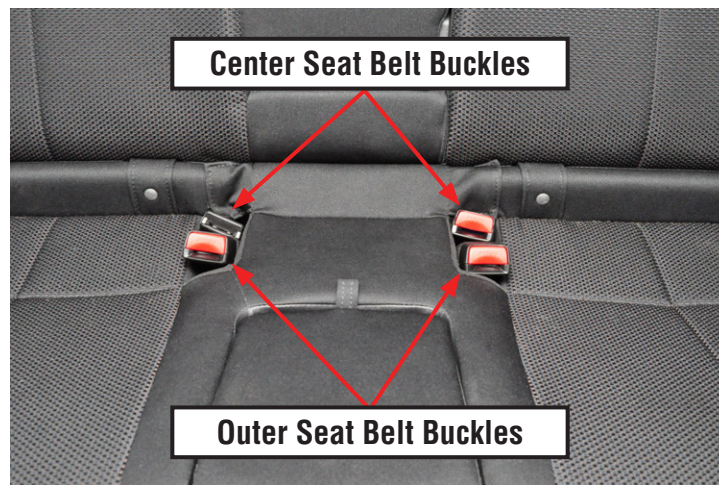
Proper seatbelt buckle(s) positioning

10. Disconnect the belts and position the buckles as shown.

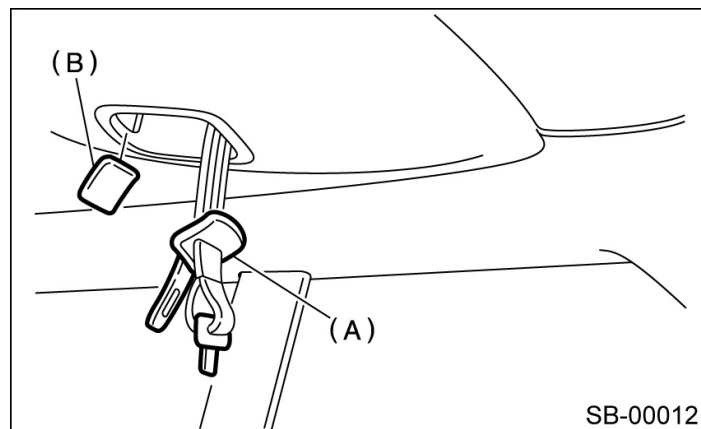
1. Carefully remove the belt trim cover (B). Pull the outer seatbelt center tongue (A) through the headliner opening.

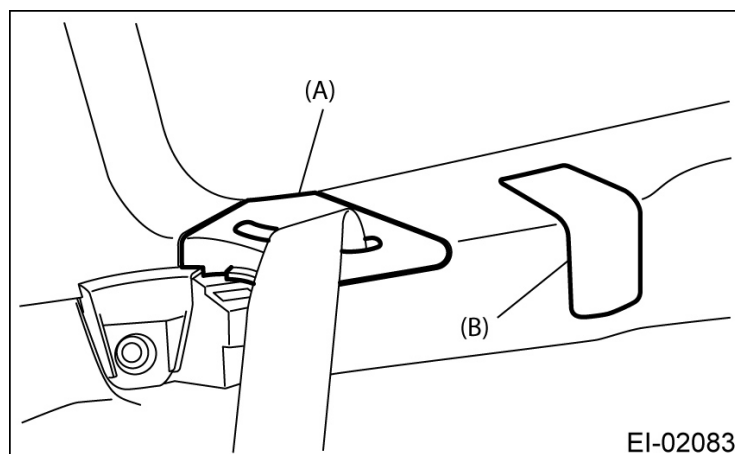
2. Remove the right rear quarter panel trim covers (A) and (B).

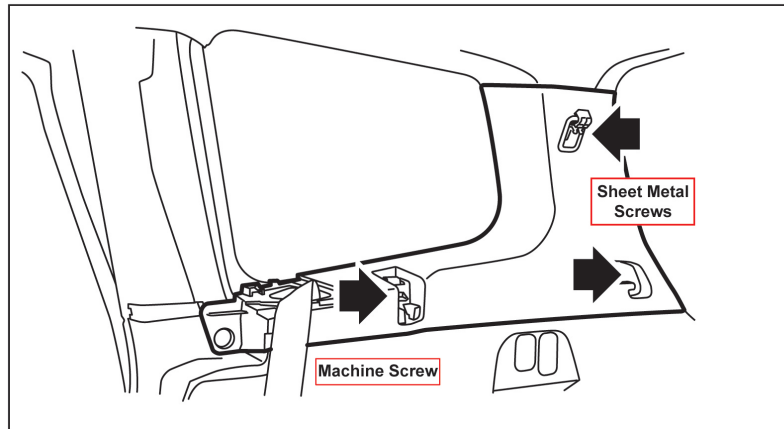
3. Remove the front machine screw and 2 rear sheet metal screws from the right rear quarter panel trim.

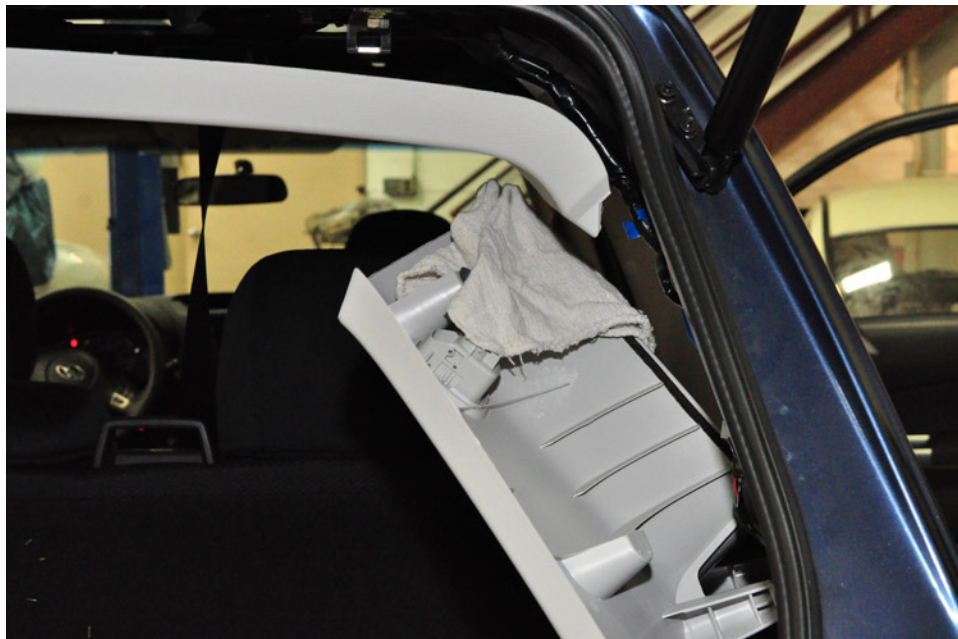
4. Carefully unclip the right rear quarter panel trim from body. It is not necessary to remove the panel. Only move it out slightly to allow the headliner to be lowered. Protect the trim edge from chafing the headliner using a shop rag or other suitable cushion. Unclip the rear upper headliner trim.

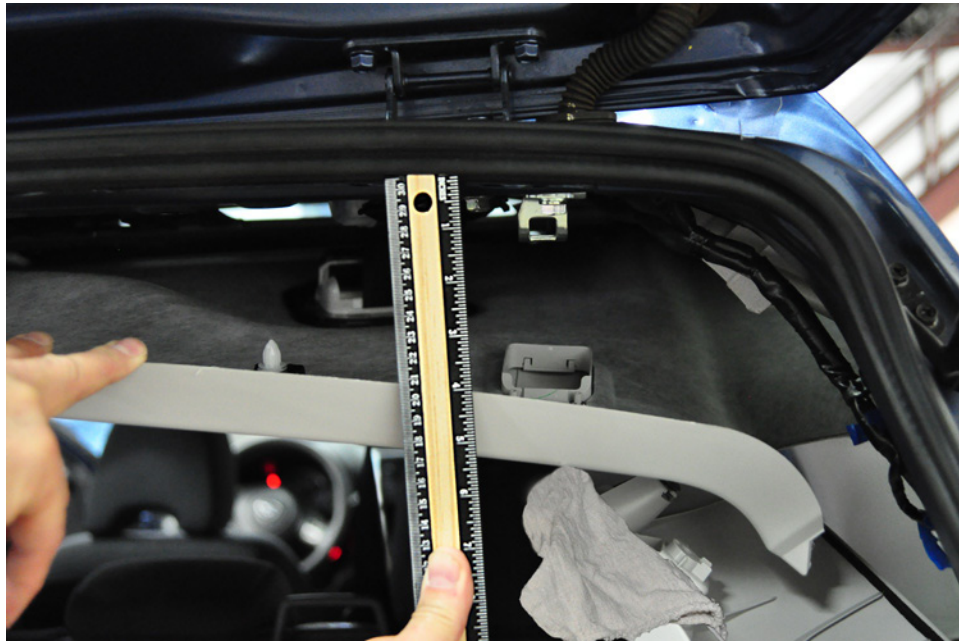
Right side

**Caution:** Headliner supports will prevent the headliner from creasing or bending, the headliner should not be allowed to drop more than 4 inches on the right side and 1.5 inches on the left side. Headliner supports must be used to prevent damage.

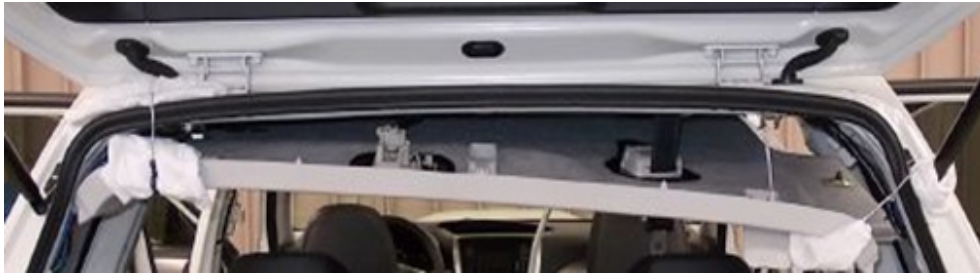
Headliner supports in place

5. Install headliner supports.

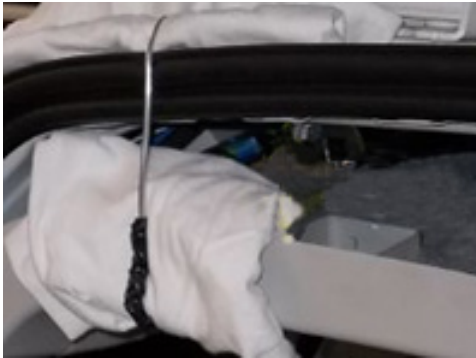
Left side headliner support  
Place over the tailgate opening  
to bottom edge of headliner

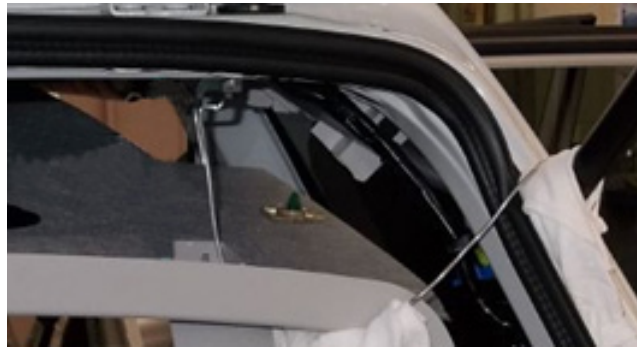
Right side headliner support  
Hook to tether anchor, then route  
through headliner opening for tether  
and attach to rear gate stay.

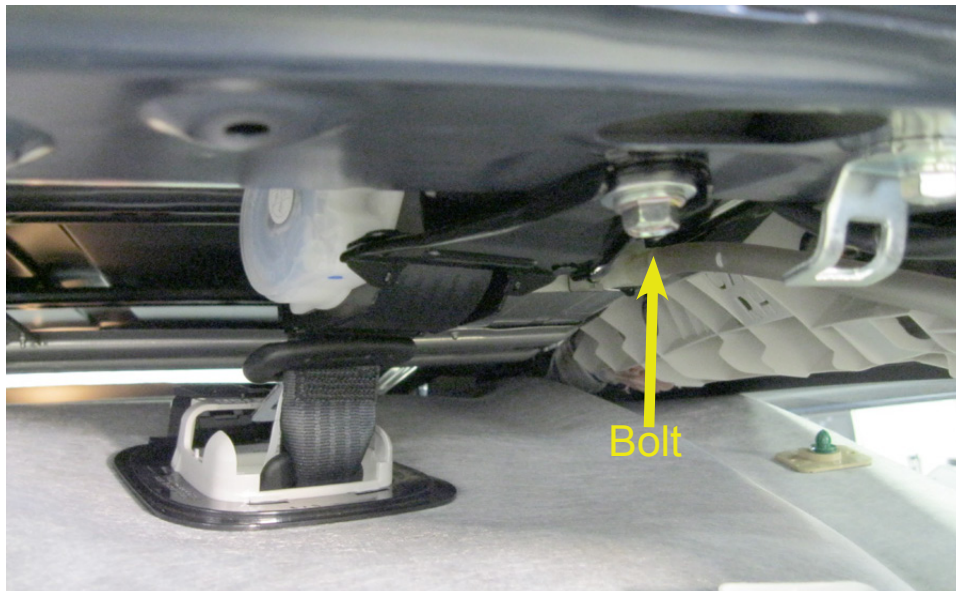
6. Remove the bolt and rear center seatbelt.

7. Install new rear center seatbelt and bolt.

**Caution: Carefully start bolt by hand to prevent cross-threading.**

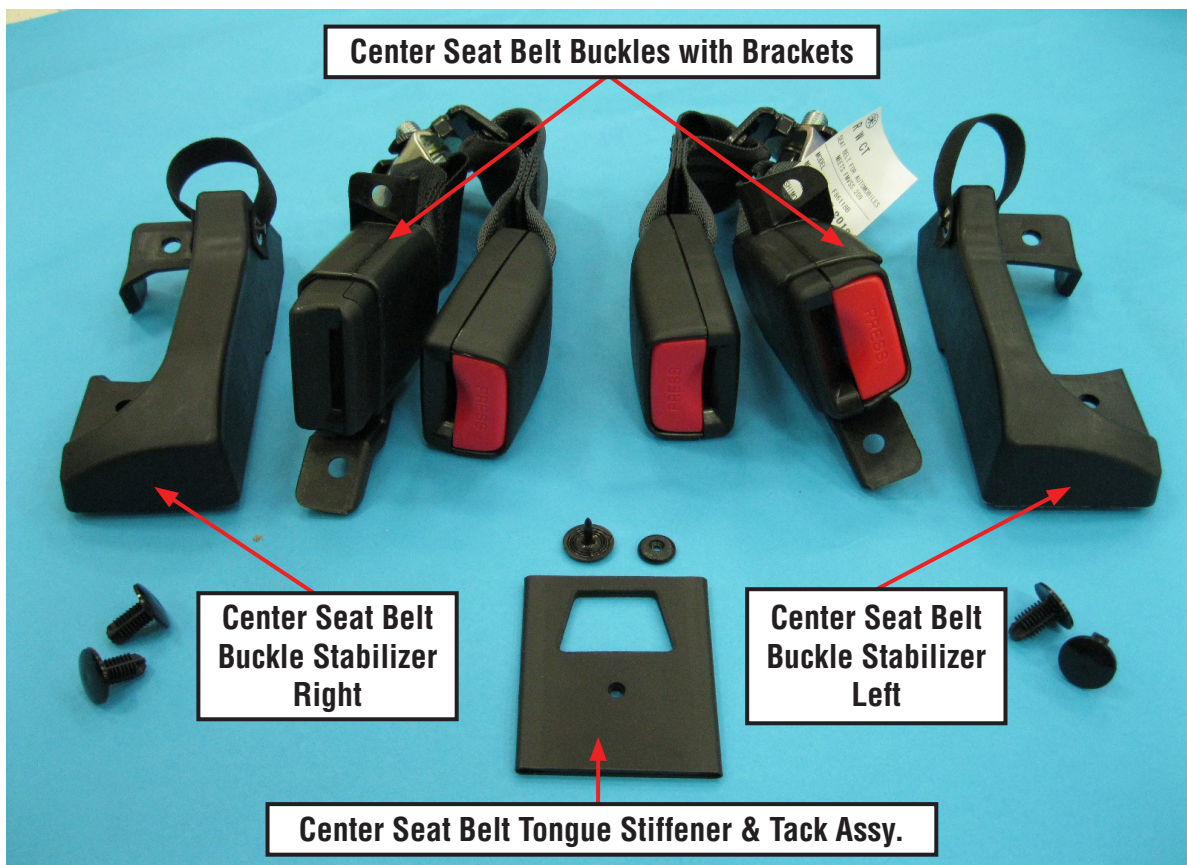
Figure 1: WQA-37 Kit 2

**Note:** The belts for Kit 2 are shorter than original belts and also shorter than those used for Kit 1. This is intentional.

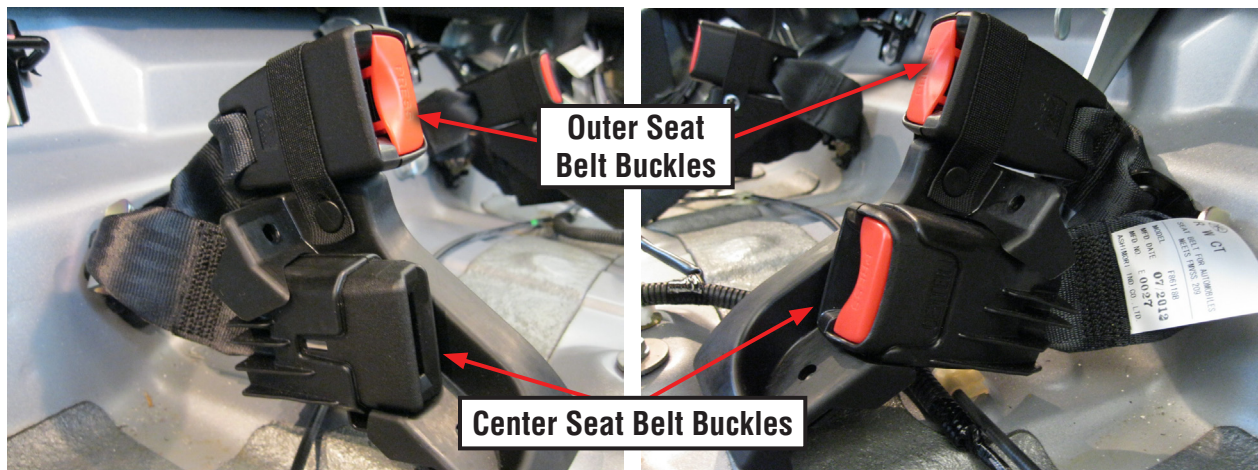
**Figure 2: Installed View Passenger side without seat**

**Figure 3: Installed View Driver side without seat**

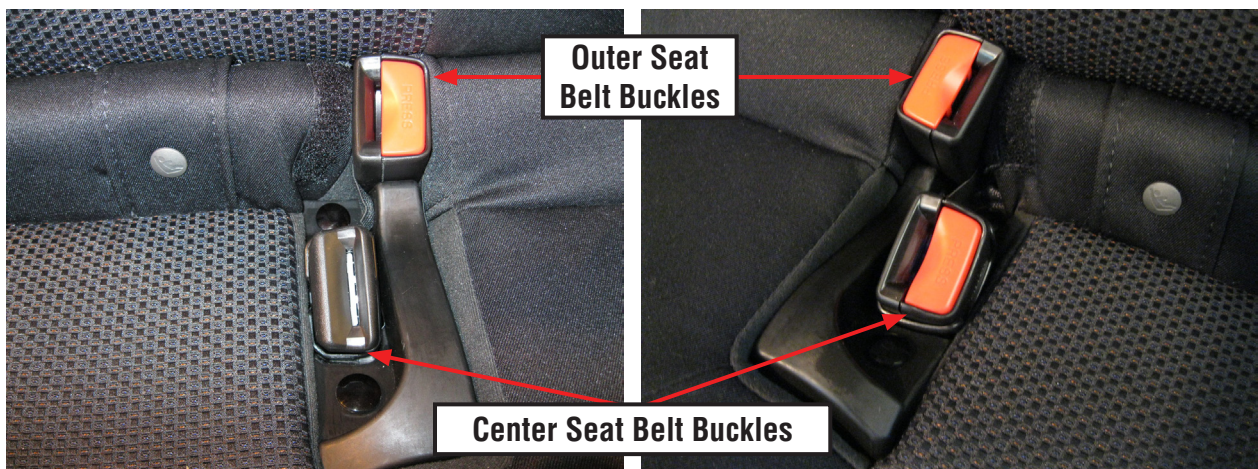
**NOTE:** Stabilizers installed in photos below for illustration only. Actual installation occurs later in the procedure.

**Figure 4: Installed View Passenger side**

**Figure 5: Installed View Driver side**

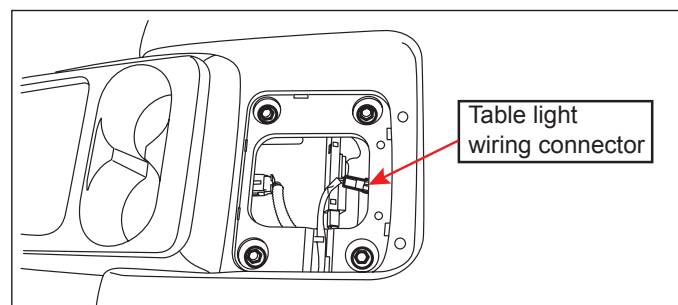
1. For models with rear seat table, flip open the seat table of the rear seat cushion, **CAREFULLY** remove the storage box floor panel with a plastic trim removal tool then disconnect the white table light wiring harness connector. Remove the 4 (10mm) bolts. **Do not disconnect the airbag satellite safing sensor connector.**

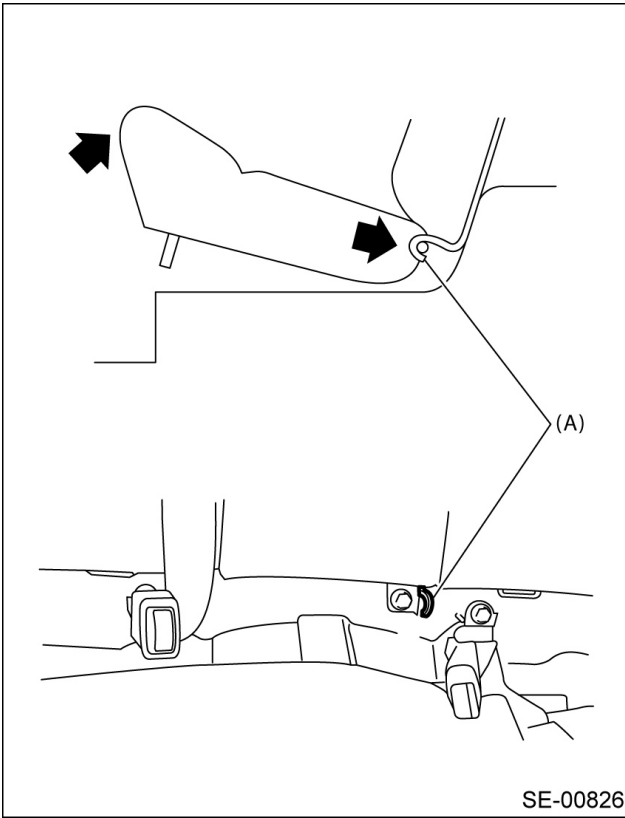
2. Disengage the backrest hook (A) by pushing it back while lifting the front side of the seat cushion. Perform the same procedure on the opposite side. Remove seat cushion from vehicle.

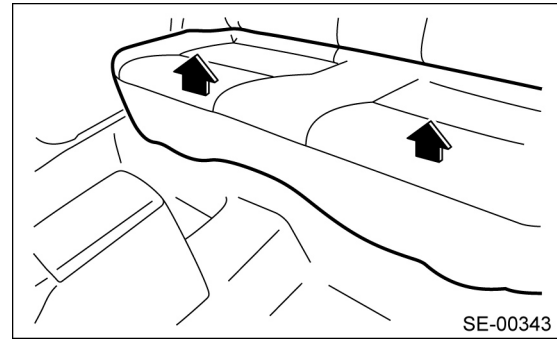
**With seat table**

**Caution:** If the cushion anchor hooks (either two or three, see drawings above) on the vehicle body side are disengaged (remain on the seat cushion) when removing the rear seat cushion, always replace with new cushion anchor hooks to prevent any reduction in the retention force.

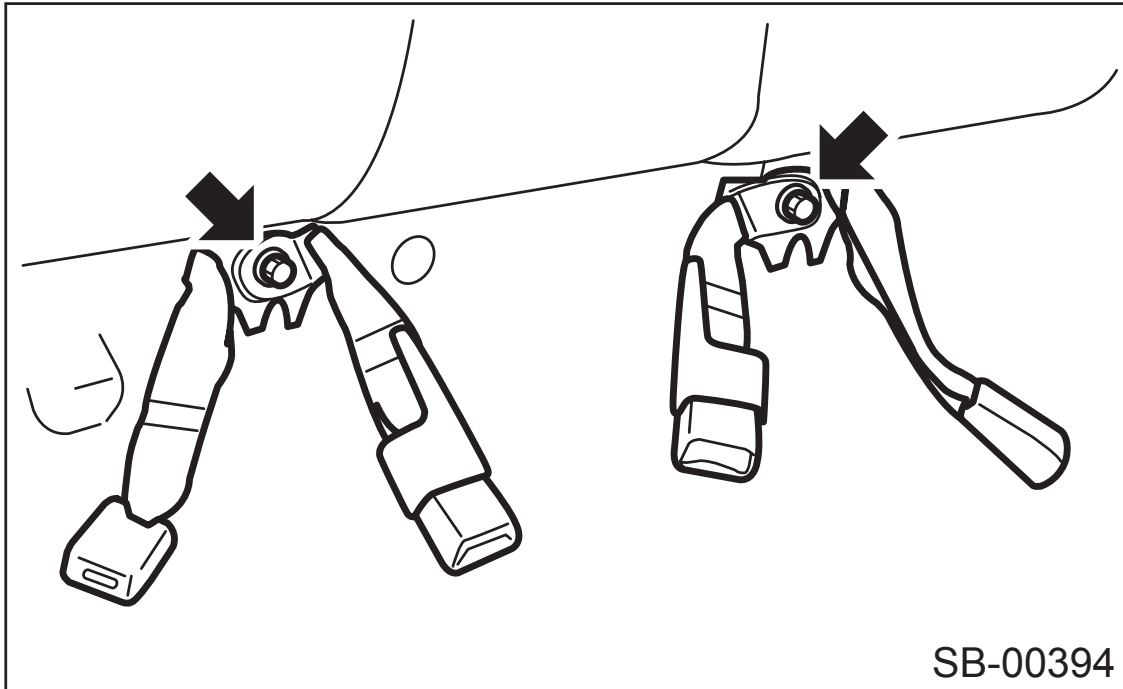
3. Remove the retaining bolts and remove the center seat belt assemblies.

- During re-installation, make sure that the seat belts are not twisted.
4. Install new seat belts and torque bolts to spec: **30 N-m (3.06 kgf-m, 22.1 ft-lb)**.

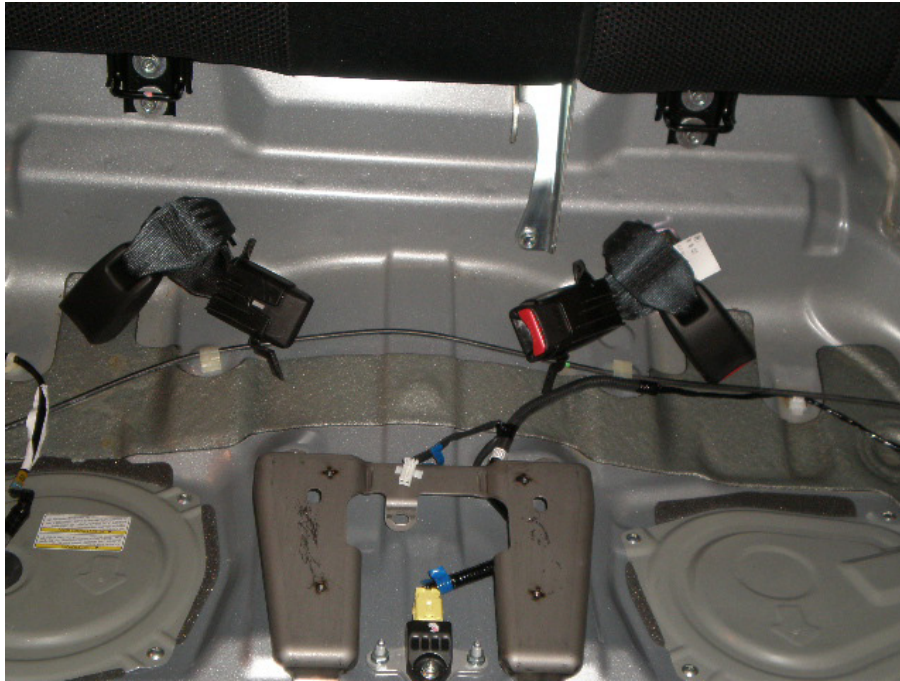
5. Position the seat belt assemblies as shown in the photo below.

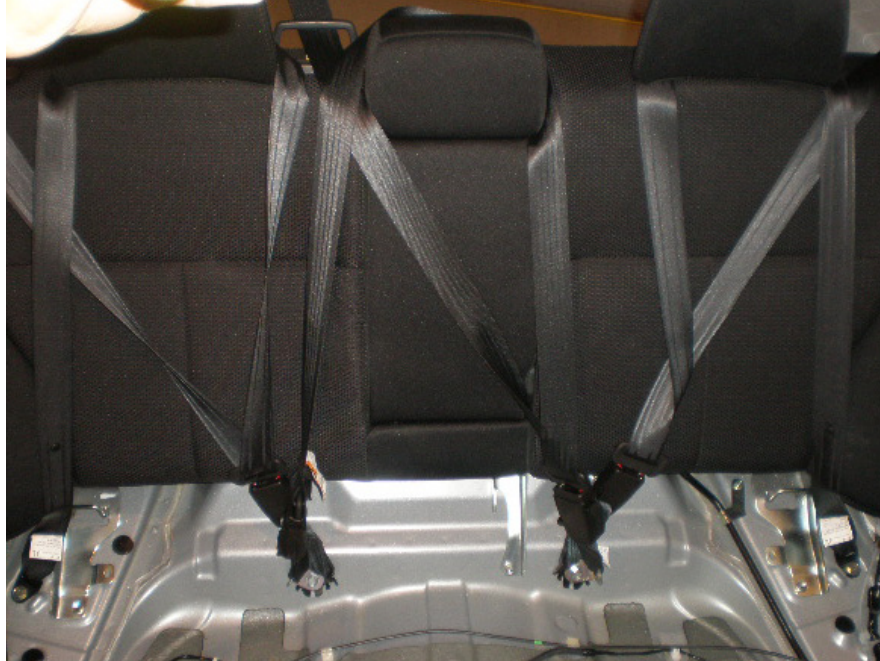
6. Connect the seat belt tongues to all buckles to assist the re-installation of the seat cushion. Extend the outer belt webbing and route them over the headrests as shown below to help hold the buckles and make it easier to re-install the seat cushion.

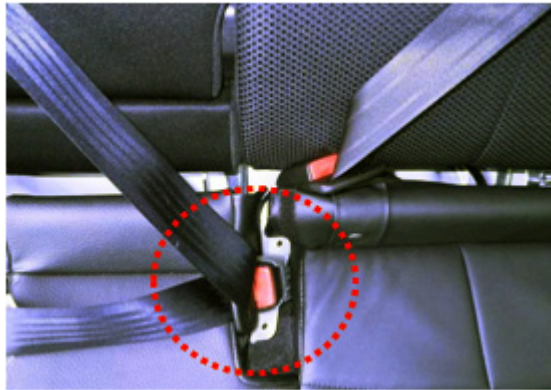
- a. Position the cushion and pull the CENTER buckles into the openings.
- b. Manipulate the brackets on the center belt over the seat openings on both sides.

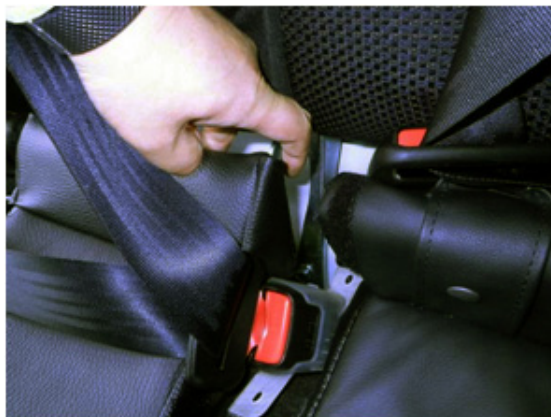
- c. Disconnect the center seat belt buckles.
- d. Push the seat rearward to almost the fully inserted position.
- e. Push the opening cover flap down into the opening out of view. It will no longer be used after installation of this Kit.

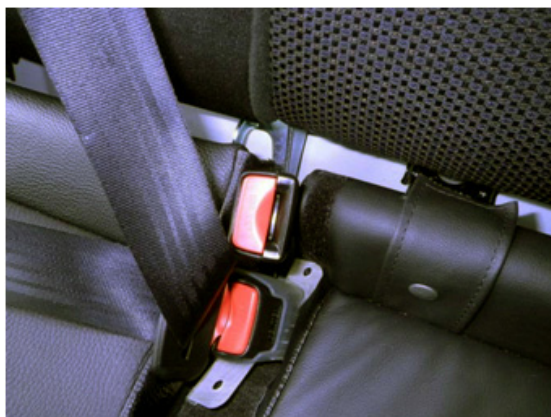
- f. Pull the outer buckles into view and disconnect the belts.
- g. Pull the outer buckles into the opening, above the center buckles on both sides. You can also refer to Figures 2 & 3 for proper positioning.
- h. Leave the outer buckles in the upper part of the opening.

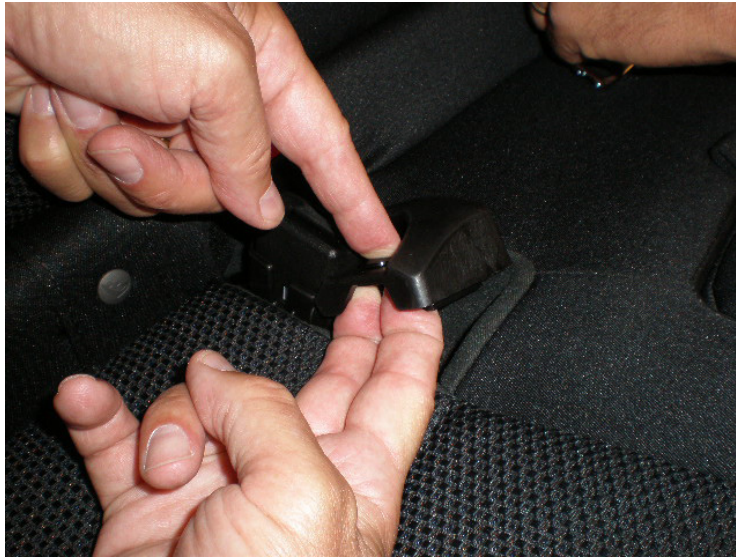
**Figure 6**

8. Install the Center Buckle Stabilizers.
  - a. Beginning on either side, insert the stabilizer into the opening in the seat, over the CENTER buckle with bracket.
  - b. Make sure the stabilizer is seated properly.
  - c. Push a clip into each hole, connecting the stabilizer to the bracket on the buckle.
  - d. To ensure that the clip is fully seated, hold the assembly up and put fingers under the buckle bracket while inserting the retaining pins as shown in Figure 6 below.

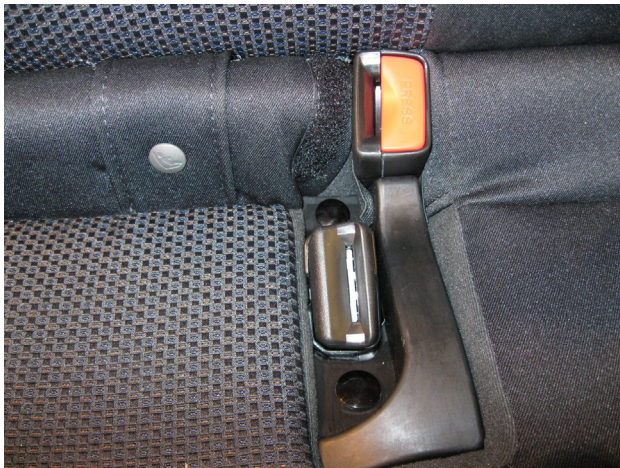
**Figure 7: Completed installation  
Passenger side**

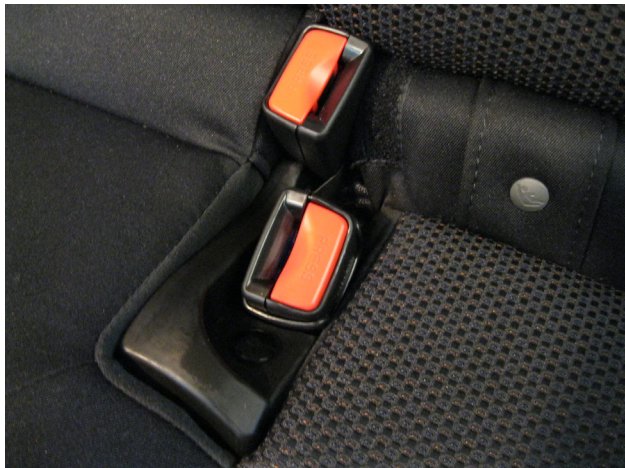
**Figure 8: Completed installation  
Driver side**

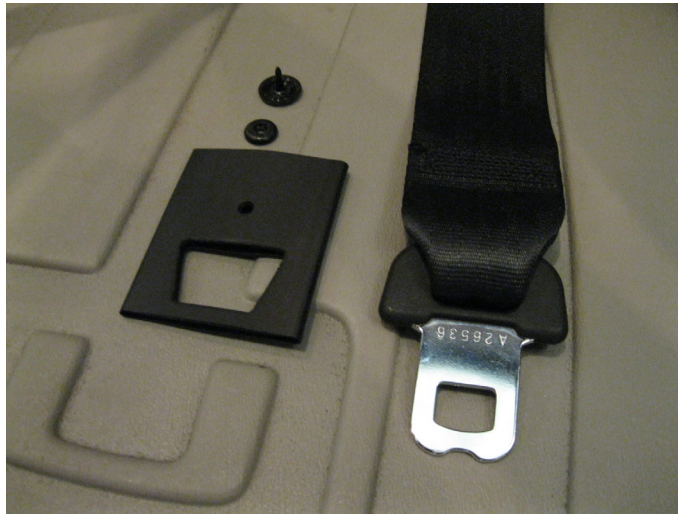
9. Center Seat Belt Tongue Stiffener Installation.

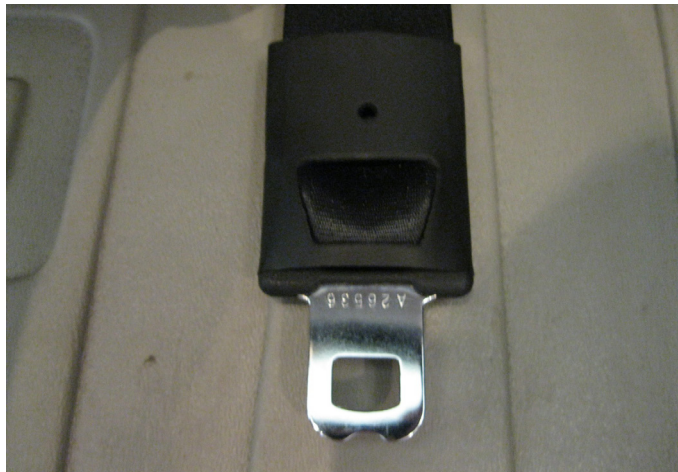
- a. Insert the Center Seat Belt Tongue into the stiffener, centering the opening in the stiffener over the bulge of belt material.

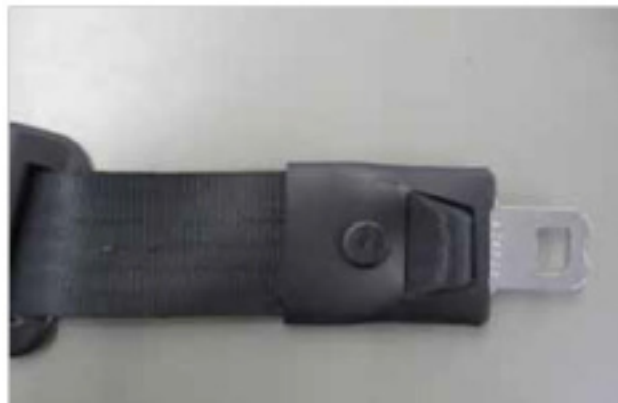
- b. Insert the tack through the hole in the stiffener from the smooth side of the belt stitching (opposite of the label).

- c. Place the female collar of the tack onto the pin from the other side.
- d. Using an adjustable wrench as shown, clamp the assembly together and compress the pointed end by first tightening the jaws of the adjustable wrench by hand as far as possible.

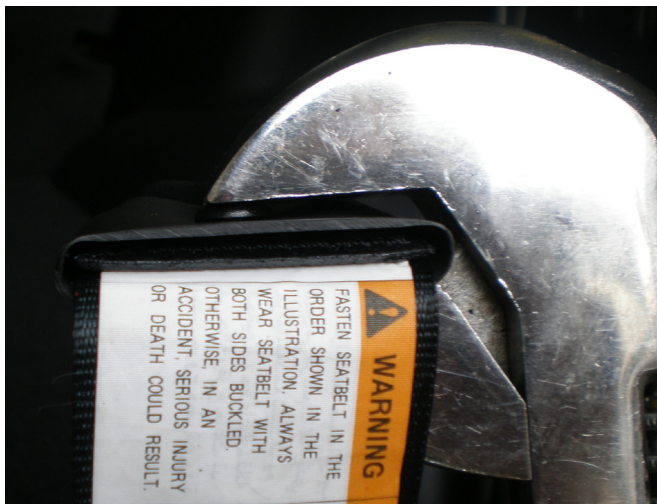
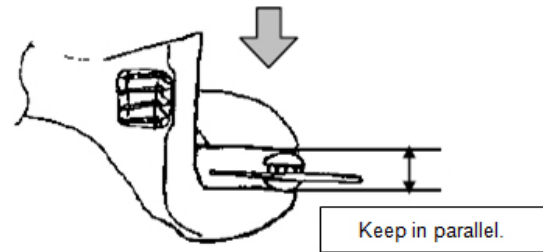
**NOTE:** Keep male and female portions of the tack assembly parallel while compressing them.

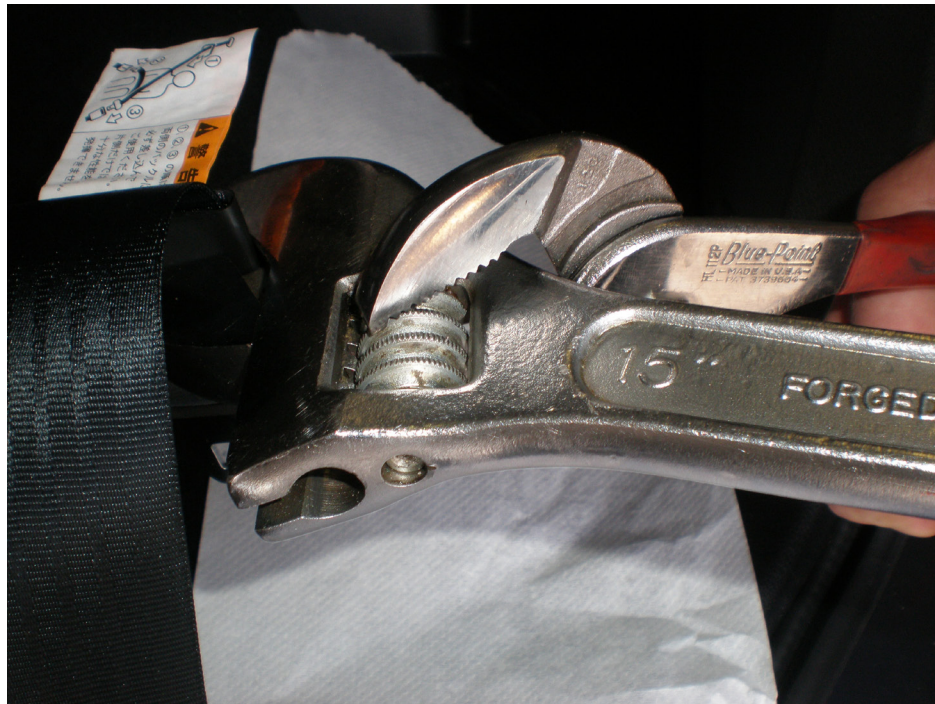
- e. Next, using channel lock pliers, tighten the adjustable wrench gear until the combined height of the tack and belt assembly is ~9.5 to 10.0 mm.

**Figure 9: Seating the Tack Collar**

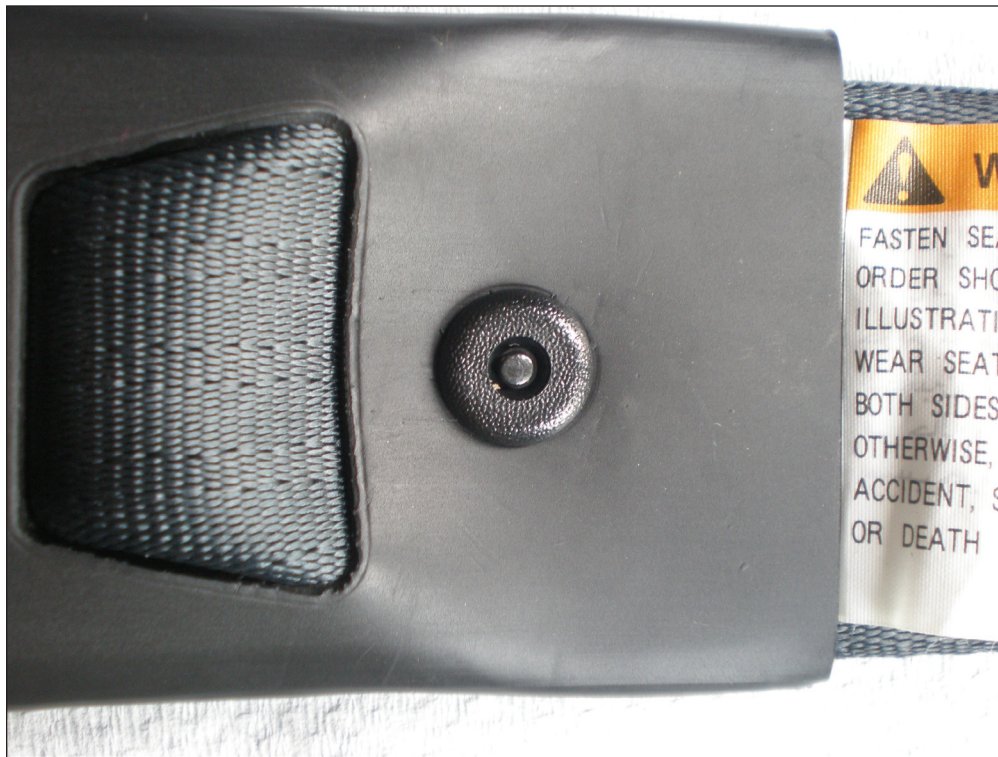
**NOTE:** Confirm that the pin of male tack is compressed as a concentric circle into the hole of collar as shown above.

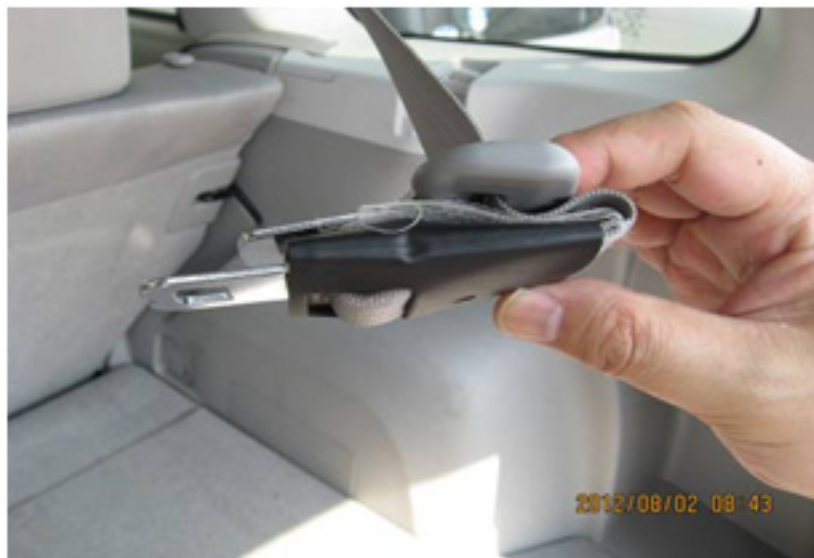
10. Since the stiffener adds some thickness to the tongue, it may be difficult to insert the tongue into the roof holder. Follow the steps in the photos below.
  - a. Fold the upper tongue over the lower tongue as shown.
  - b. While holding the pieces together, insert both into the opening and push up as shown.
