**PRODUCT CAMPAIGN BULLETIN**

**APPLICABILITY:** 2009-2012MY Subaru Forester  
**SUBJECT:** Rear Seat Center Seatbelt

**NUMBER:** WQA-37  
**DATE:** March 2012

**REVISED:** 10/10/12

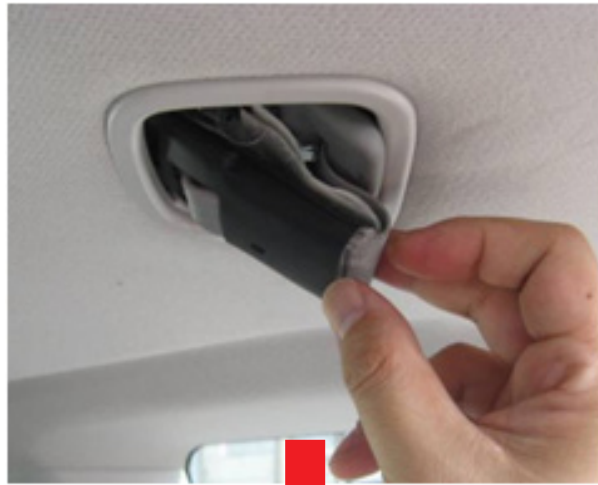
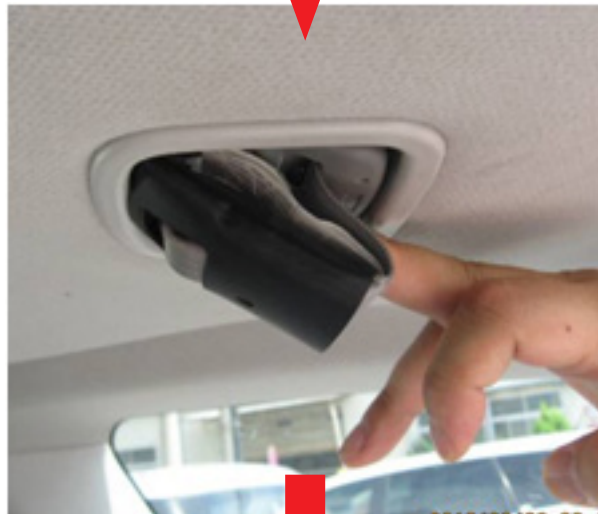
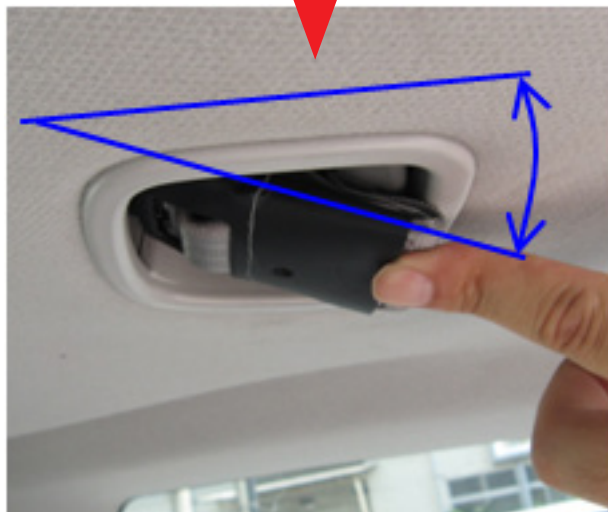
10. Since the stiffener adds some thickness to the tongue, it may be difficult to insert the tongue into the roof holder. Follow the steps in the photos below.
  - a. Fold the upper tongue over the lower tongue as shown.
  - b. While holding the pieces together, insert both into the opening and push up as shown.

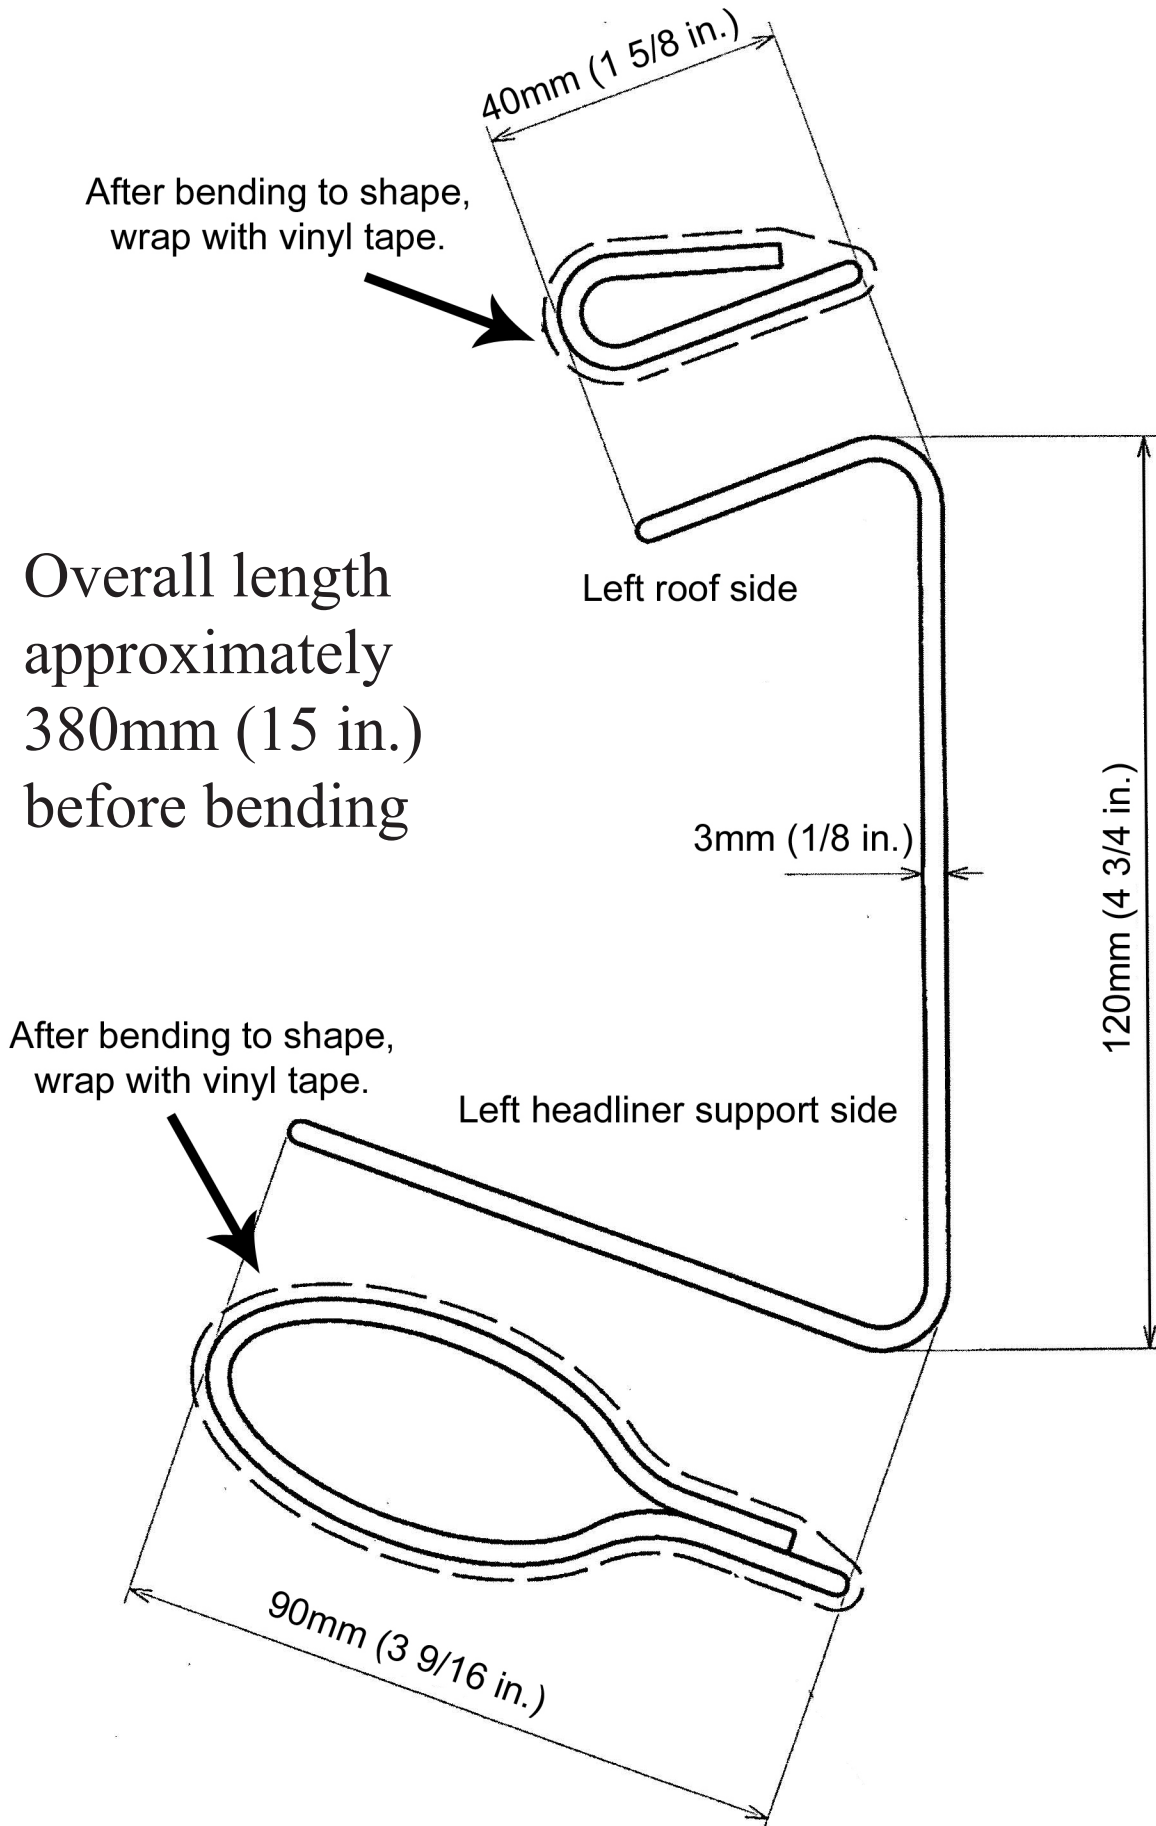
# Left Side

In preparation **for installing Kit 1 only**, prepare two headliner supports, one of each design using the materials listed above and the diagrams found on pages **31-32**.
