SERVICE BULLETIN

APPLICABILITY: 2011MY and later Forester **NUMBER:** 11-123-12
SUBJECT: Ice and Snow Clogging of Evaporative System Hoses **DATE:** 12/03/12
DTC P1449

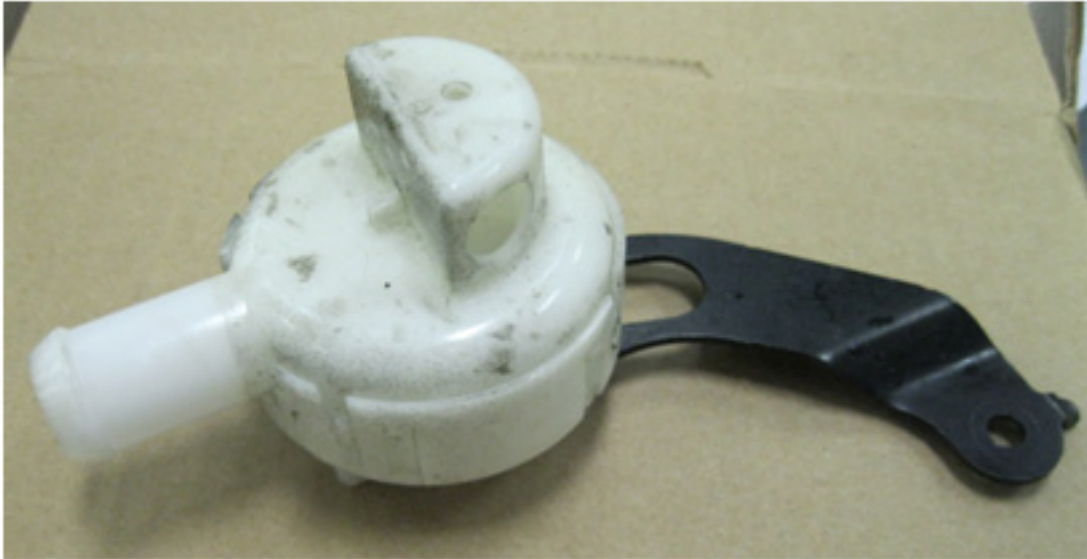
Drain Separator and Mounting Bracket

- Remove the right rear tire and wheel assembly, mud flap (if equipped) and rear portion of the inner splash guard covering the filler neck.
- Disconnect the drain separator shown in the photo below from the drain hose.
- Remove and discard the drain separator and mounting bracket assembly.
