Technical Service Bulletin

66 Wind noise from roof carrier bars

66 12 26 2031853/1 November 30, 2012.

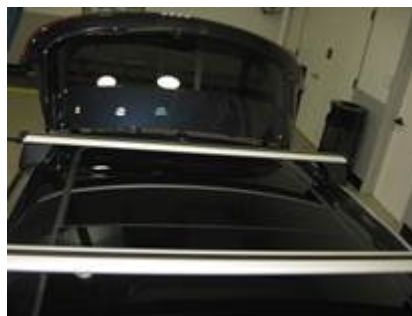
Figure 1. Roof carrier bars installed.

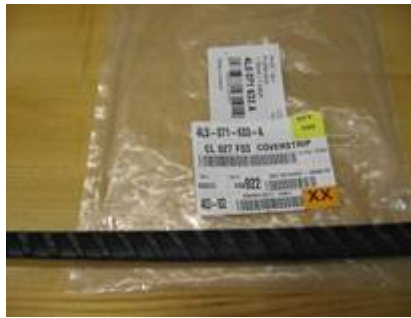
Figure 2. “Fluted” protection strips, part number 4L0 071 633 A.

The wind noise that results from the installation of the carrier bars can be mitigated, although not eliminated, by the installation of “fluted” protection strips, part number 4L0 071 633 A. These are being installed in production and will be included in the carrier bar kit that accompanies the Audi Q5.

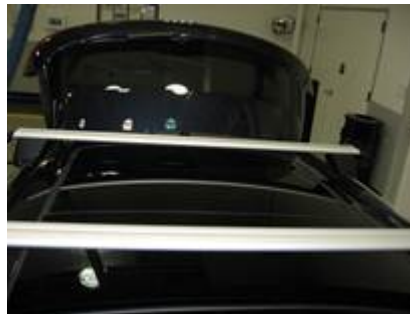
Figure 3. Protection strips removed.

1. Remove the “smooth” protection strips.

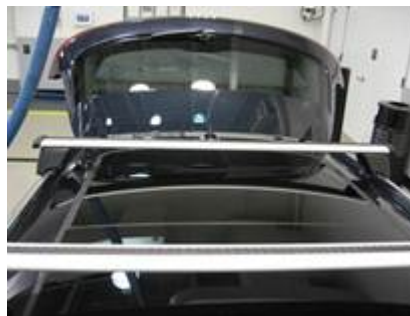
Figure 4. “Fluted” protection strips installed.

2. Install “fluted” protection strips.
