Technical Service Bulletin

57 Outer door seals loose

57 12 71 2027494/3 September 17, 2012. Supersedes Technical Service Bulletin Group 57 number 11 – 61 dated October 31, 2011 for reasons listed below.

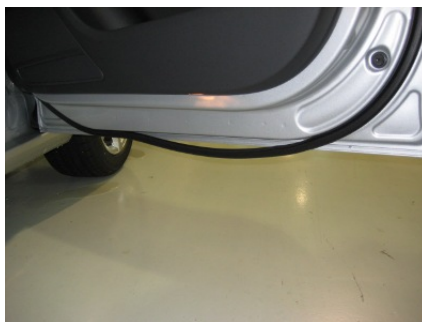
Figure 1. The outer door seal, partially detached.

The outer door seals have become partially detached

Loss of adhesion between the door structure and door seal due to a flaw in the attachment process in production.

In cases where the outer door seal has become partially detached, it may not be necessary to replace the outer door seal. Seals can be reattached provided they are not damaged, have not been previously repaired or previously reattached, and the detachment length does *not* exceed 10 cm.

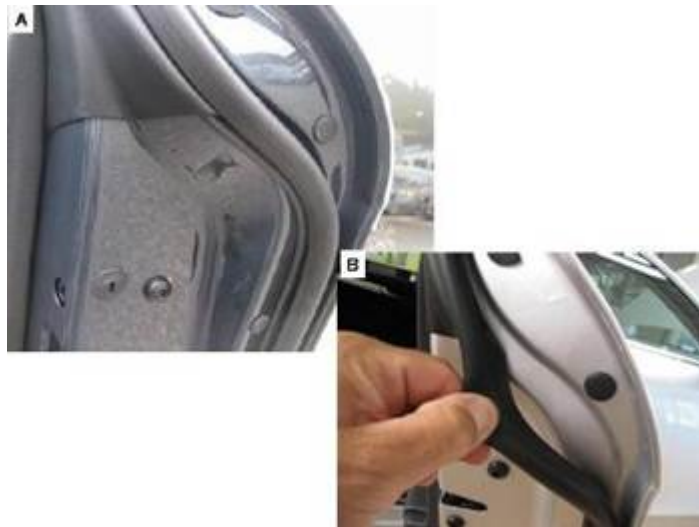
Figure 3. The door seal pressed to the door (A), and detached again (B).

6. Press the door seal lightly to the door surface and then detach it again (Figure 3). This ensures that the glue is distributed as evenly as possible on the surfaces to be bonded.

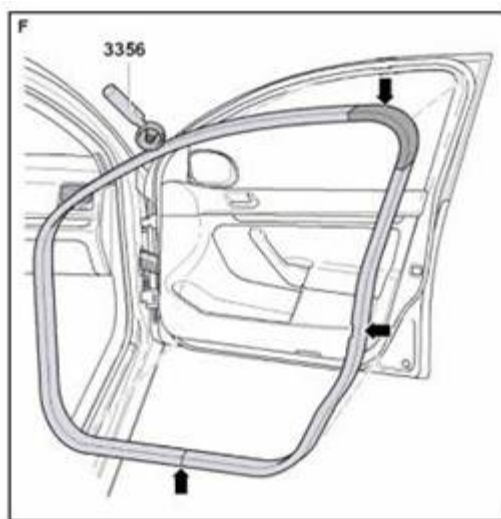
Figure 4. Use of special tool 3356.

8. After this time attach the seal firmly to the door surface. Roll over this area several times with special tool **3356** (or equivalent).

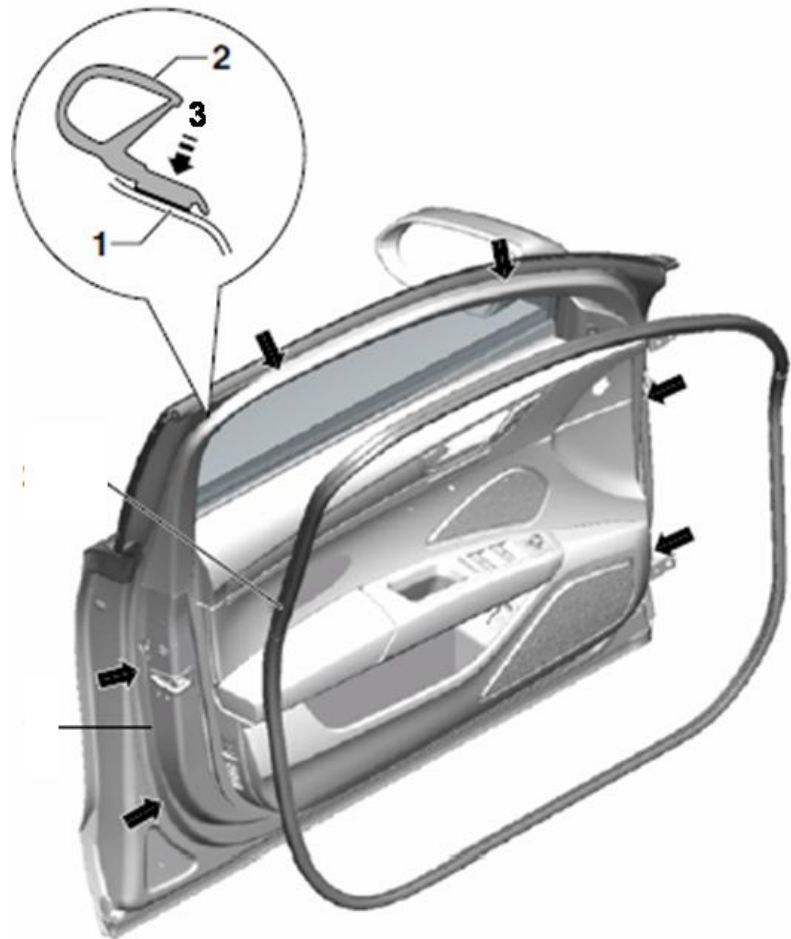
Figure 5. Apply force to seal.

9. Apply force to the seal with the **3356** only at the base of the seal (Figure 5, 3).
