Bulletin No.: PI0850

# Service Bulletin

**Subject:** Whistle Noise Heard from Engine Compartment, Rough Idle and/or DTC P0171 Set

**Models:** 2011-2012 Chevrolet Cruze  
Equipped with 1.4L Engine (RPO LUJ)

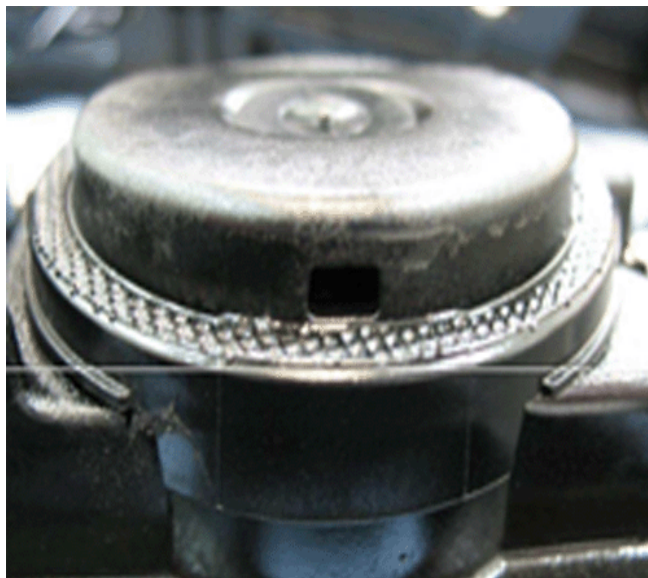
2911929

This may be caused by a vacuum leak in the positive crankcase ventilation (PCV) located on the camshaft cover.

**Note:** The old style camshaft cover has a taller design PCV cap as shown in the illustration above.

With the engine running using your finger, place it over the breather port of the PCV diaphragm to see if the whistle noise goes away and/or the fuel trims are high then return to normal levels.

If the noise goes away, replace the camshaft cover and clear the DTC.
