Service Bulletin

Bulletin No.: PIC5767

Subject: Normal Characteristic - "No Active Route" Message Displayed After Touching Navigation Icon

Models: 2013 Cadillac ATS, SRX, XTS
Equipped with CUE Infotainment System

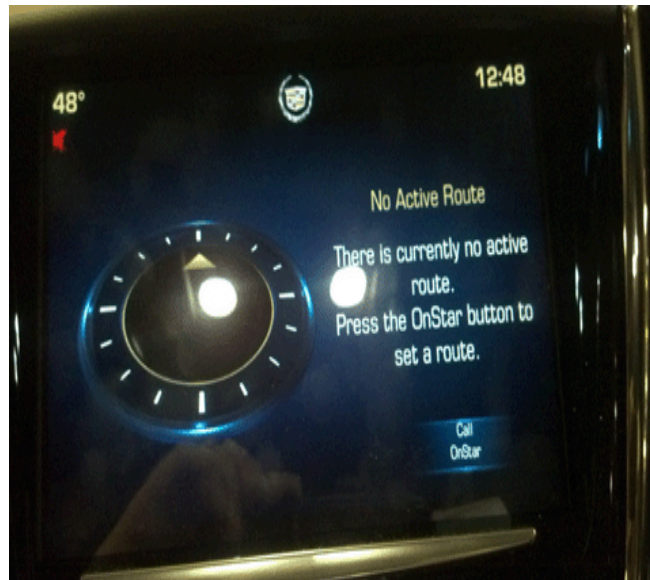
2920184

There are different option levels of the CUE system; not all of them are equipped with a navigation system.

The Navigation icon is displayed in both systems, but they function differently dependent on which option the vehicle is equipped with.

Inspect the vehicle build / RPO code for the vehicle to determine if the CUE system is equipped with Navigation feature.

For ATS the Navigation equipped CUE RPO code is Y26.

For SRX the Navigation equipped CUE RPO code is UY4.

For XTS the Navigation equipped CUE RPO code is IO6.

If the vehicle is not equipped with the model-specific RPO code listed above, then it is not equipped with the Navigation function and cannot be upgraded. The vehicle is operating as designed and no repairs should be performed.
