Technical Service Bulletin

66F5 UPDATE - Emblems on rear lid incorrect (NVLW)

Model(s)	Year	VIN Range	Vehicle-Specific Equipment
Audi Q7	2013	000001 – 003182	3.0TDI

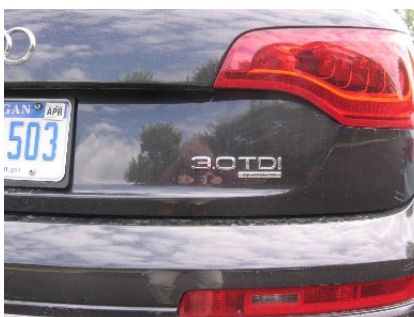
The emblem package on the rear lid of certain model year 2013 Audi Q7 3.0 TDI vehicles is incorrect (Figure 1). The labeling “3.0 TDI Quattro” was installed on the right side of the rear lid. The correct emblem is displayed in Figure 2.

Figure 1. Wrong labeling.

Please check any of these vehicles in dealer inventory and remove the “3.0” emblems leaving the “TDI Quattro” emblems installed.

Please ask the customer if they wish to have the “3.0” emblems removed or if they wish to leave the emblems installed before performing any repair. Proceed as the customer desires.

Tip: As specified in ElsaWeb the emblems may need to be warmed using a hot air gun to a temperature of 40°C (104°F). If necessary, clean any remaining residue with **D 009 401 04** All Purpose Cleaner. Exercise care when removing the emblems to protect the surrounding painted area.
