Technical Bulletin

68 12 02 December 18, 2012 2032124

Windscreen Damaged or Bent Locking Pin

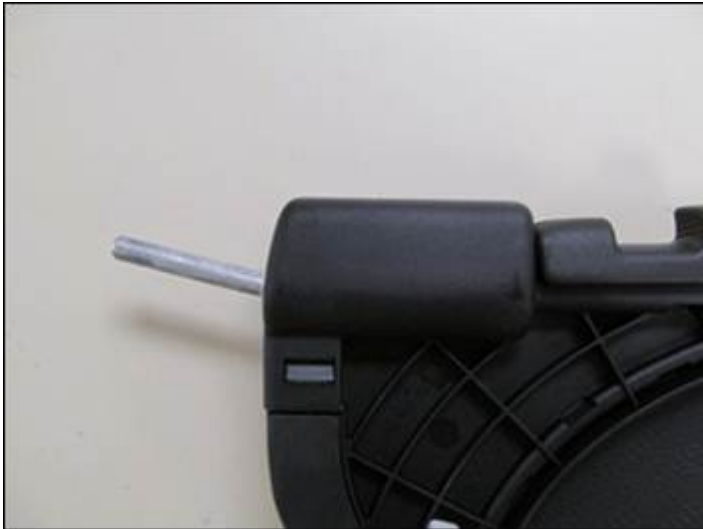
If the pin is bent, you may need to straighten the pin first before removing

- Remove the damaged locking pin from the windscreen, see Repair Manual Group 68 Interior Equipment – Windscreen Locking Pin Removal and Installation in ElsaWeb

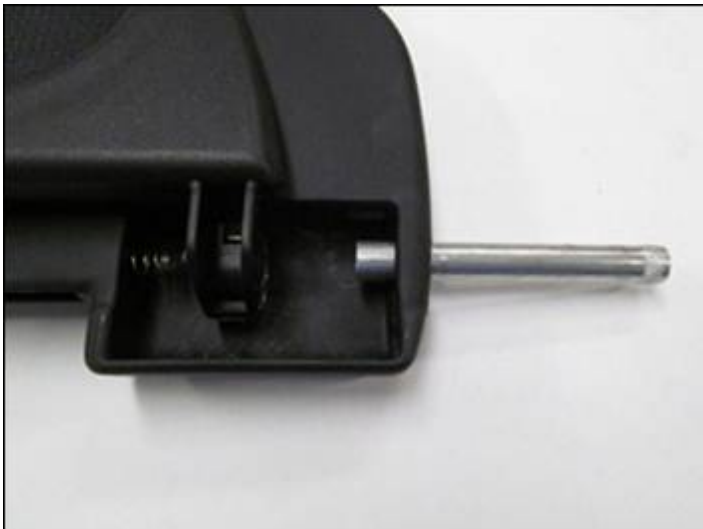
The sleeve may come out with the locking pin
