Model(s)	Year	Eng. Code	Trans. Code	VIN Range From	VIN Range To
Jetta, Jetta SportWagen, Beetle Sedan	2013	All	All	All	All

92 12 05 December 17, 2012 2032040 Windshield Fluid Level Warning Indicator ON

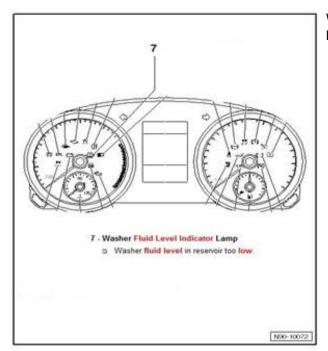
Figure 1

Windshield washer fluid level warning light ON, fluid level in reservoir OK.

The washer fluid prefilled from factory may have high resistance and impair the conductivity through the washer fluid sensor in the vehicle.

- If wiring is ok and washer bottle is full, replace washer fluid.
- Validate low fluid level indicator lamp is off.

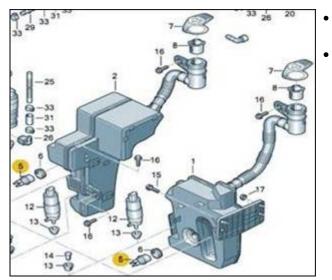
Figure 2

- Remove wheel and wheel housing lining, see Repair manual.
- Check wiring harness and connector for washer fluid reservoir sensor (see figure 2, item 5).
