Tech Tips

TT 60-12-01

2009-2013 Tiguan – Water Leak from Front Sunroof Drain Grommet

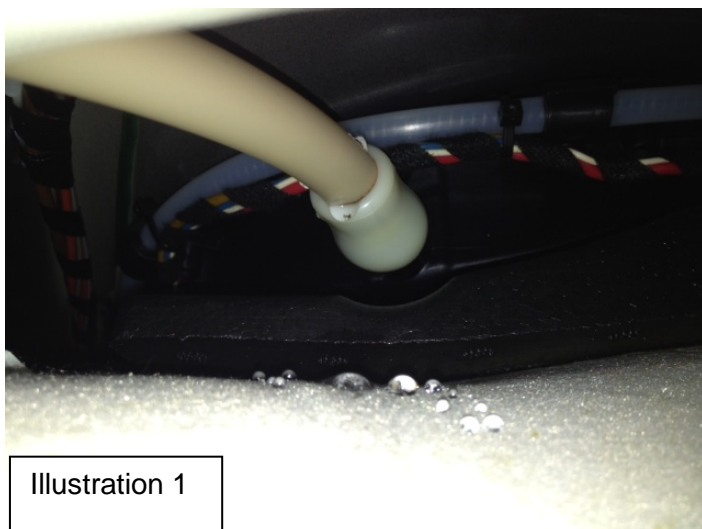
Illustration 1

For concerns with water leaks around “A” pillar trim area, inspect the front sunroof drain hose and grommet as shown in illustration 1, completely dry grommet and hose, then seal area using 3M 08690 Urethane as shown in illustration 2.
