## Scheduled Preventive Inspection of Battery & Alternator Cabling

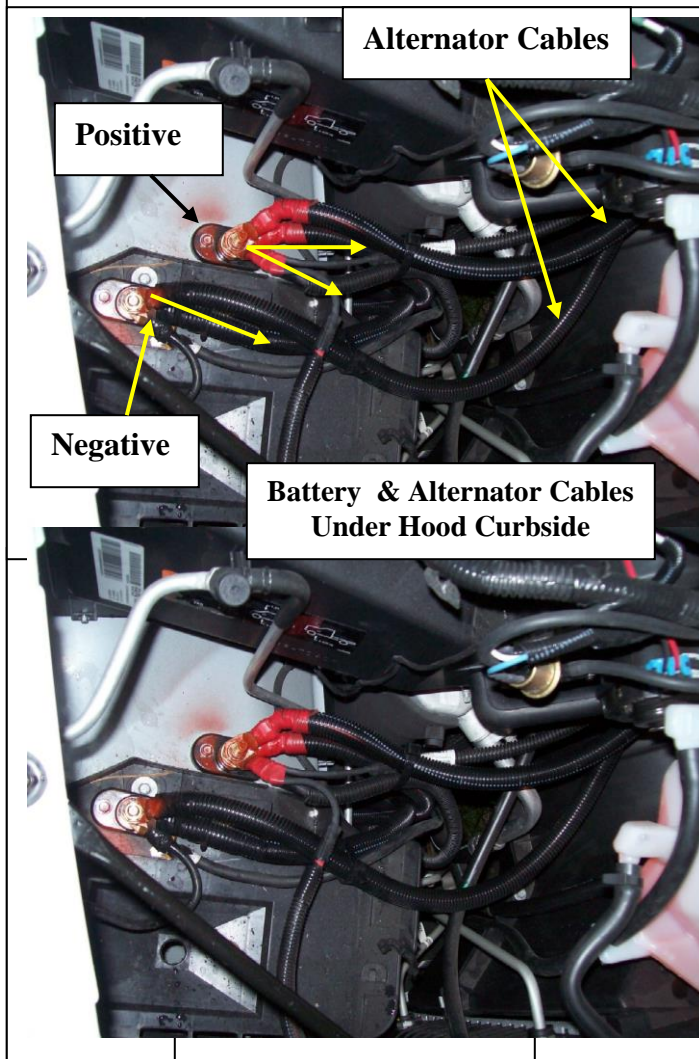
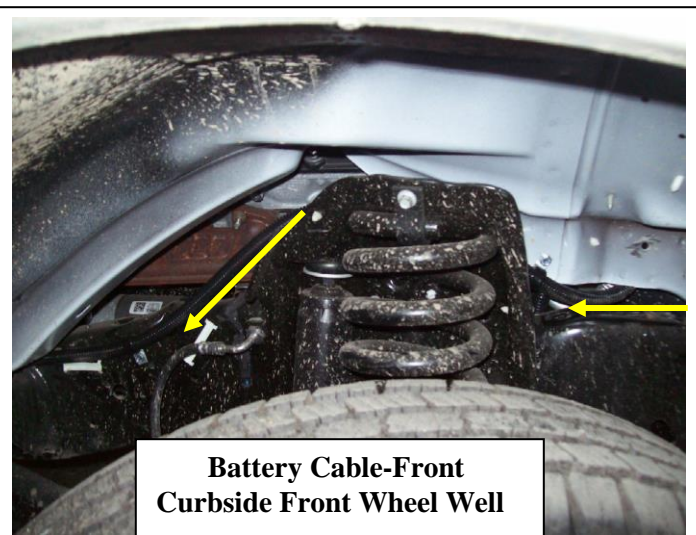
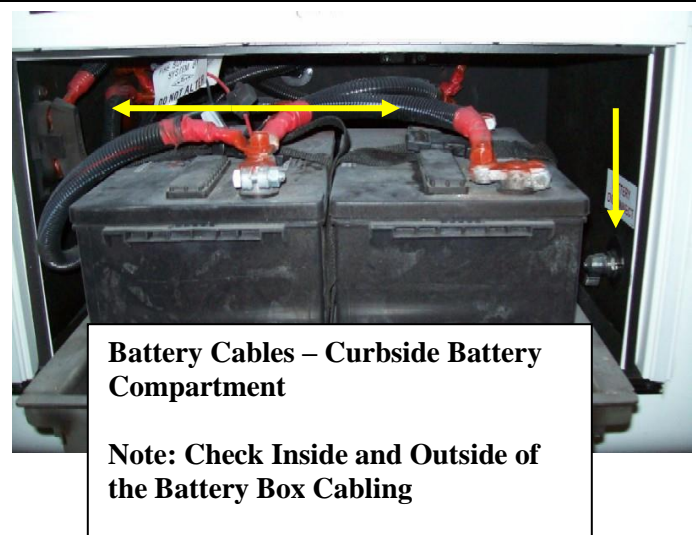
Visual inspection of all non-OEM battery and alternator cables is essential to maintain safe operation of the vehicle. In the highlighted areas shown below, it is necessary to inspect for chaffing, cuts or slices in cable conduit, and excessive rubbing of loom and/or cable on surrounding components. The pictures below show the typical routing of these cables in Goshen Coach units built for Florida DOT.
