Service Bulletin

Subject: Instrument Panel Cluster (IPC) Warning Lamps and/or MIL are Illuminated, Diesel Exhaust Fluid (DEF) Message Displayed, Various DTCs Set, Transmission May Not Shift or Defaults to Second Gear (Inspect Wiring Harnesses for Chafing, Connectors Not Fully Seated, and Backed Out or Damaged Terminals, Repair as Needed)

Models: 2011-2013 Chevrolet Silverado 2500HD, 3500HD
2011-2013 GMC Sierra 2500HD, 3500HD
Equipped with 6.6L Duramax™ Diesel Engine RPO LGH or LML

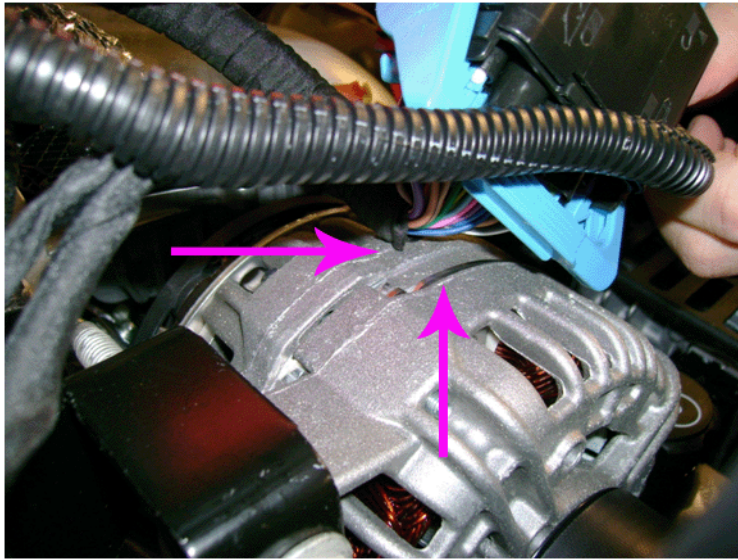
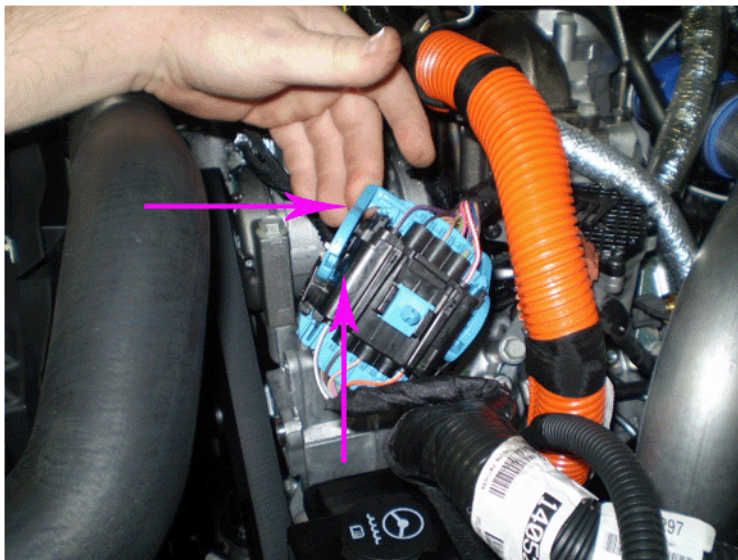
Typical View of Wiring Harness Chafing and of an Improperly Seated Connector Assist Lever

The wiring harness of connector X107 is chafing on one of the generators on trucks equipped with dual generators and/or the assist lever for connector X107 is not fully or properly seated or has backed out or damaged terminals.

1. Inspect connector X107 and its wiring harness for the following conditions:
 - 1.1. Chafing of the wiring harness insulation from contact on the generator as shown.
 - 1.2. A connector assist lever that is not fully or properly seated as shown.
 - 1.3. Backed out or damaged connector terminals.
 - 1.4. Poor terminal contact or tension. Refer to Testing for Intermittent Conditions and Poor Connections in SI.

⇒ If any of the above conditions exist, repair as needed. Refer to > Power and Signal Distribution > Wiring Systems and Power Management > Diagnostic Information and Procedures > Wiring Repairs and Repairing Connector Terminals in SI.

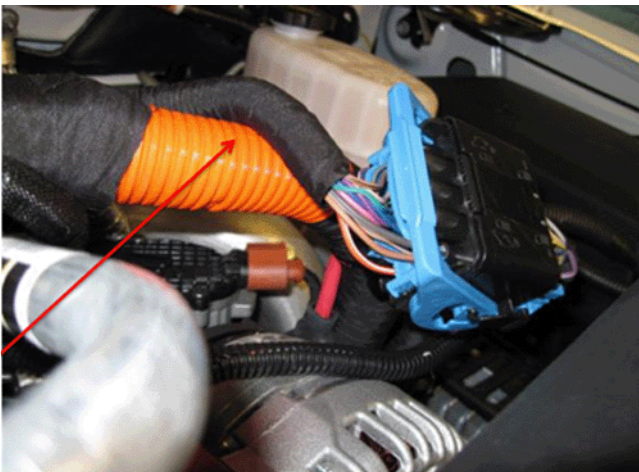
Notice: If the wiring harness was contacting the generator, the wiring harness **MUST** be rerouted.

2. Route the harness of the X107 connector over the top of the orange conduit as shown.
3. Clear the DTCs with a scan tool.

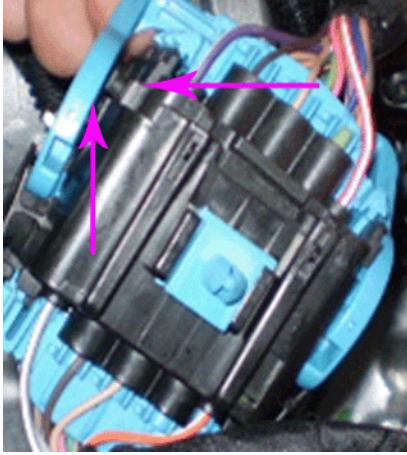
Typical View of an Improperly Seated Connector Assist Lever

The assist lever for connector X300 is not fully or properly seated or has backed out or damaged terminals.

1. Inspect wiring harness connector X300 for the following:
 - 1.1. A connector assist lever that is not fully or properly seated as shown.
 - 1.2. Backed out or damaged connector terminals.
 - 1.3. Poor terminal contact or tension. Refer to Testing for Intermittent Conditions and Poor Connections in SI.

⇒ If any of the above conditions exist, repair as needed. Refer to > Power and Signal Distribution > Wiring Systems and Power Management > Diagnostic Information and Procedures > Wiring Repairs and Repairing Connector Terminals in SI.
2. Clear the DTCs with a scan tool.

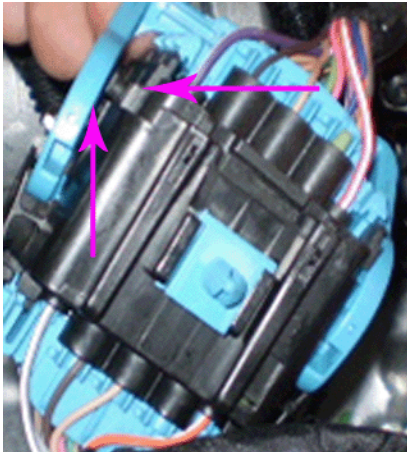
Typical View of an Improperly Seated Connector Assist Lever

The assist lever for connector X395 is not fully or properly seated or has backed out or damaged terminals.

1. Inspect wiring harness connector X395 for the following:
 - 1.1. A connector assist lever that is not fully or properly seated as shown.
 - 1.2. Backed out or damaged connector terminals.
 - 1.3. Poor terminal contact or tension. Refer to Testing for Intermittent Conditions and Poor Connections in SI.

⇒ If any of the above conditions exist, repair as needed. Refer to > Power and Signal Distribution > Wiring Systems and Power Management > Diagnostic Information and Procedures > Wiring Repairs and Repairing Connector Terminals in SI.

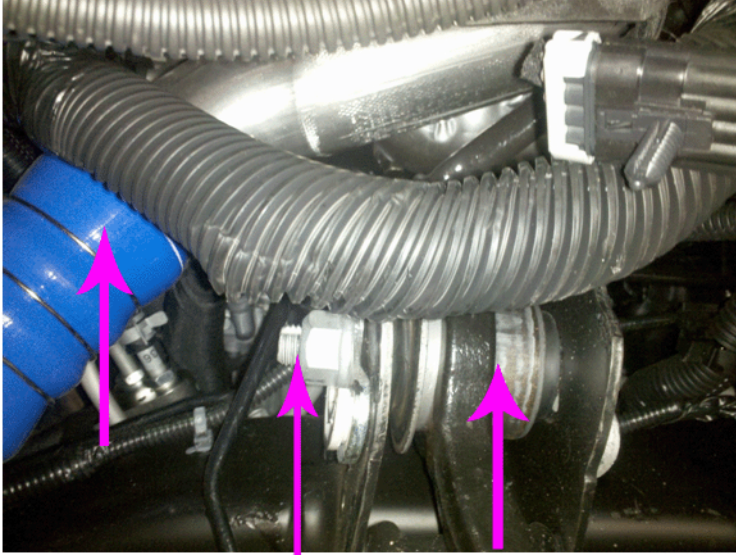
Typical View of Improper Wiring Harness Contact Points in the Control Arm Area

Chafing of the insulation of the wiring harness that is routed by the left front control arm.

1. Inspect the wiring harness insulation for chafing from contact on the left front control arm and from contact on the charge air cooler (CAC) pipe, in the areas as shown by the arrows.
 - ⇒ If chafing of the wiring harness insulation is observed, repair as needed. Refer to > Power and Signal Distribution > Wiring Systems and Power Management > Diagnostic Information and Procedures > Wiring Repairs in SI.
2. Clear the DTCs with a scan tool.

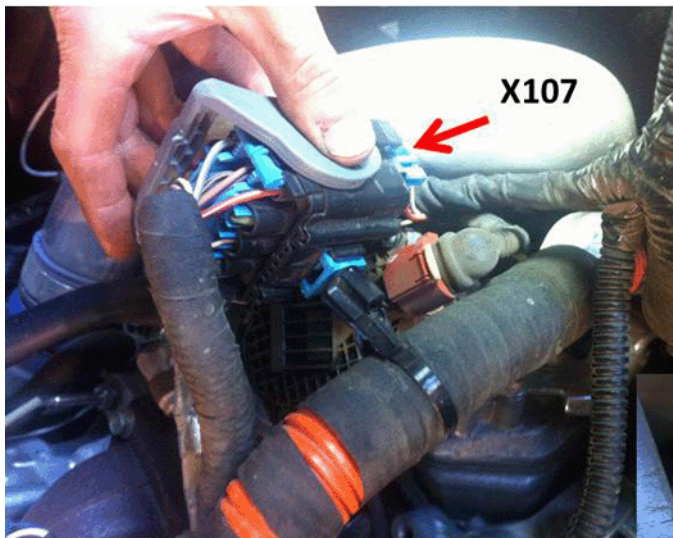
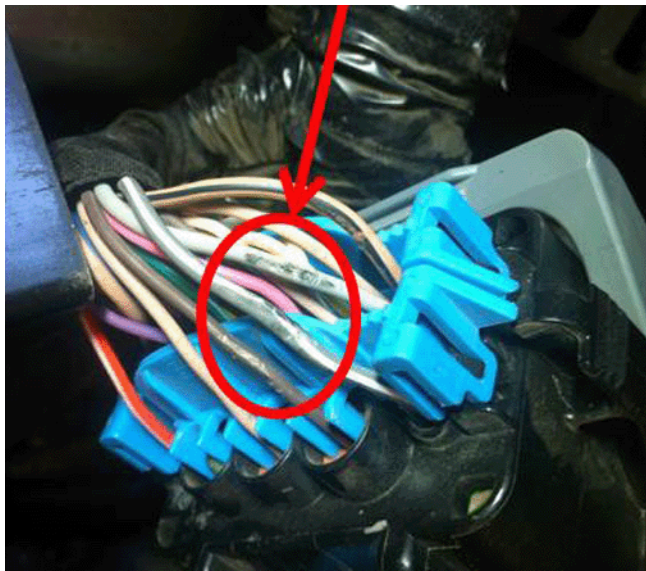
Typical View of Wiring Harness Chafing From Contact With the EGR Valve

Chafing of the insulation of the wiring harness immediately adjacent to harness connector X107 on the EGR valve.

1. Inspect the wiring harness insulation in the area immediately adjacent to wiring harness connector X107 for chafing from contact on the EC valve as shown.
 - ⇒ If chafing of the wiring harness insulation is observed, repair as needed. Refer to > Power and Signal Distribution > Wiring Systems and Power Management > Diagnostic Information and Procedures > Wiring Repairs in SI.
2. Clear the DTCs with a scan tool.
