Service Bulletin

Subject: Water Intrusion (Leak), Rear Side Door Stationary Window

Models: 2012 Chevrolet Sonic Sedan

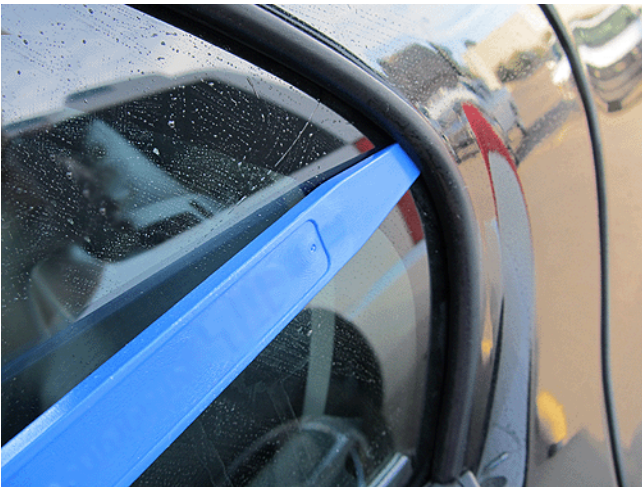
Some customers may comment on a water intrusion (leak) condition on the left or right rear door around the perimeter of the stationary window. This condition may be the result of a poor fit between the glass and rubber seal. This condition only occurs on sedan bodied vehicles. The hatchback uses a different window assembly.

1. Remove the outer window sealing strip (belt molding) on the affected door. Refer to Rear Side Door Window Outer Sealing Strip Replacement (Sedan) in SI. Use care to not damage the sealing strip when removing.
