Service Bulletin

Subject: Front Floor Console Cup Holder Rattles in Open Position

Models: 2013 Cadillac XTS
Built Prior to September 24, 2012

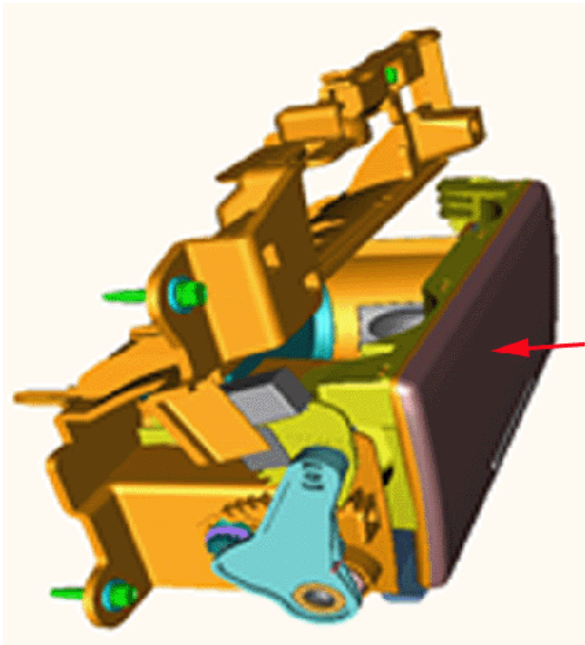
Some customers may comment that the front floor console cup holder rattles when in the open position.

1. Push in the cup holder door to the open position.
