## SERVICE BULLETIN

**APPLICABILITY:** 2012-13MY Impreza (excluding WRX & STI Models)  
2013MY XV Crosstrek™

**NUMBER:** 12-143-12

**SUBJECT:** Separation or Swelling Appearance of the Front Carpeting

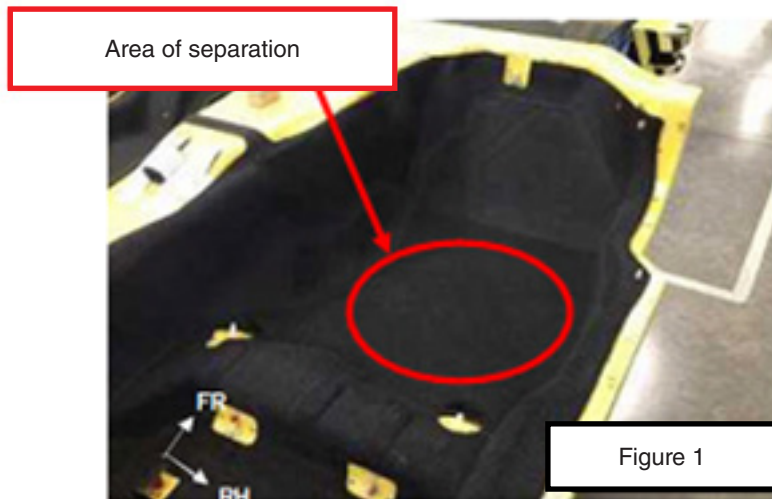
This Service Bulletin provides a procedure to repair the front foot well area carpeting which may separate from its insulation pad and / or have an unsatisfactory appearance to the customer.

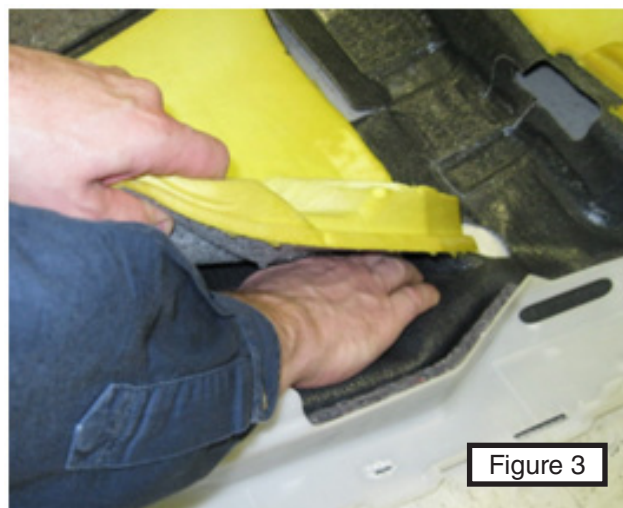
- Remove the carpeting following the procedure in the applicable Service Manual.
- Turn the carpeting upside-down then, using your fingers, **CAREFULLY** separate the foam insulation pads from both front under-seat floor areas as shown in Figures 2 & 3 below.
