## **SERVICE ADVISORY # 12-184**

### Laredo Furnace Return Air Vent

It has been determined the vehicles listed in the population below may have been manufactured without a return air vent for the furnace.

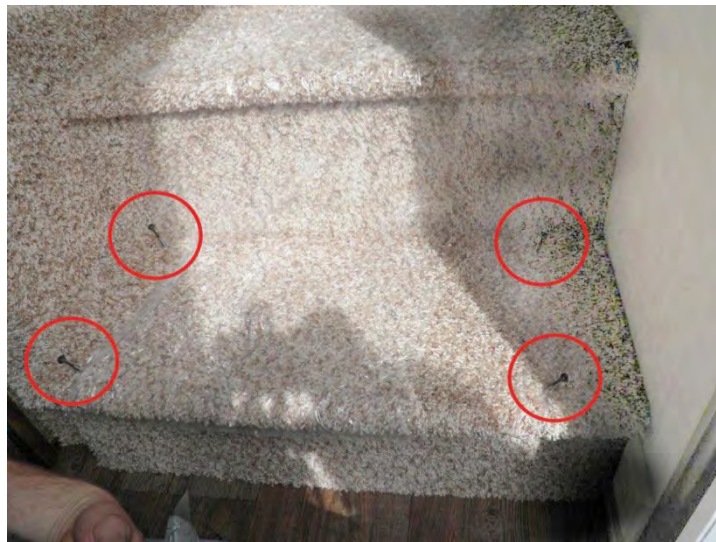
Fig. 1

**Step 1** Locate and remove the (4) screws from the bottom step tread board. See figure 1.

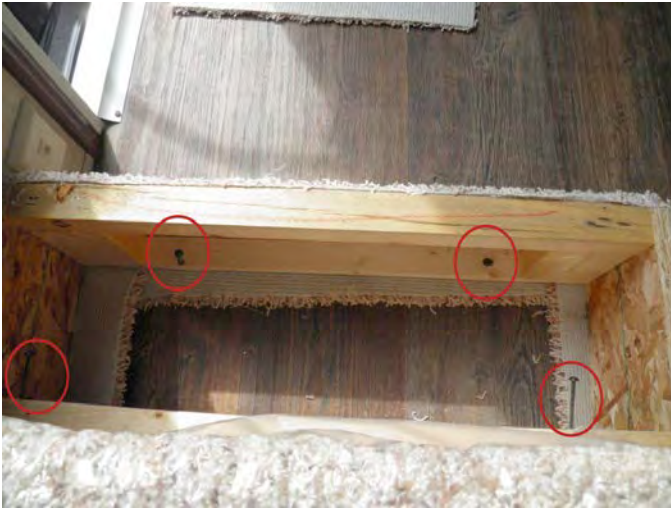
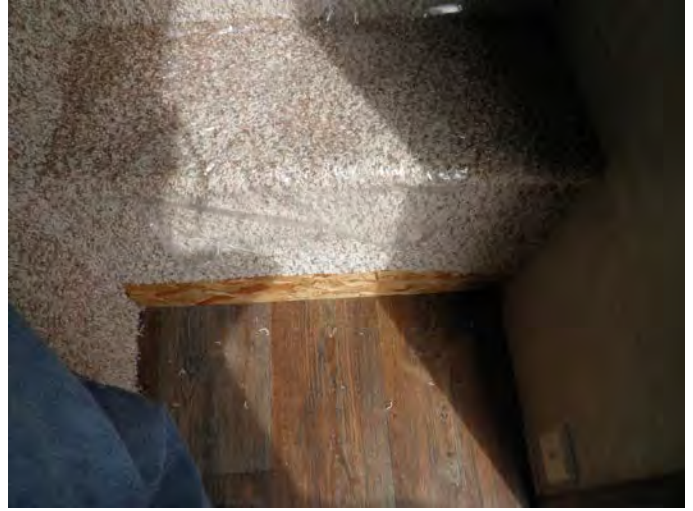
Fig. 2

- Step 2** Remove the (2) screws from the bottom step where the step secures to the second step assembly. Remove the (2) screws from the front step where it secures to the floor. Remove the bottom step support. See Figure 2 & 3.

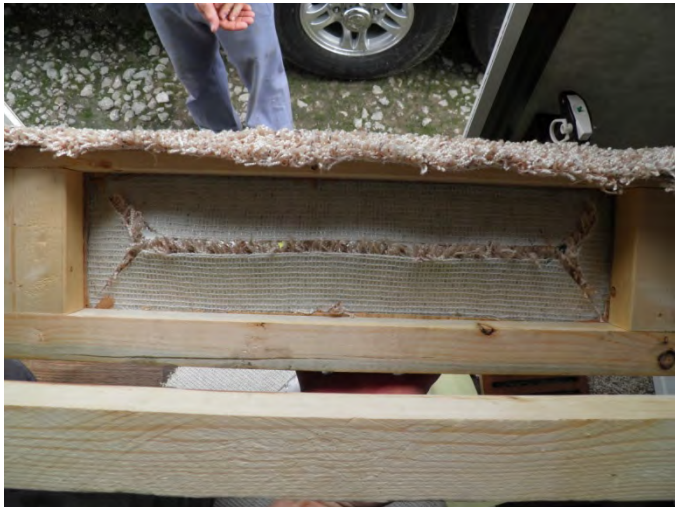
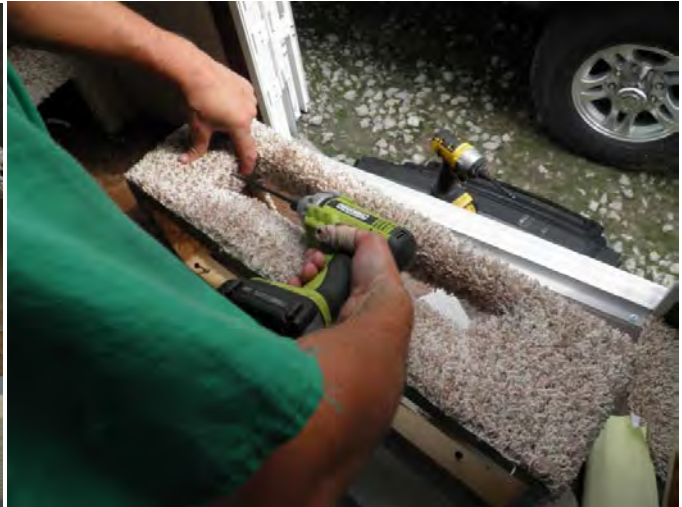
Fig. 4

- Step 3** Using a utility knife, cut and remove the panel from the backside of the support removed in step 2. Cut an elongated "X" in the carpet so it can be folded over the step frame. See figure 4. Fold the carpet over the step frame and secure with screws or staples. See figure 5. Set the step support aside to be reused in step 6.

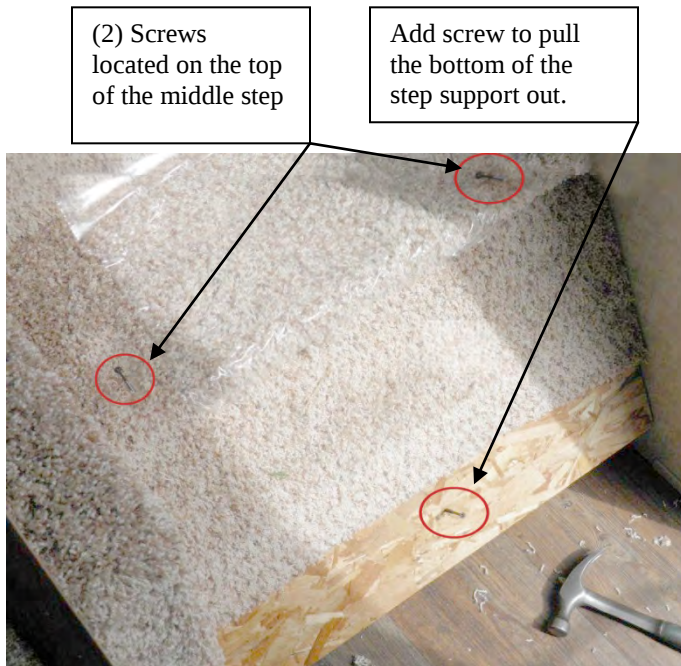
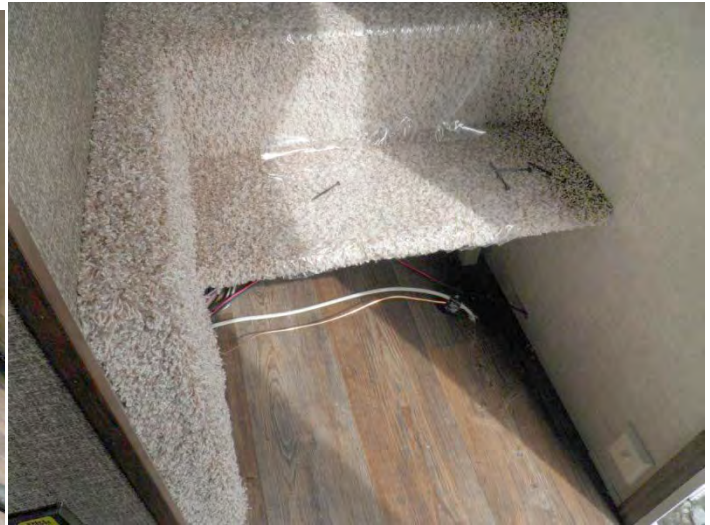
Fig 4

- Step 4** Remove the (2) screws from the top of the middle step to allow the front of the step to be removed. It may be necessary to put a screw in the front of the step to pull the step front out. See figure 4& 5.

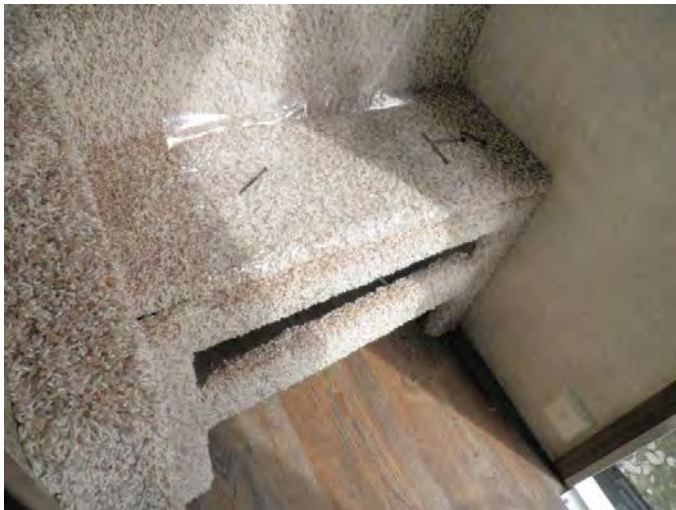
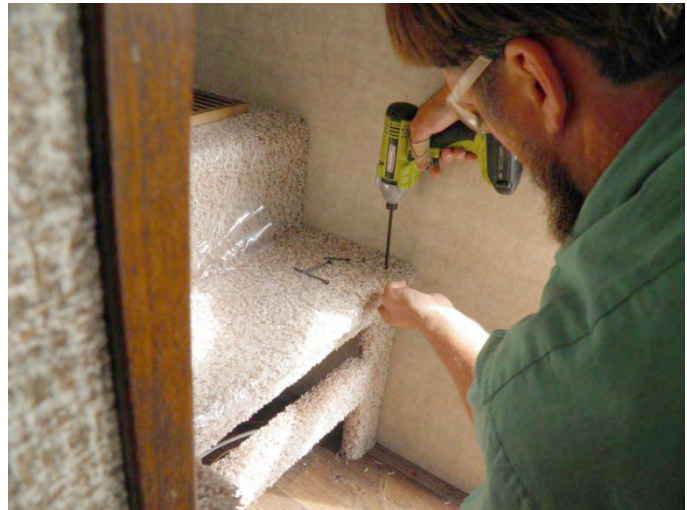
Fig. 6

- Step 5** Install the supplied step support for the middle step. Insert the support below the step and against the wall. Align the support to be evenly set back  $\frac{3}{4}$ " from the front edge of the step. Screw through the top of the step into the middle step support. See figure 6 & 7.

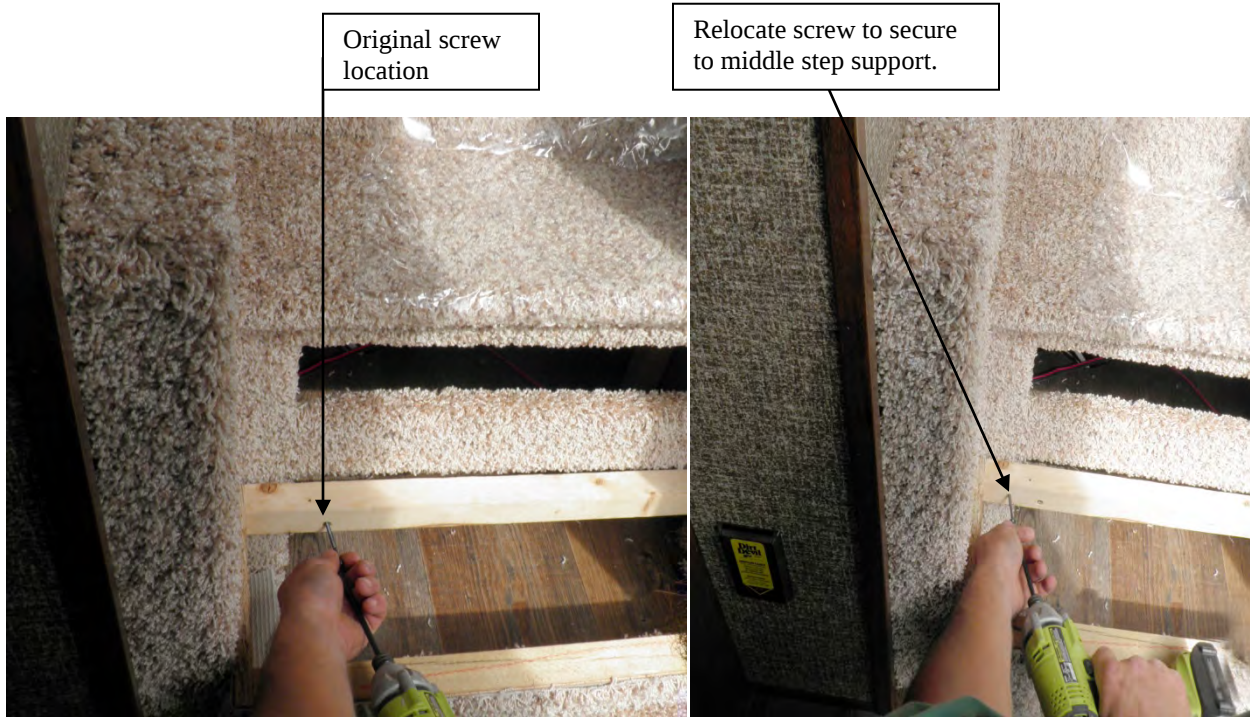
Fig. 8

- Step 6** Place the bottom step support that was removed in step 2 back in place. Secure the support to the floor at the original locations. Remove the screws from the back support and relocate them closer to the edge of the step and secure to the middle step support. See figure 8 & 9

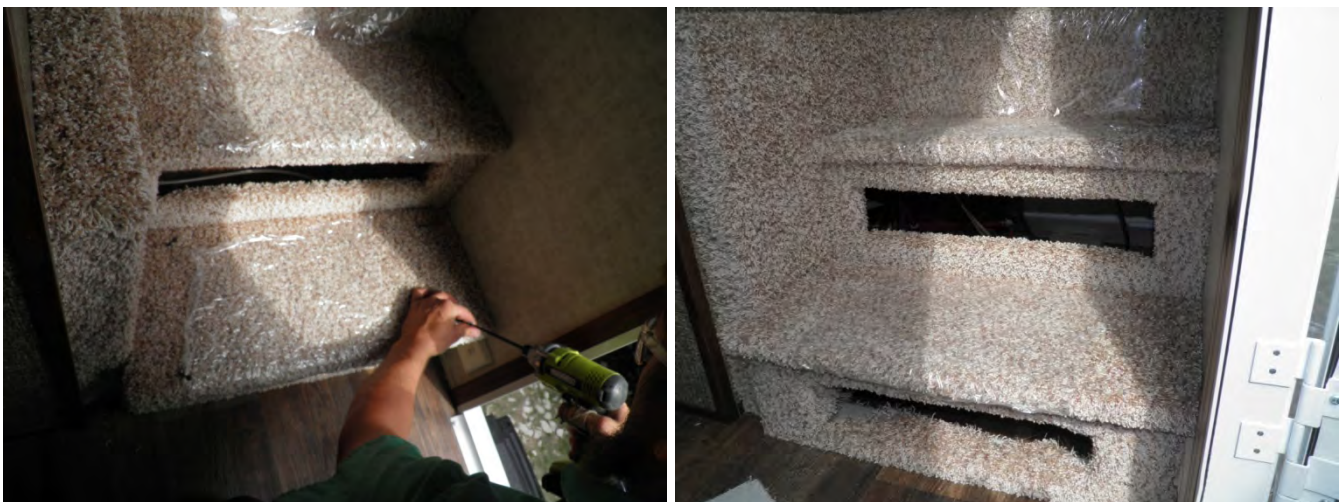
Fig. 10

**Step 7** Replace the bottom step tread board on the support and secure with screws in the original location. See Figure 10 & 11.

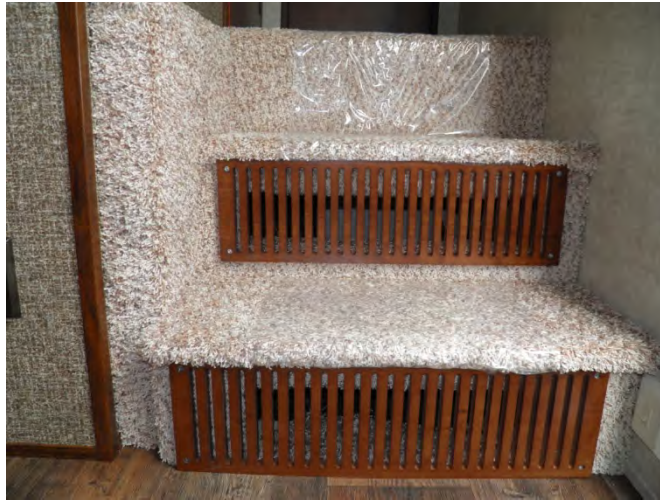
Fig. 12

**Step 8** Secure the supplied vent covers centered over the step openings. See figure 12.
