Subject: BRAKE FLUID SPILLAGE CAUTION	Bulletin No: 04-004/12
	Last Issued: 10/18/2012

2007-2012 CX-7

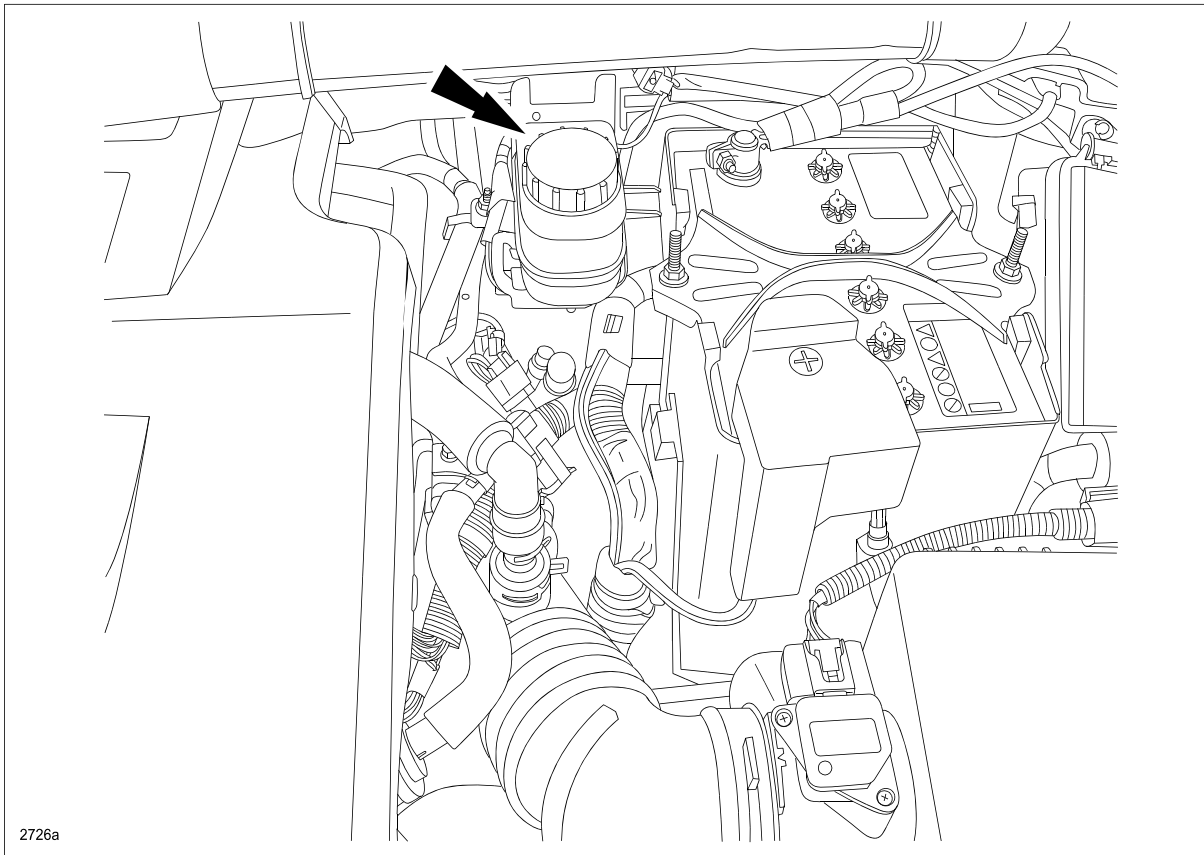
Use extreme care when replacing or re-filling brake fluid at the master cylinder. There are several wiring harnesses that run under the master cylinder that can be easily spilled upon.

CAUTION: Brake fluid contains properties that can cause a short-circuit in a wiring harness. If brake fluid is spilled on any wiring harness, clean it up immediately using a shop rag and water. Be sure to wipe the fluid completely from the harness.
