Service Bulletin

Bulletin No.: PIC5912

Subject: Diagnostic Tip - Loss Of Glove Box Operation Perform Manual Release Method

Models: 2014 Cadillac CTS Sedan

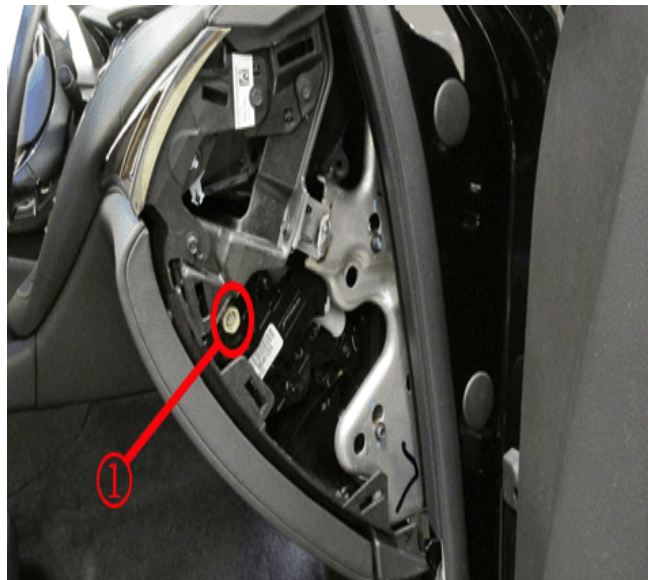
3619322

A customer may comment that the glove box is inoperative. To open the glove box door manually follow the instructions below.

Please remove the right Instrument Panel Outer Trim Cover. Locate the plastic nut (14mm - 6 point socket) on the glove box motor assy. Refer to locator number 1 in picture below. Rotate the nut counter-clockwise to release the glove box door.
