## Ceiling Panels - Rivets

**Property and Top Bus Number:** DART: 304500

**Issue:** Ceiling panels coming loose.  
**Reason/ cause:** Rivets are breaking.  
**Solution:** Replace aluminum rivets with stainless steel.  
**Affected buses:** **39001-39087**  
**Estimate repair hours/bus:** 2 hours

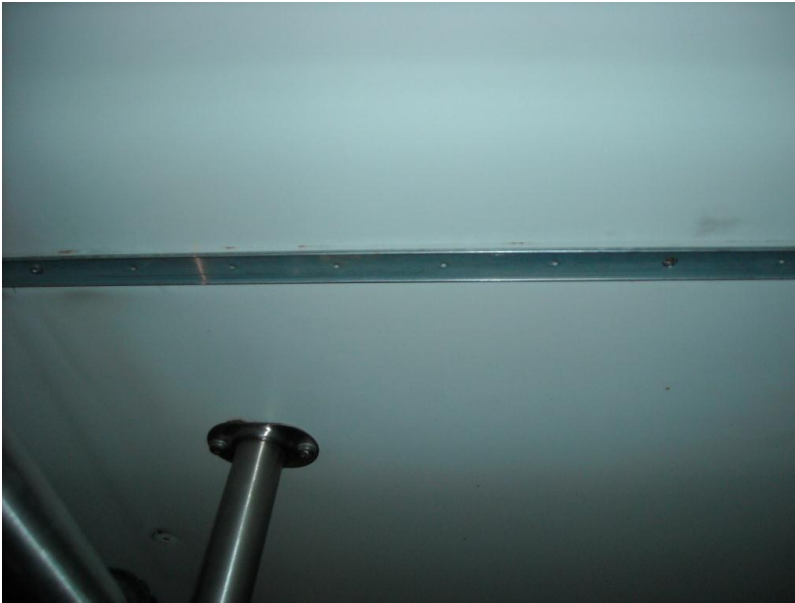
1. Park the bus and apply the parking brake.
2. Turn off main battery disconnect switch(es).
3. Remove cover from ceiling base molding.

4. Install rivet within 2 inches from each end and add rivets between existing rivets.
5. Re-install cover for ceiling base molding.
6. Clean bus of all debris and metal shavings.
7. Check for completeness of work.
8. Remove all tools from working area.
9. Turn the main battery disconnect switch(es) on.
