42BRT: Roof Cap Bolt Addition

Property and Top Bus Number: Broward 60BRT 295000 and 42BRT 303000

Issue: Roof cap bolts addition

Solution: Add bolts per this work instruction

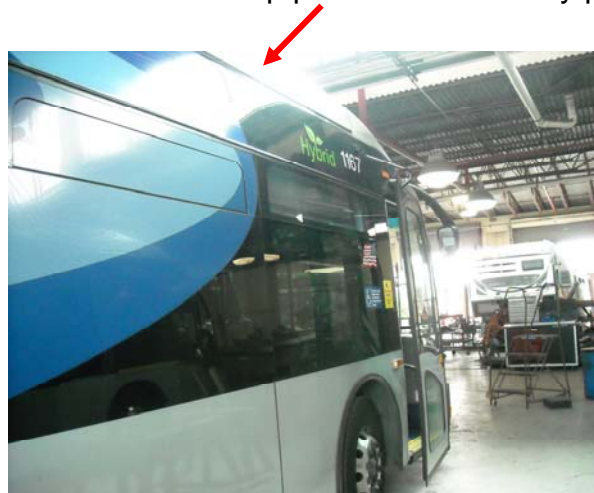
1. Park the bus and apply the parking brake.
2. Turn off main battery disconnect switch(es).
3. Go to the roof and locate the front roof cap panel. Follow safety precautions when working on the roof.

4. There are four access holes on the roof cap. Underneath each opening there is a M8 threaded hole in the frame.
5. If there is a bolt in the frame then remove bolt.
6. Inspect threads and clean them with an M8x1.25 thread tap if required.
7. Add the 3/16" thick 2"x3" size square washer, M8 lock washer and apply Loctite 246 to the first 3 threads of the new M8x1.25-30 Class 10.9 (grade 8) bolt.
