NABI BRT: Battery Disconnect Switch Compartment Repair

Property Name: NABI 42 and 60BRT-s

Issue: Corrosion at battery disconnect compartment.

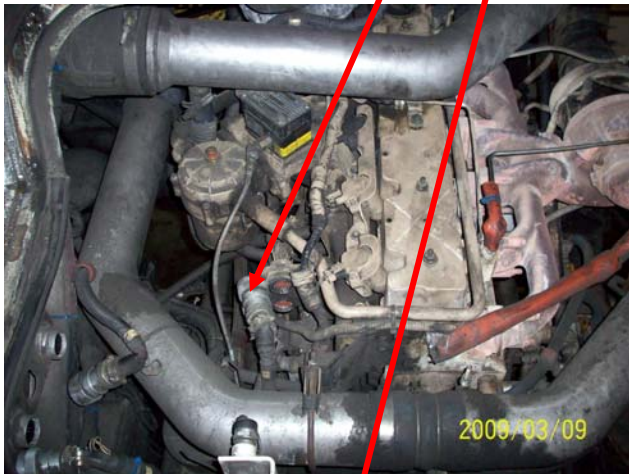
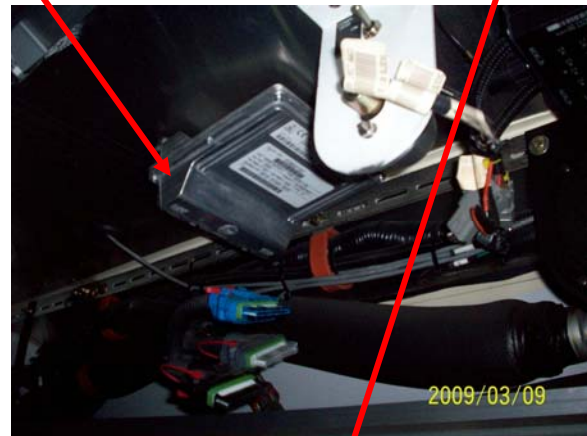
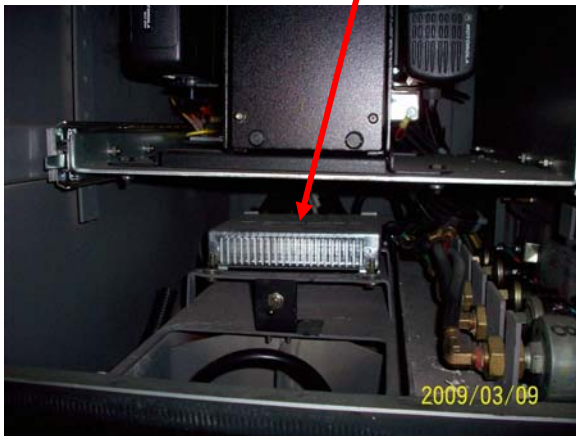
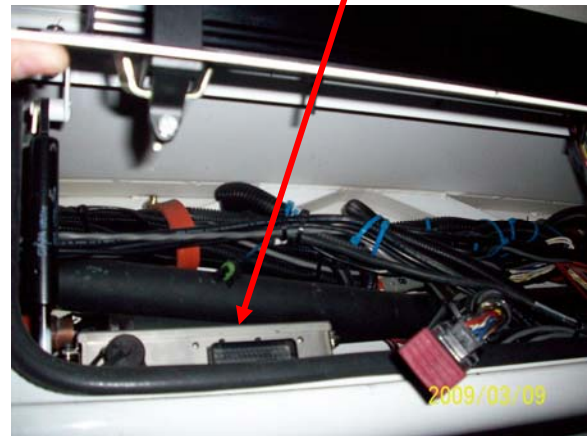
1. Park the bus on a leveled surface and apply the parking brake.
2. Turn off the battery disconnect switches.
3. Tag and disconnect the batteries cables.
4. Disconnect the ECU of engine, ABS, transmission, and the Hubner (anti knife system).

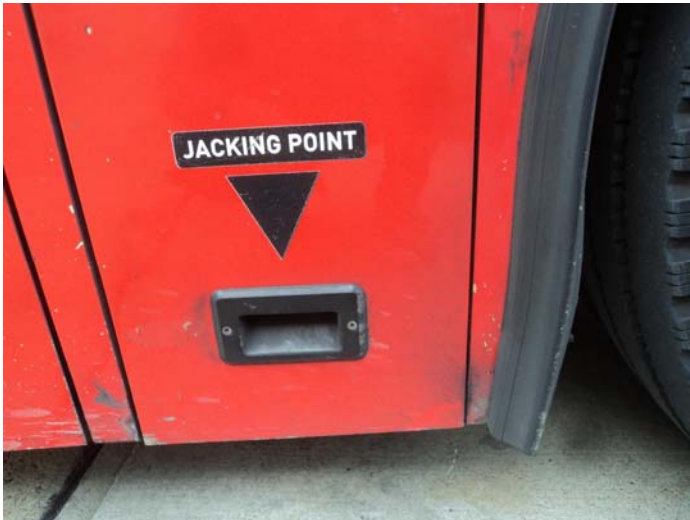
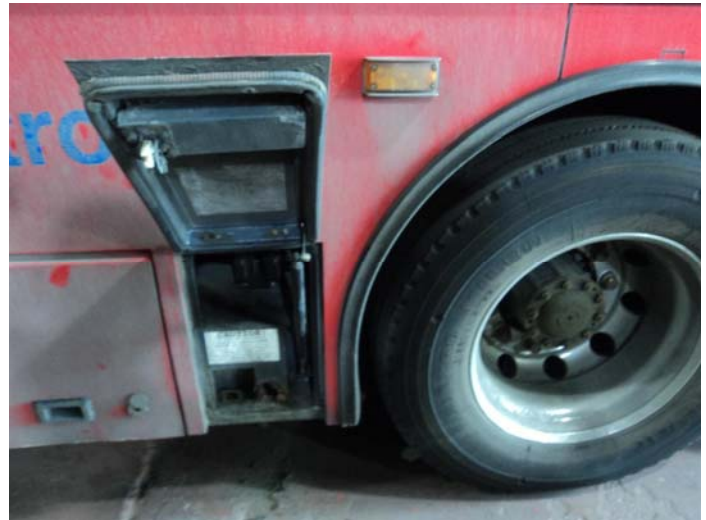
7. Remove battery disconnect switch compartment door with gas spring.

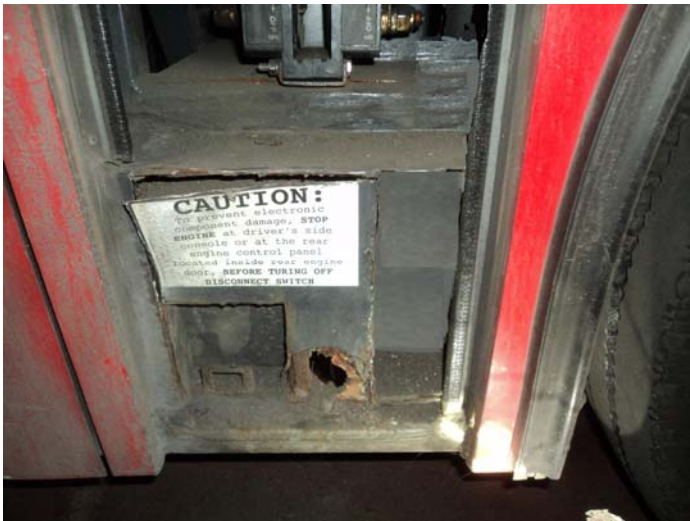
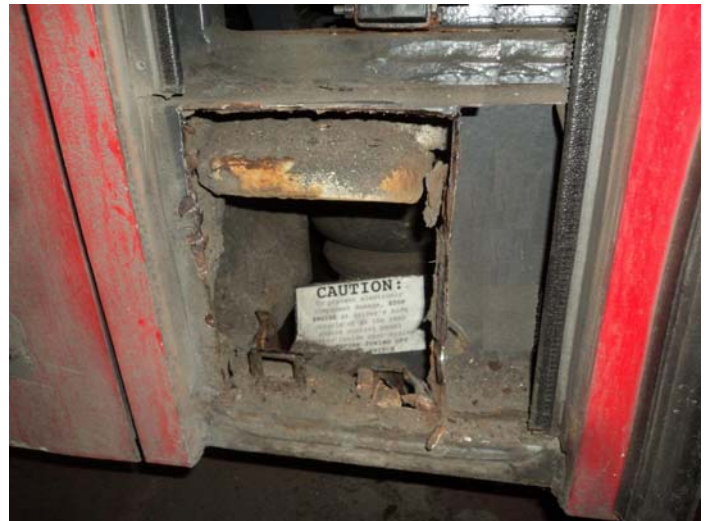
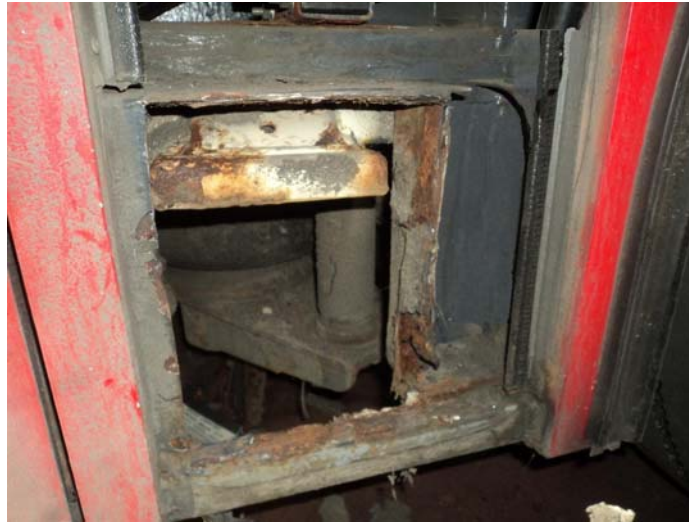
8. Cut and remove corroded sheet metal parts. Cut only as needed in order to remove the corroded area. See pictures below.

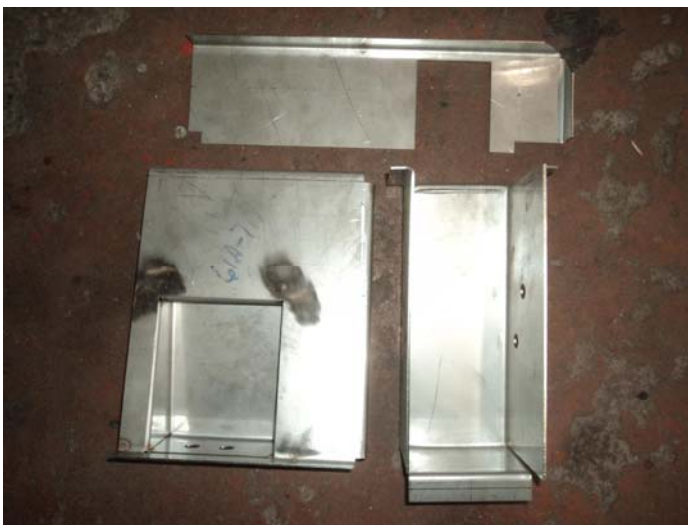
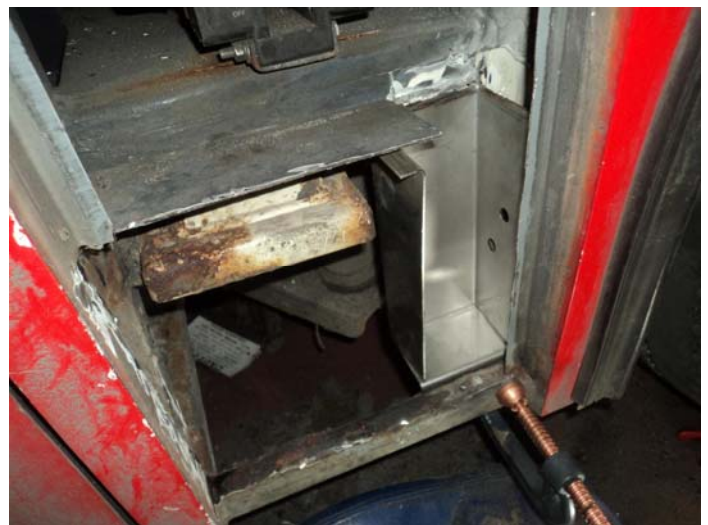
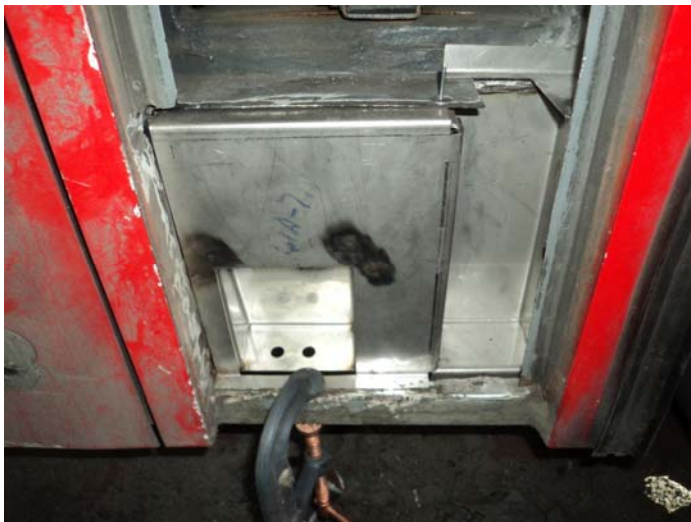
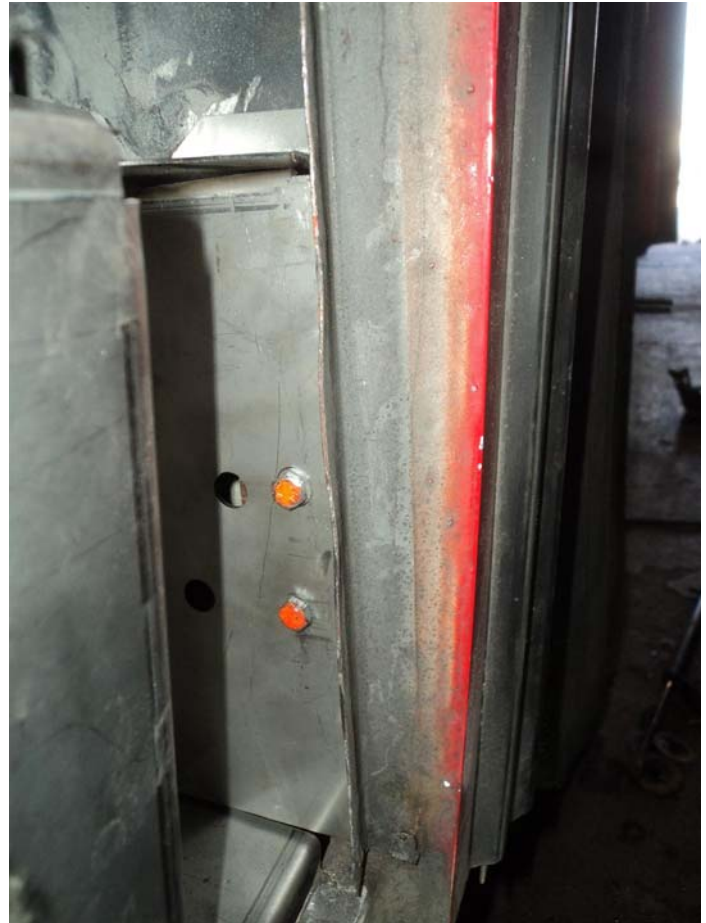
9. Clean and prime/paint any parts (as required) that will cover by the new sheet metal parts.
10. Install new parts per pictures below. Use rivets and clamps to temporary secure parts in place.

Note: according to the size of the corroded area, maybe not all of the new sheet metal parts are required. Cut new sheet metal parts if only the section of it required. Weld parts according to the followings:

- Use GMAW (MIG) welding process with 309LSi .030/.035 welding wire and 98%Argon 2%Oxigen shielding gas (or Trimix) with 8-10 liter/min gas flow.
- Tack and stitch weld sheet metal parts together and to the existing sheet metals.

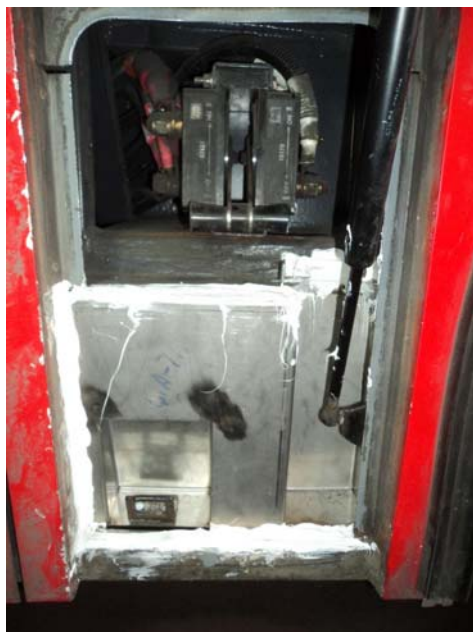
11. Prime and seal the connections of new and original sheet metal parts.

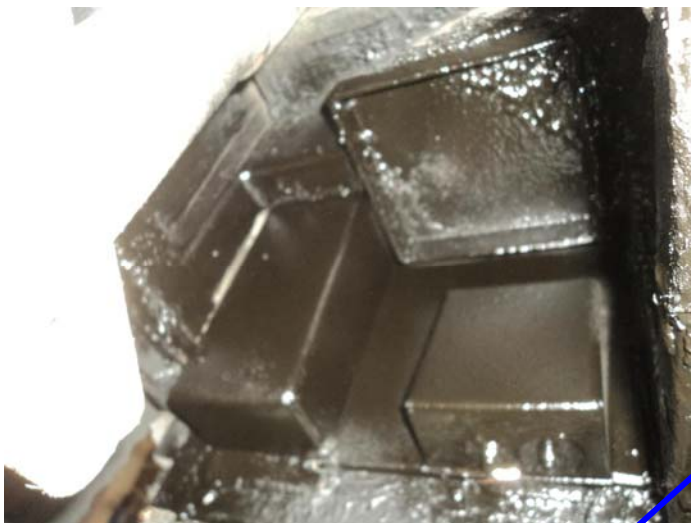
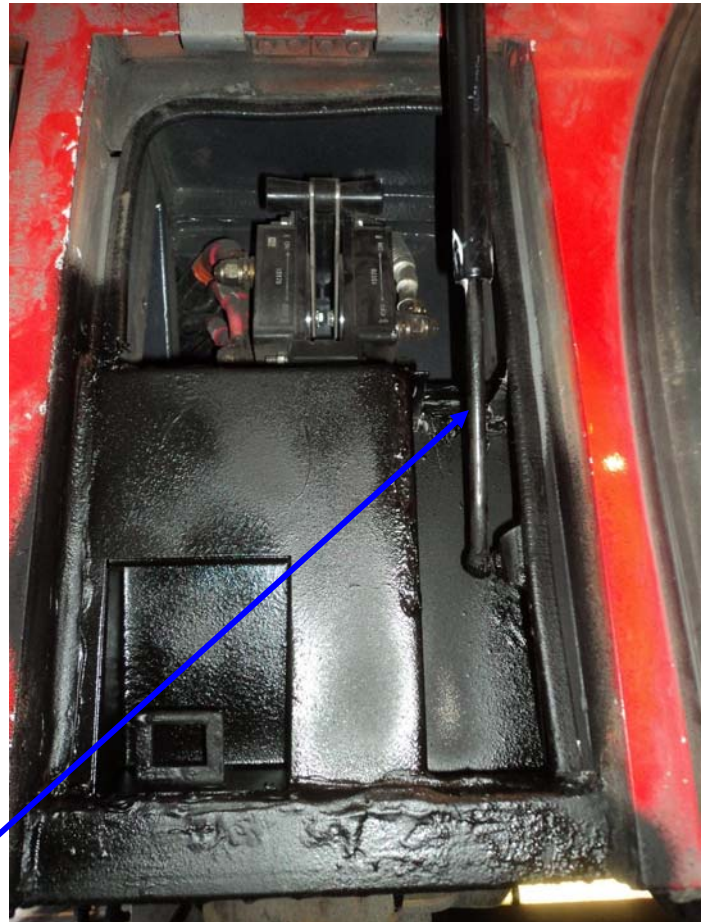
12. Apply rubberized undercoating both sides of the repaired area.
