NABI 40 LFW: Front Understructure Repair

**Property name:** MBTA

**Model:** NABI 40LFW-24

Work instruction number: L3/FSV-137  
L4/QUA-003

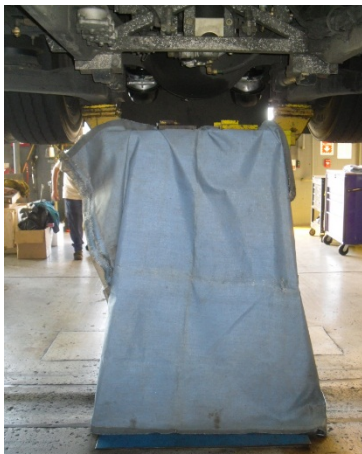
Protect  
the lift  
with  
welding  
blanket

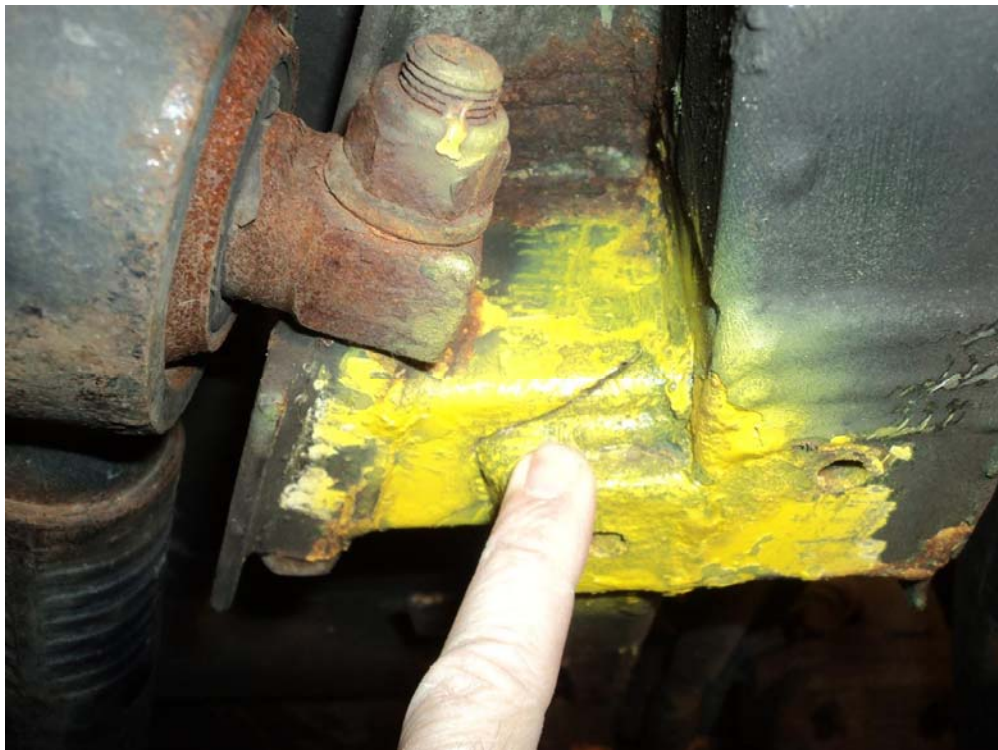
- Find the end of the crack (use magnifier or penetrate as needed).

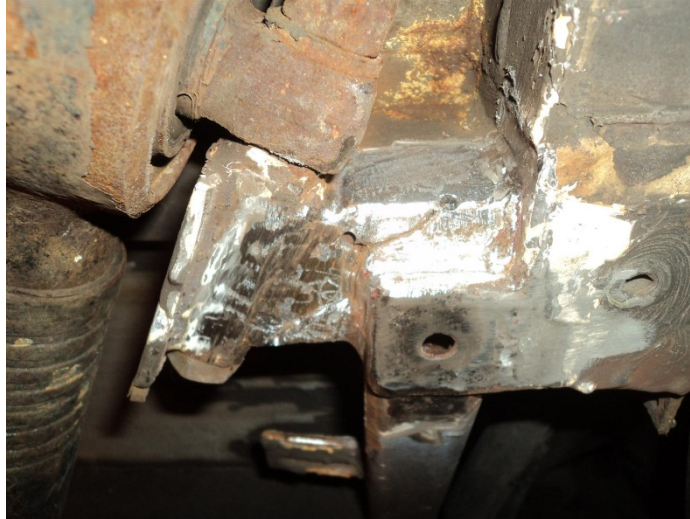
- Drill a 1/8" size hole at both ends of the crack.

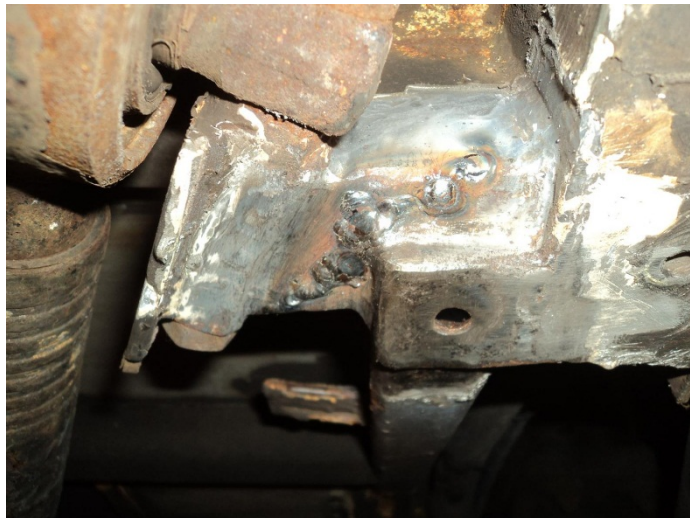
- Bevel the crack profile 2x30° for single "V" butt (groove) weld.
- Clean the welding surface area with 36G abrasive disc, wire wheel and de-burr bits as required.
- Degrease the surface with alcohol or industrial degreaser.
- Weld the cracked along the bevelled line with continuous weld per **WPS NABI-R02-CS**.

- Grind the weld surface until the same height as the parent metal.
- Check the welds by Visual Test and/or Penetrate Test. Prep and re-weld if required.

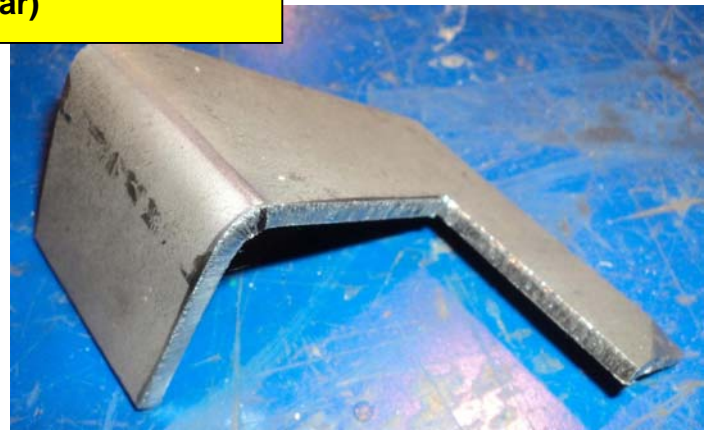
**Gusset Shown for Street Side radius rod bracket (curb side is similar)**

Install 12 gauge carbon steel (like A36) gussets only if the base metal is corroded and the gap can't be closed by simple welding. This gusset has to be welded between the square block (that holds the radius rod bolt) and the nearby structural tubes. This gusset is intent to provide a strong connection between these structural components and not just to cover the hole. Considering this follow the instructions below:

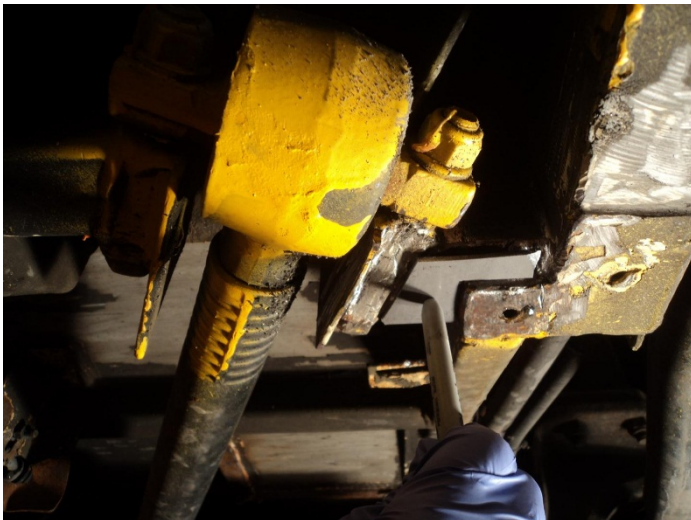
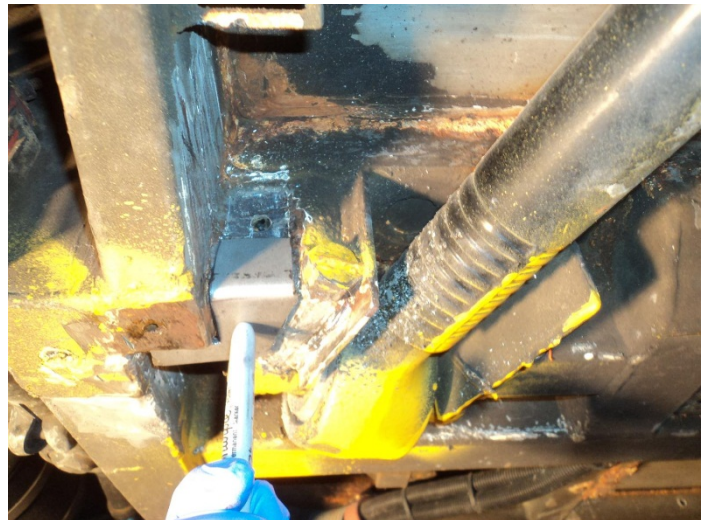
- Place and set the gussets in position (see pictures below).
- Check the position, gap and if necessary, bend/cut/grind the part as required.

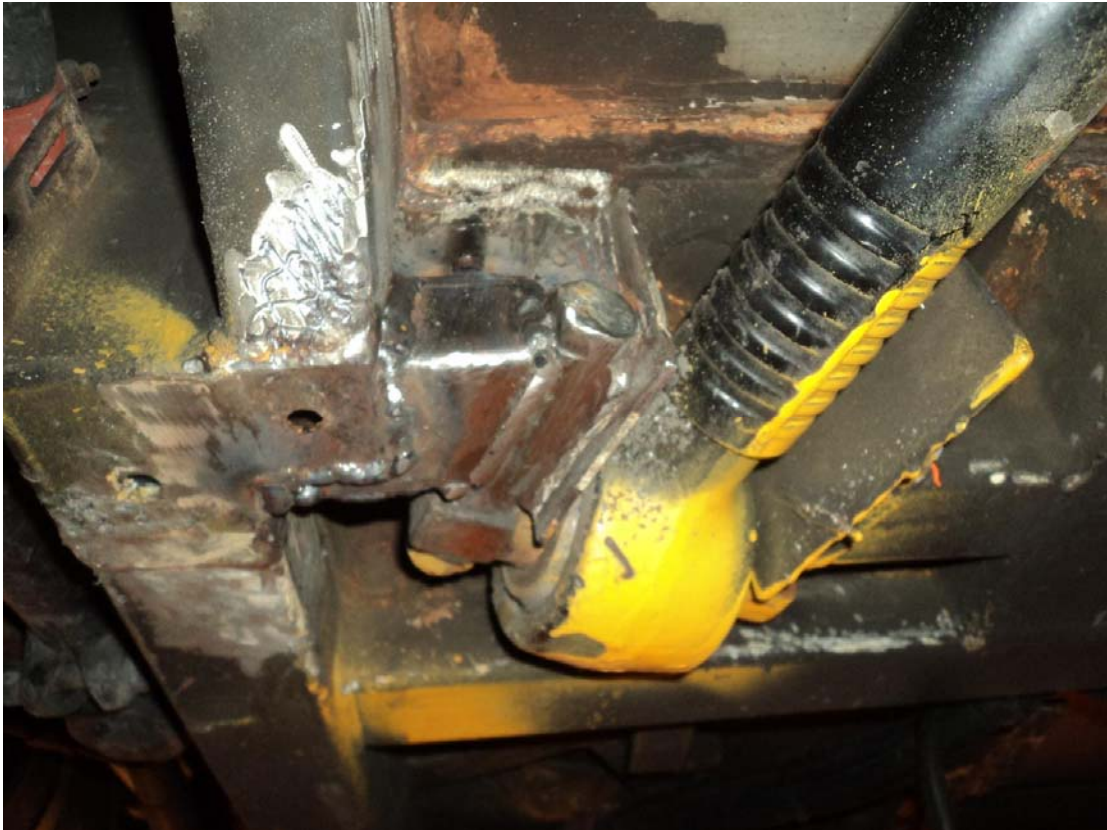
- Weld the gusset all around with continuous weld according to the WPS NABI-R02-CS.
- Clean welded area with wire wheel or brush.
- Check the welds by Visual Test and/or Penetrate Test. Prep and re-weld as required.

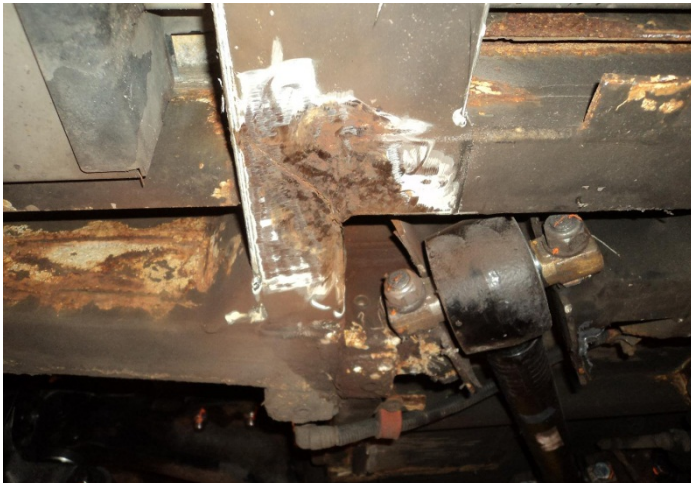
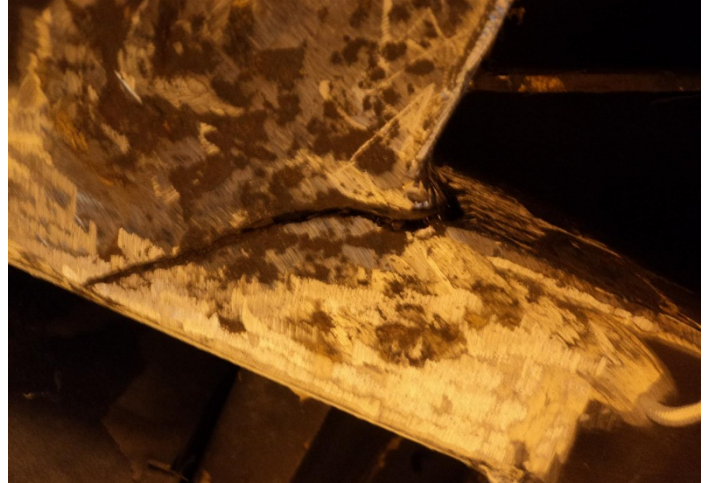
- Locate the end of the crack (use magnifier or penetrate if required).

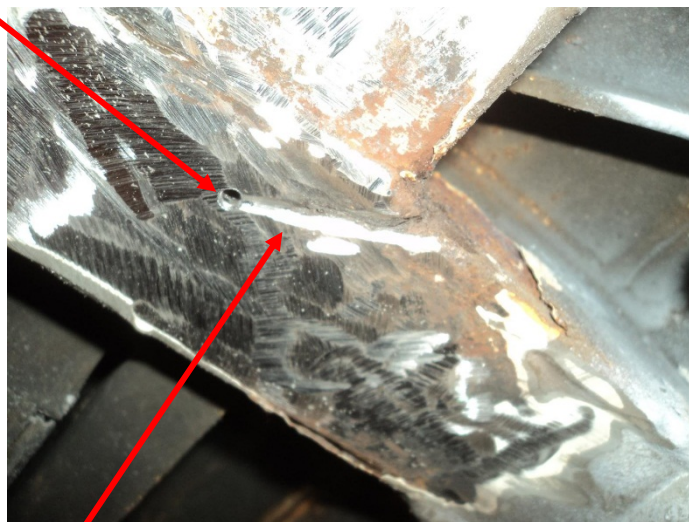
- Drill a 1/8" size hole at both ends of the crack.

- Bevel the crack profile 2x30° for single "V" butt (groove) weld.
- Clean the surface at the welding area with 36G abrasive disc, wire wheel and de-burr bits as required.
- Degrease surface with alcohol or industrial degreaser.
- Weld the cracked along the bevelled line with continuous weld per **WPS NABI-R02-CS**.
- Grind the weld surface until the same height as the parent metal.
- Check the welds by Visual Test and/or Penetrate Test. Prepare and re-weld as required.

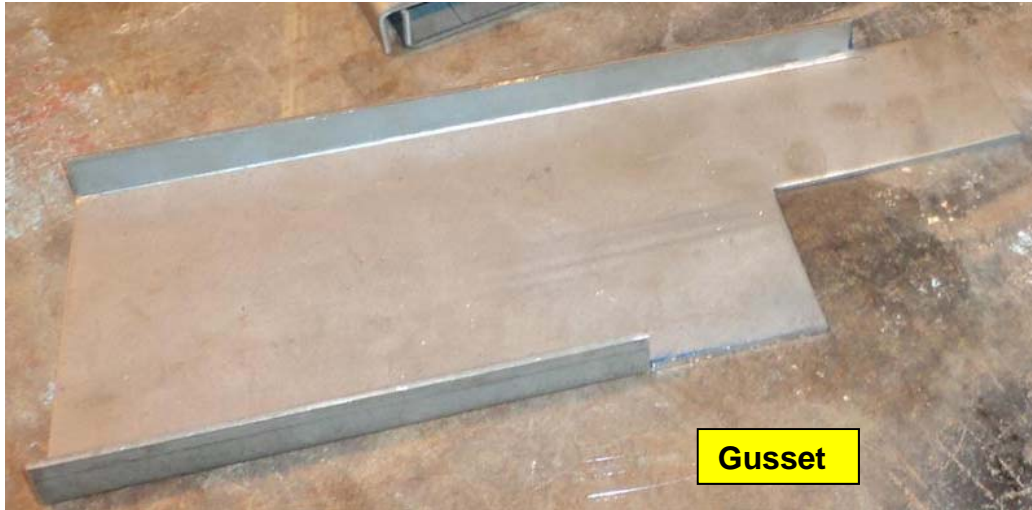
- Install 12 gauge carbon steel (A36 or equivalent) gusset only if the base metal is corroded and the gap can't be closed by simple welding. This gusset, if needed, is welded between the longitudinal structural tube and the second crossmember and is intended to provide a structural repair between these components. Follow the instructions below:

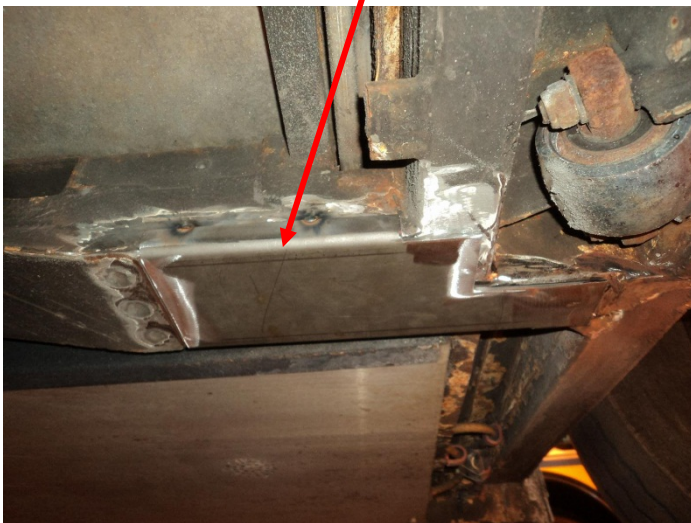
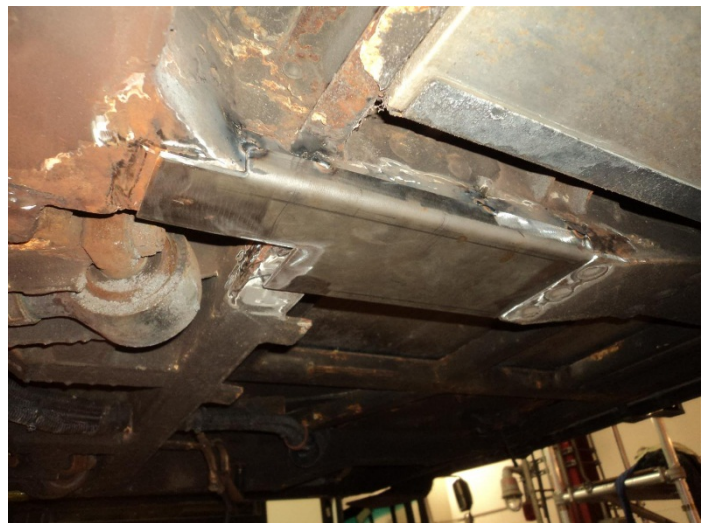
- Clean the surface at the welding area with 36G abrasive disc, wire wheel and de-burr bits as required.
- Place and fix the gusset in the right position (see pictures below).

- Check the position, gap etc., if necessary bend/cut/grind the part as required.

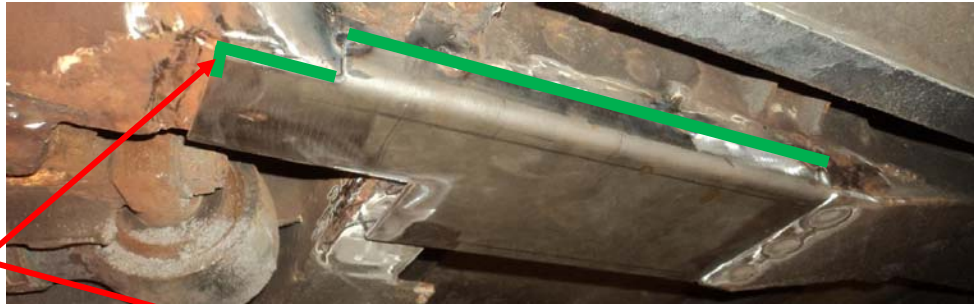
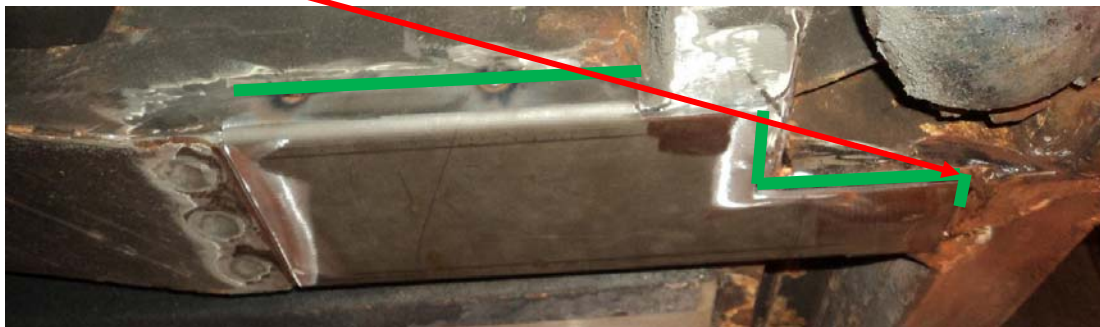
- Weld the gusset along the green lines only (shown on picture below) with continuous weld according to the **WPS NABI-R02-CS**. Note the  $\frac{1}{2}$ " long welds at the corners. **Do not cross-weld the tubes just max  $\frac{1}{2}$ " as picture shows below!**

Turn  $\frac{1}{2}$ "  
at these  
corners  
without  
interrupt  
the weld

- Clean welded area with wire wheel or wire brush.
- Check the welds by Visual Test and/or Penetrate Test. Prep and re-weld as required.
- Prep the surface for seal and paint per paragraph 4. Apply Sikaflex 221 sealer along the edges where no welds were applied.

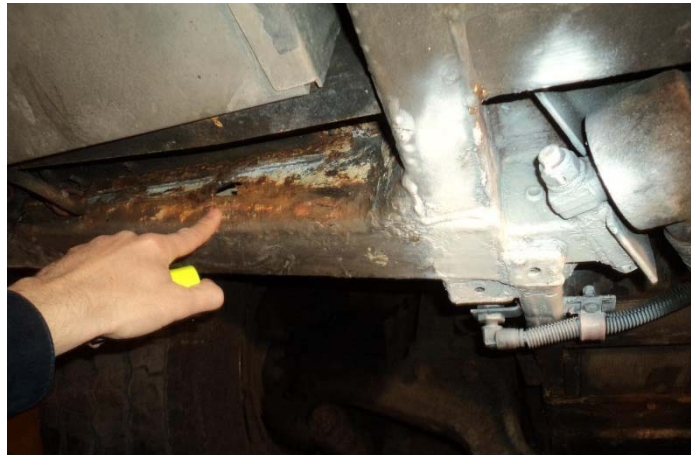
The second crossmember in front of the curbside wheel is an assembly of square steel tubes welded together and sheet metal that covers this tube frame. Corrosion on the sheet metal doesn't affect the structural integrity of the second crossmember assembly. If repair is required, follow the process below:

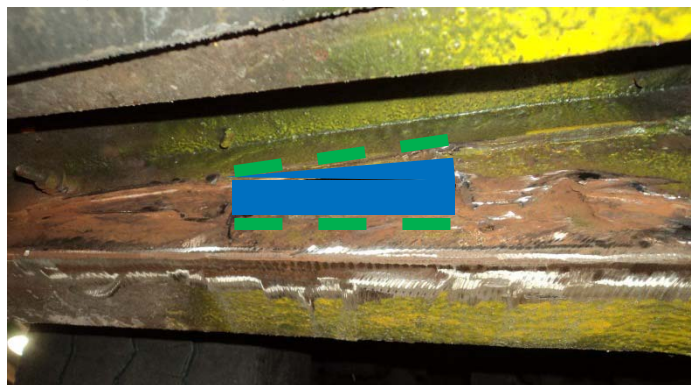
- Cut the corroded sheet metal section out. **Take caution not damage or disturb the structural tubes.**
- Clean the welding surface area with 36G abrasive disc, wire wheel and de-burr bits as required.
- Install a 14 gauge carbon steel (A36) sheet metal piece flush against the existing sheet metal.
- Stitch-weld (1" weld - 2" gap) the new piece onto the existing sheet metal and to the structural tube according to the photograph below.

- Grind the welds to provide a smooth surface.
- Surface preparation is according to Step 4 (see page 14).

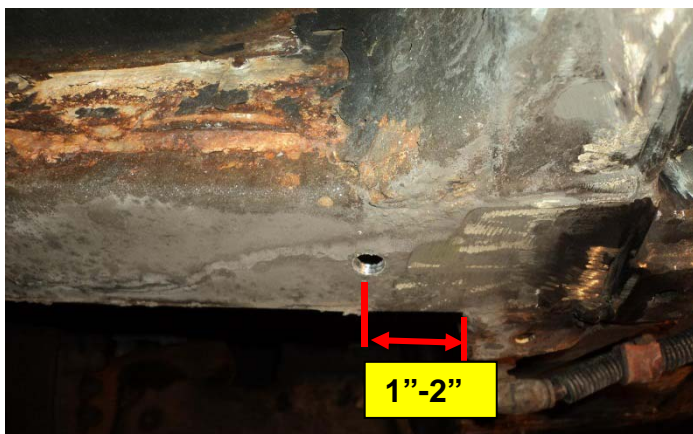
Drill 3/8" size holes to the following locations:

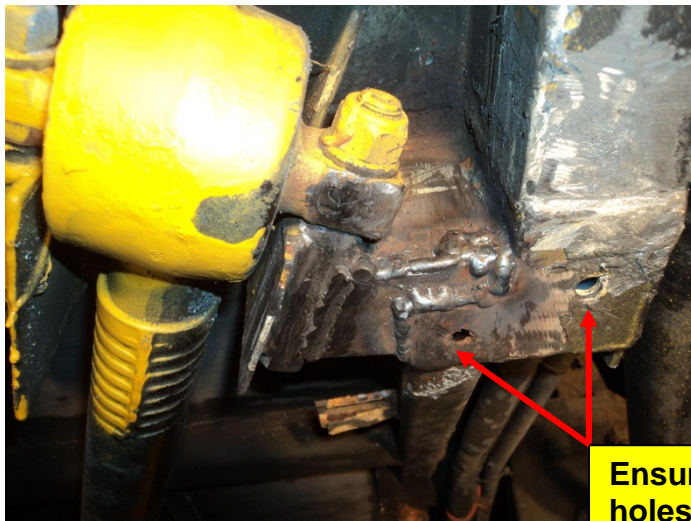
Ensure that these holes are clean beside the front radius rod brackets.

De-burr holes then spray primer and undercoating to around the bare edges of the holes.

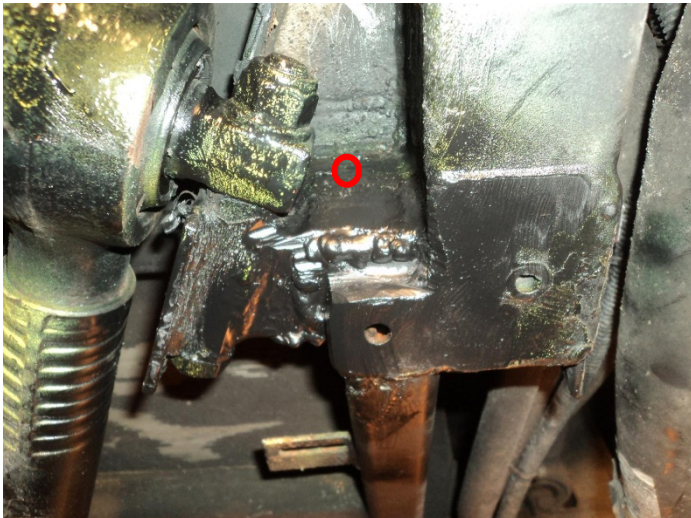
- 4.1 Remove weld splatter.
- 4.2 Grind welding as required.
- 4.3 Restore surface treatment and under coating.
- 4.4 Surface protection instruction:
  - 4.4.1 Degrease all repaired area.
  - 4.4.2 Prime all crude surfaces with industrial primer.
  - 4.4.3 After two inspection (12,000 miles), apply rubberized undercoating material to the primed surfaces and spray undercoating inside the small tubes through the existing holes (see below).
