45CLFW 8100: Cooling System Updates (4B)

Property name and top bus number: NABI 45CLFW 8100 series buses

Issue: Air in the cooling system.

Reason/ cause: Cooling system was updated to enhance de-aeration.

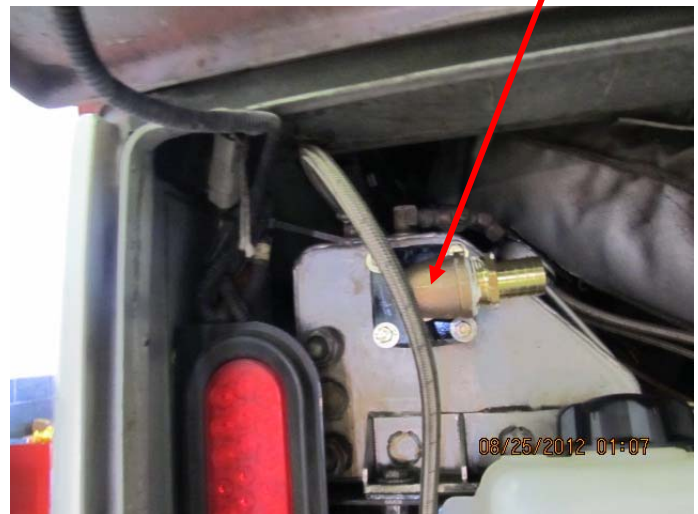
4. Replace existing surge tank fill cap with new adapter plate assembly, which includes 90 elbow and 1" hose barb. Seal treads with thread sealant.

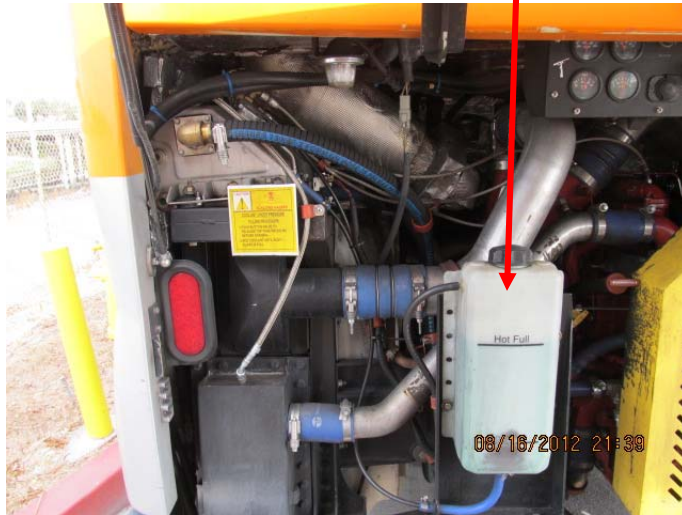
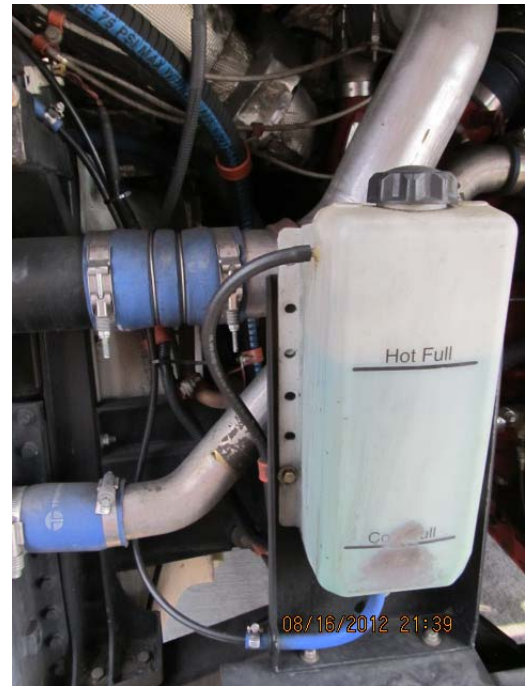
5. Install recovery tank bracket, recovery tank and the required hoses and clamps per the pictures below.

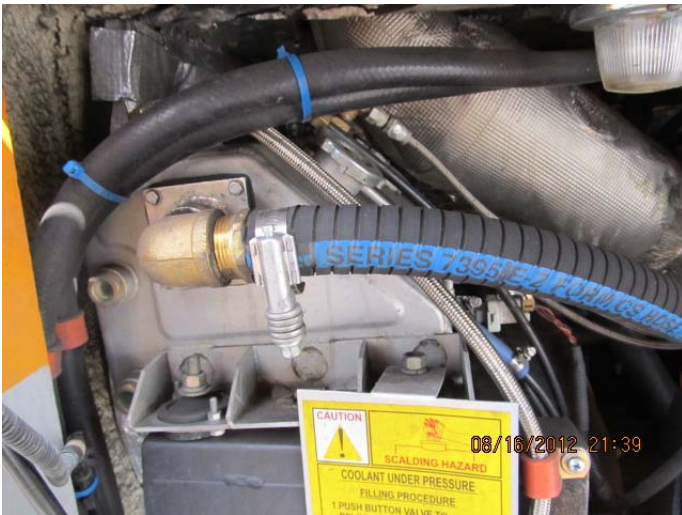
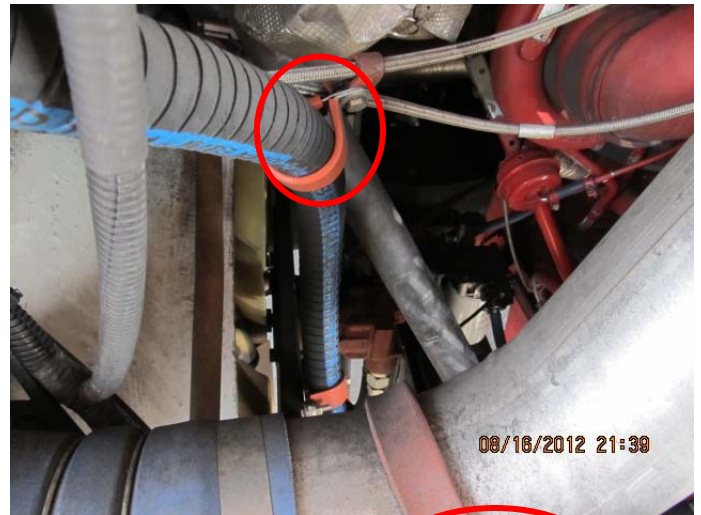
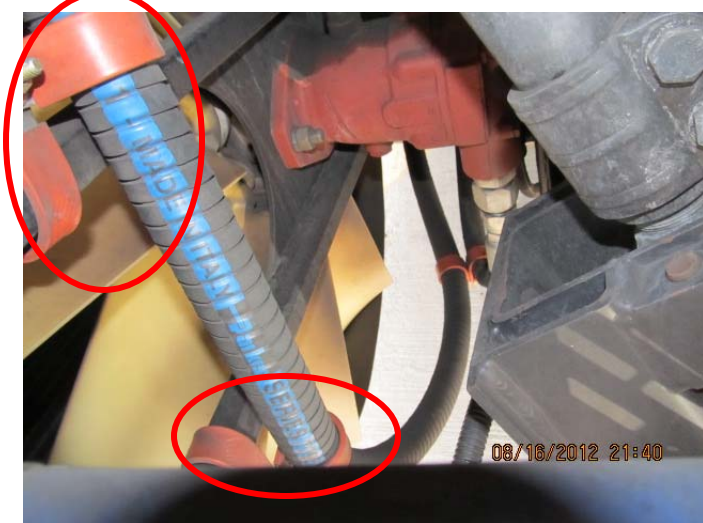
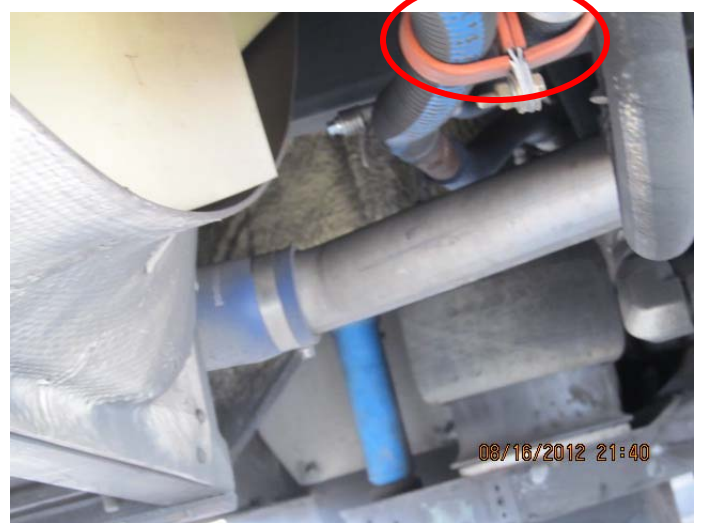
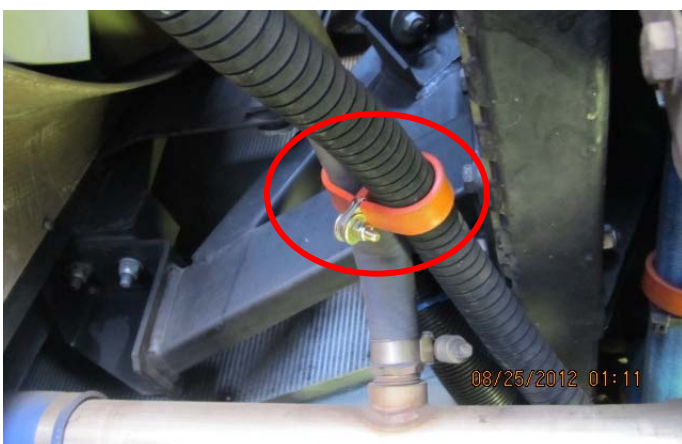
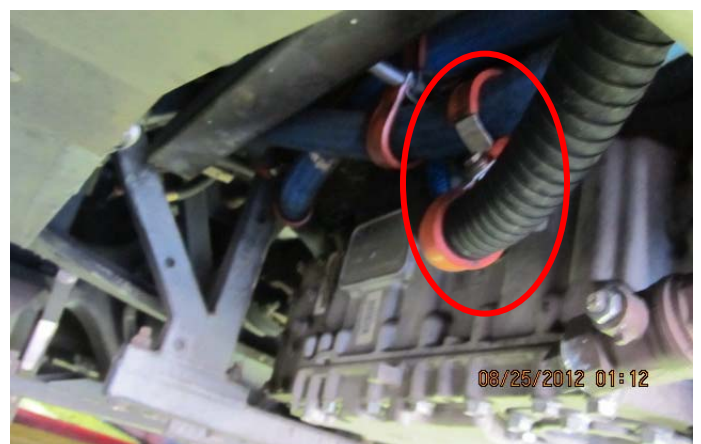
- Route 10' of EZ Form hose from adapter plate on surge tank and secure it with P-clamps as pictures show below.

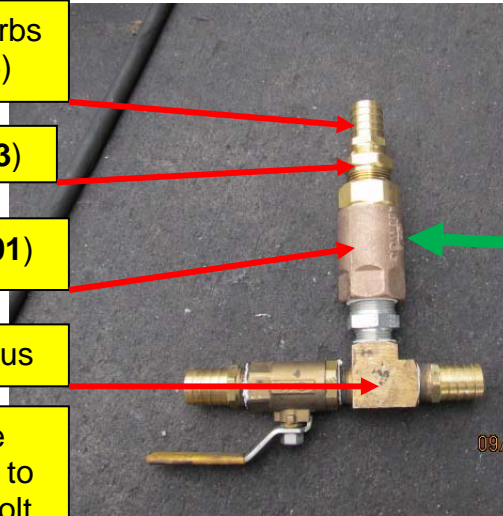
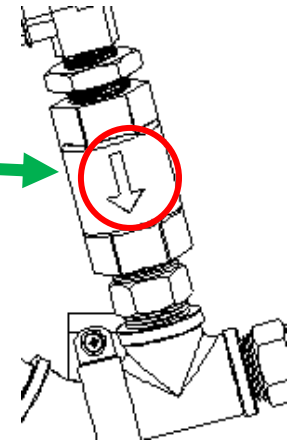
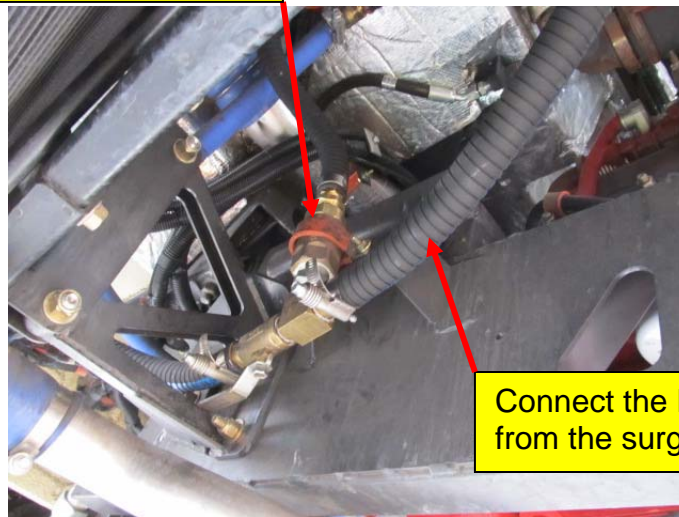
- Remove heater return hose in between ¼ turn valve at heater return tube and ¼-turn valve at lower radiator tube.
- At the lower radiator tube, remove ¼ turn shut off valve and install plug in port.
- Install check valve with fittings as pictures show below.

16MP-16HO hose barbs
(PN 436.00.1355.905)

Nipple (PN 5030503)

Check valve (PN 5000001)

Use existing Tee and ¼-turn valve on bus

Install check valve / Tee / 1/4-turn valve assembly here. Secure valve assembly to the bracket with P-clamp and ¼-20x1 bolt.

Connect the EZ-form hose coming from the surge tank to the here.

- Connect EZ- form hose from adapter plate on surge tank to valve assembly.
- Remove tools and unused material from work area.
- Check for completeness of work. Ensure that hoses are not rubbing or kinked. Check that the vent lines are continuously rising towards the surge tank.
- Refill and de-aerate cooling system per **NABI L3-FSV-026** work instruction.
- Record bus number, date of completing, mileage and the name of the technician who completed the work.
