NABI Service Bulletin: SB-13-17-01

Subject: Steering - Pitman Arm Nut Securement to the Steering Gear Output Shaft

Date: February 15, 2013

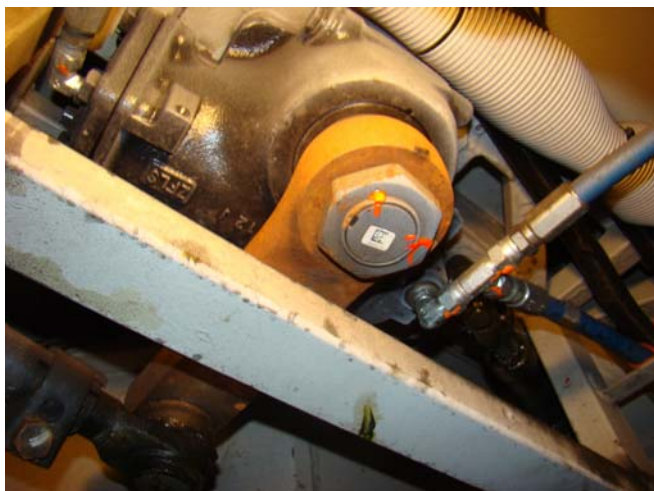
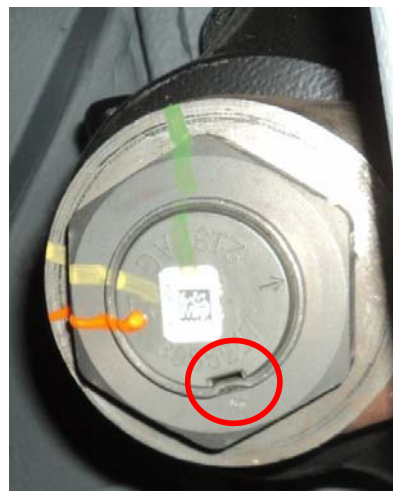
- The torque for the pitman arm nut to the steering gear output shaft is 520 lb.-ft. (+/- 15 lb.-ft.).
- After torquing, ensure the collar of the nut is deformed into the groove of the steering gear output shaft as shown on the attached photos (see highlighted red area).
- Replace the pitman arm nut if required.
- Apply torque seal to the nut and shaft as appropriate for future visual inspections.
