LFW: Corrosion Repair

Property name and Top bus number: NABI LFW

Issue: Corrosion issues were reported by the customer.

Solution: Repair the effected area per this work instruction.

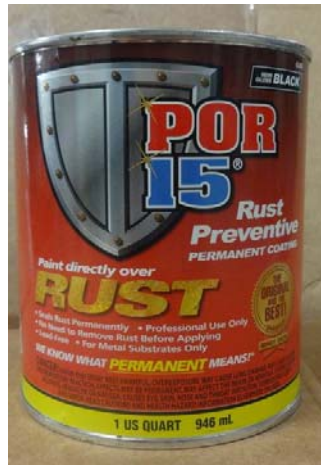
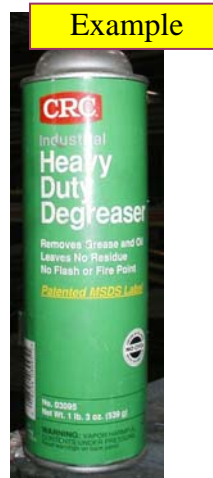
Example

See some pictures below about the possible usable products.

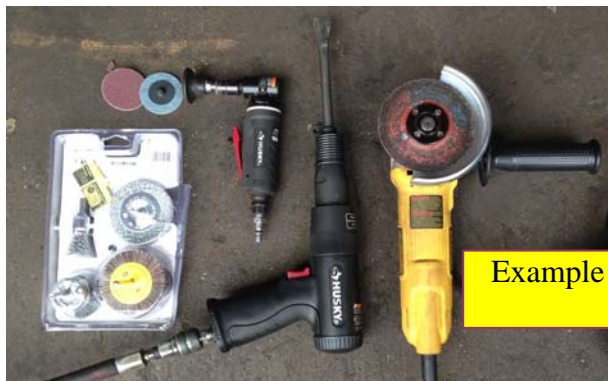
Example

Usual hand tools (wrenches, screwdrivers, hammer, chisel, etc.) putty knife, Sika applicator gun, angle grinder, wire wheel, 36G and 60G abrasive discs, de-burr bits

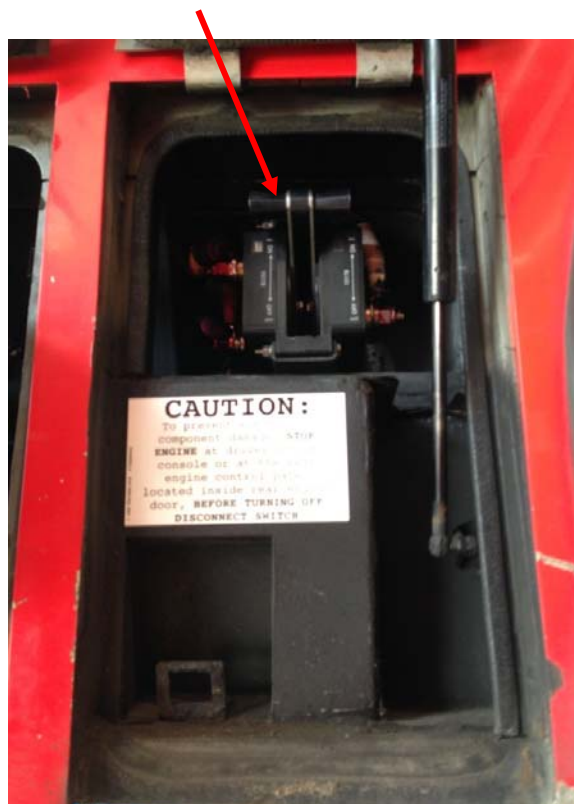
1. For the chassis inspection/repair the bus needs to be lifted. Place wheel lifts underneath the wheels and lift the bus approximately 2 feet from the ground. **Follow safety precautions when lifting the bus. Only trained personnel can operate bus lift!**
2. If bus parked on a scissors type lift then apply parking brake and also place wheel chocks underneath the B-axle wheels.
3. Turn off the battery disconnect switches.

4. Lift the bus up as high as required to perform inspection/repair underneath the bus. **Follow safety precautions when lifting the bus. Only trained personnel can operate bus lift!** Use jack stands underneath the official jacking pads.

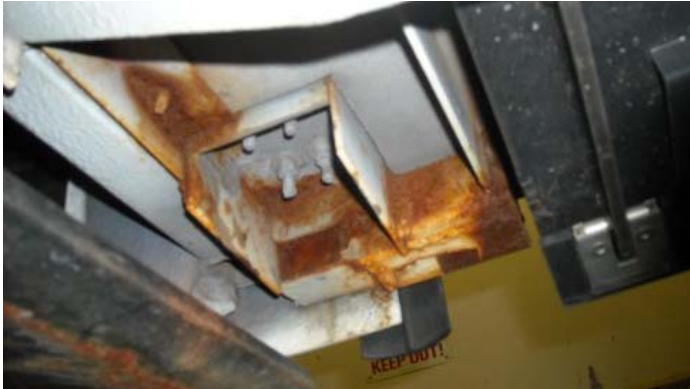
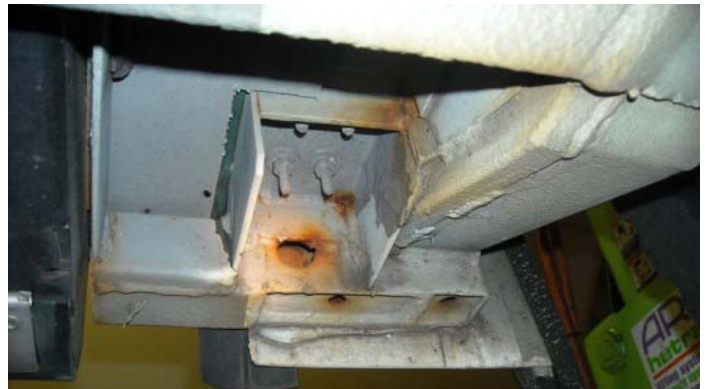
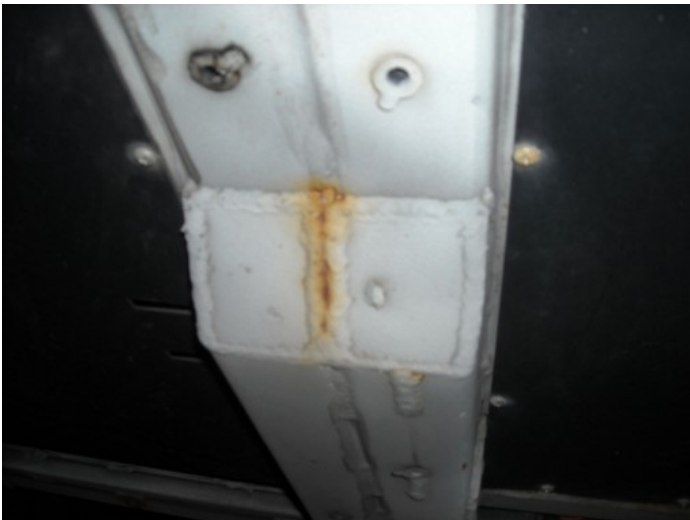
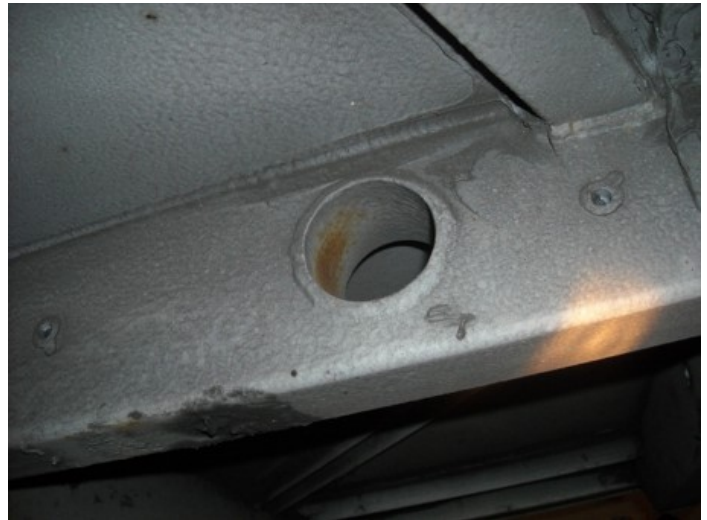
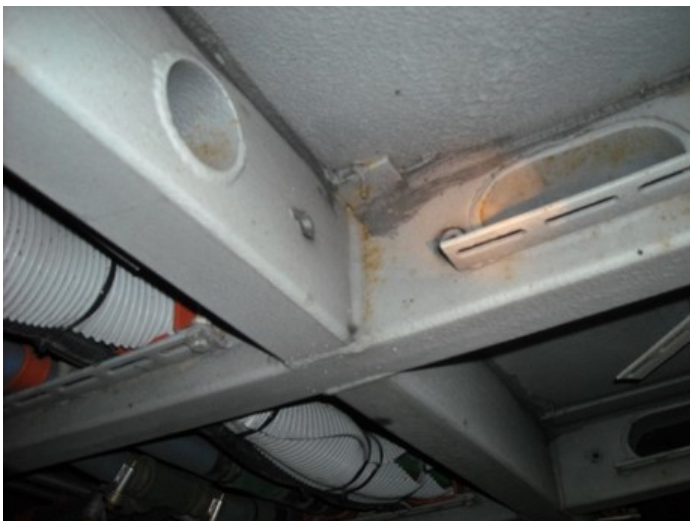
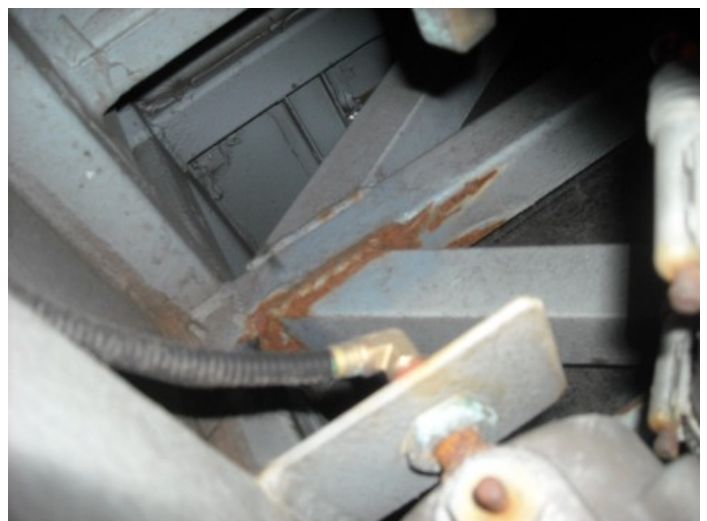
5. Inspect chassis from front to back and identify areas (if any) that needs to be repaired (see some examples below). If corrosion was found follow the steps written below. The below repair is an example and other area of the chassis should be repaired the same way.

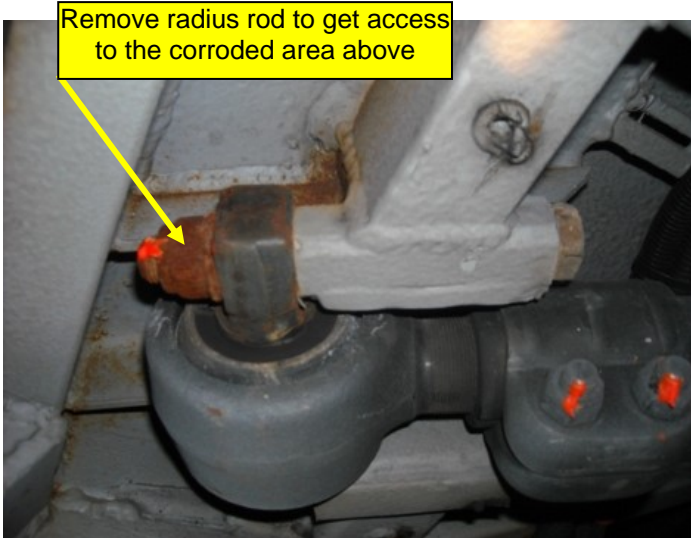
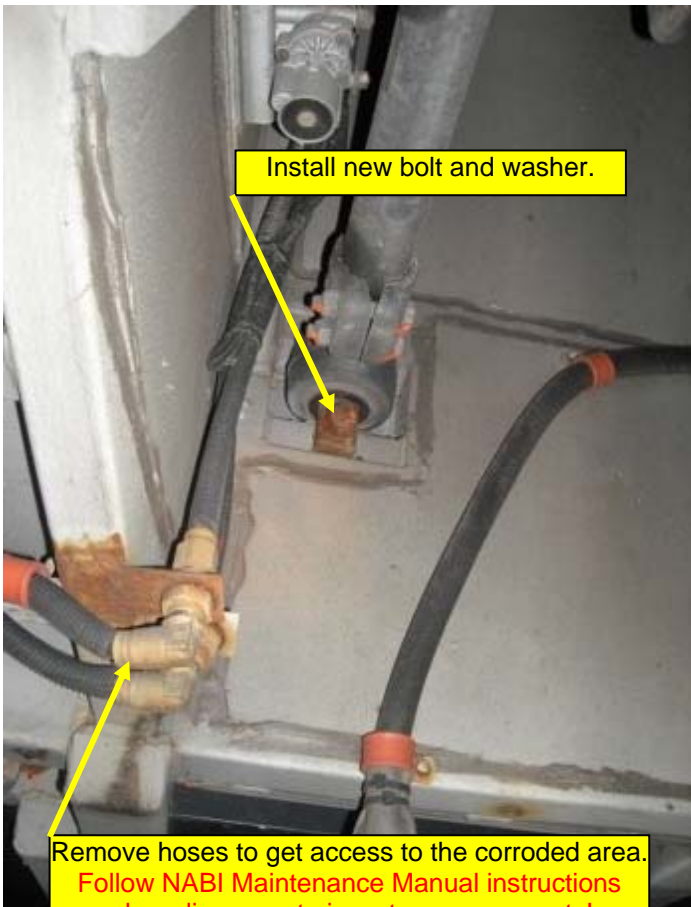
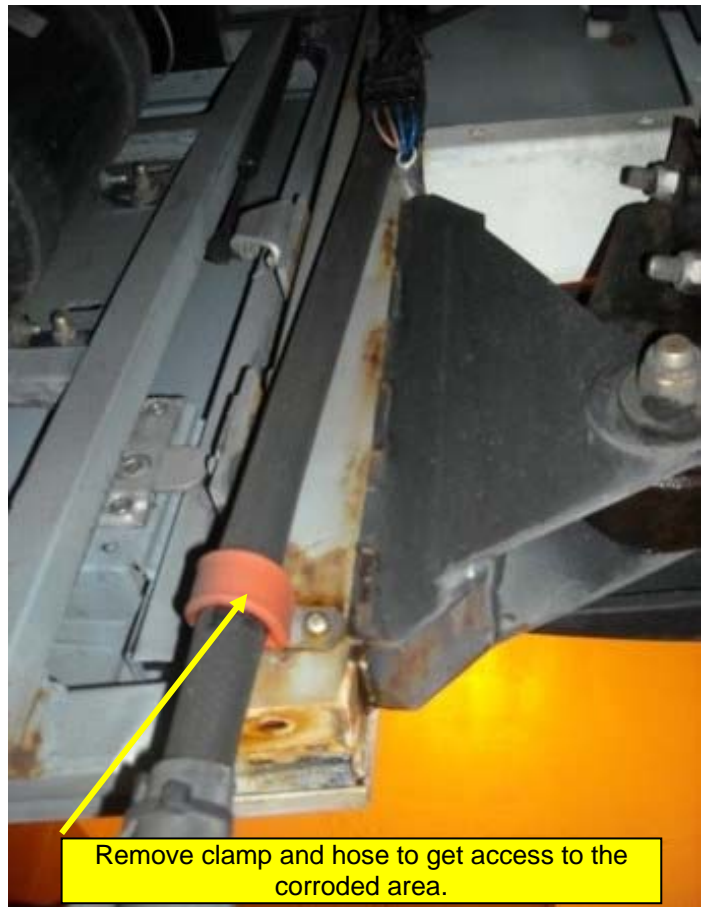
6. Remove nearby components (clamps, hoses, bolts, suspension components, etc.) as required (See some examples below.). Drain cooling and/or hydraulic system as required. Follow the safety precautions and recommendation of NABI Maintenance Manual.

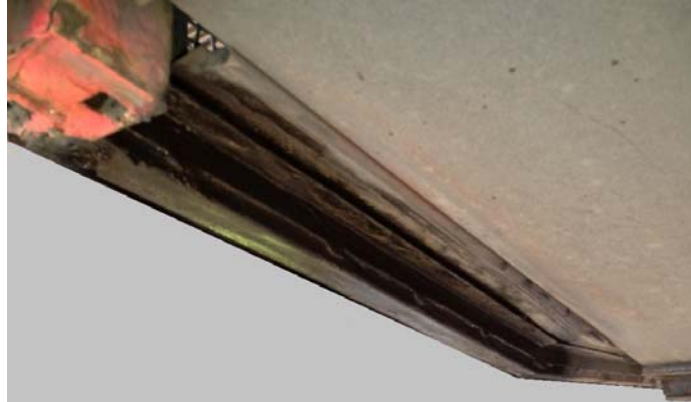
10. Apply POR 15 to the degreased area. Follow instruction written on the can. Let POR 15 dries before proceeding with the next step.

11. If Sikaflex sealer was present originally (for example between the top edges of structural tubes and floor panels) then reapply Sikaflex 221 sealer as required.
12. After the POR 15 (and or Sikaflex 221) dried apply undercoating to the primed area. Follow instructions written on the can.
